#### **4.0 GEOTECHNICAL TESTING, KEY DISTRESS INDICATORS, AND GEOTECHNICAL COMPARATIVE ANALYSIS**

##### **4.01 Introduction**

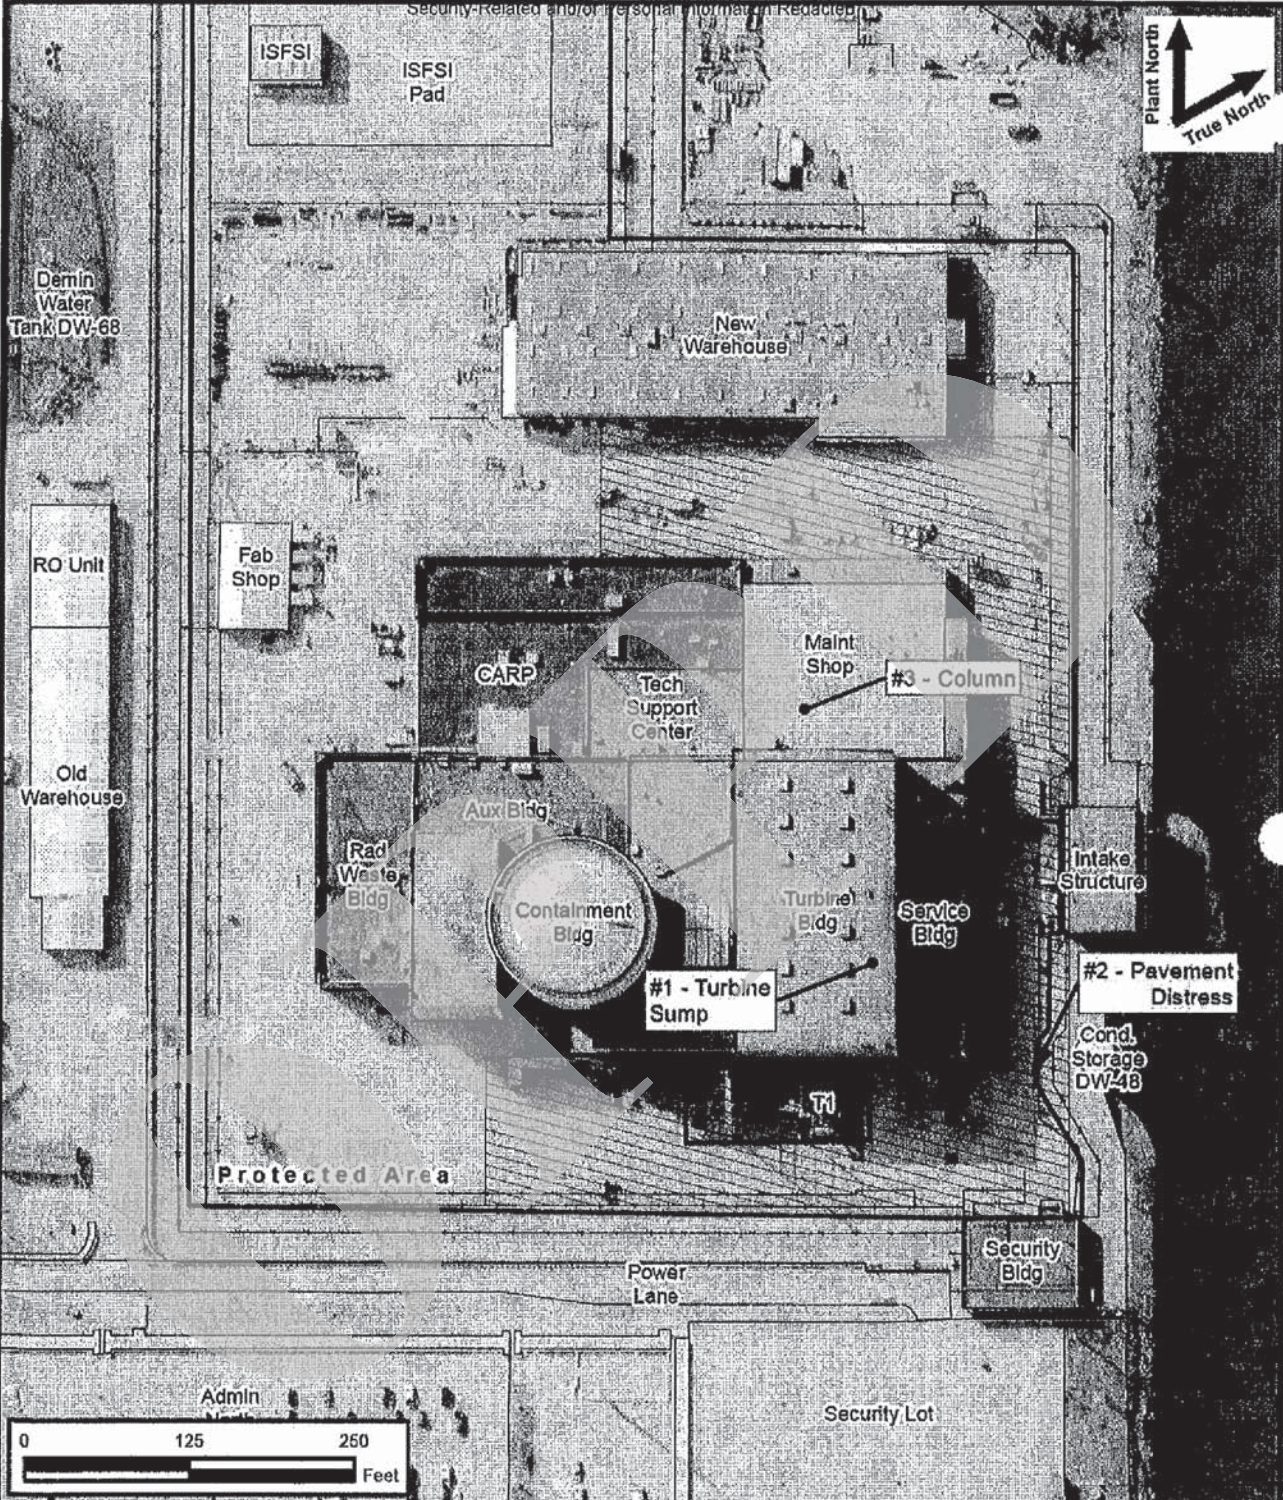
1. Increased flow into the Turbine Building sump
2. Pavement failure and surficial void in the Paved Access Area between the Intake Structure and Service Building
3. Column settlement in the Maintenance Shop

The locations of these KDIs are shown in Figure 4-1. Each of the observed KDIs was evaluated using PFM analysis to determine the associated Triggering Mechanism, to identify the CPFMs, to identify other structures that could be affected by the same PFM, and to recommend remedial measures intended to restore the KDIs to their pre-flood condition.
