4.3 KDI #3 – Column Settlement in Maintenance Shop

Maintenance Shop Drilling Locations
Cross Section Location Plan
Sections A-A, B-B, C-C
Fort Calhoun Station
 Plant and Facility Geotechnical and Structural Assessment

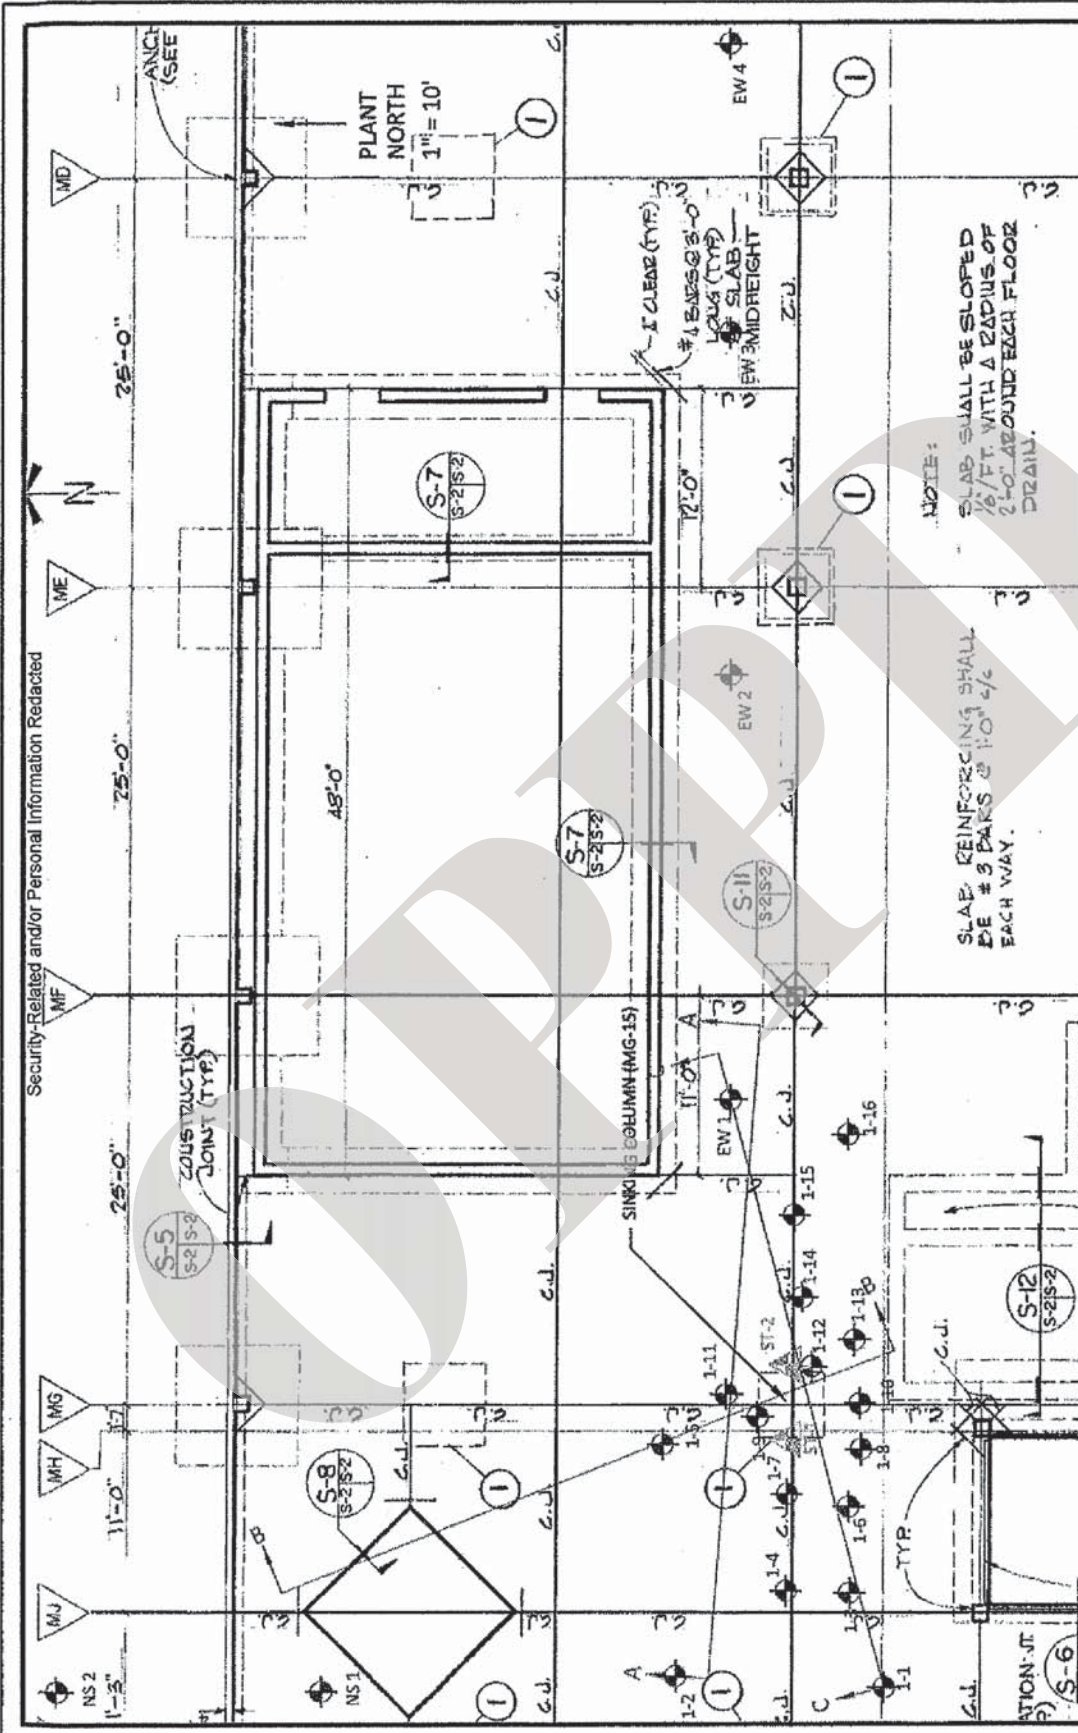
DATE April 2012
 FIGURE 4-13

Forensic investigation of the Maintenance Shop was conducted from November 9 through December 2, 2011. A total of 22 1-in.-diameter floor slab locations were drilled and the underlying subgrade evaluated during the investigation. This included 16 holes at locations nearby and surrounding Column MG-15 (drill-hole locations 1-1 through 1-16), 4 holes investigated to the east of Column MG-15 (drill-hole locations EW-1 through EW-4), and 2 holes investigated to the north of Column MG-15 (drill-hole locations NS-1 and NS-2). A total of two 4-in.-diameter holes were drilled and investigated with Shelby tube sampling (ST-1 and ST-2). These investigation locations are illustrated in Figure 4-13.

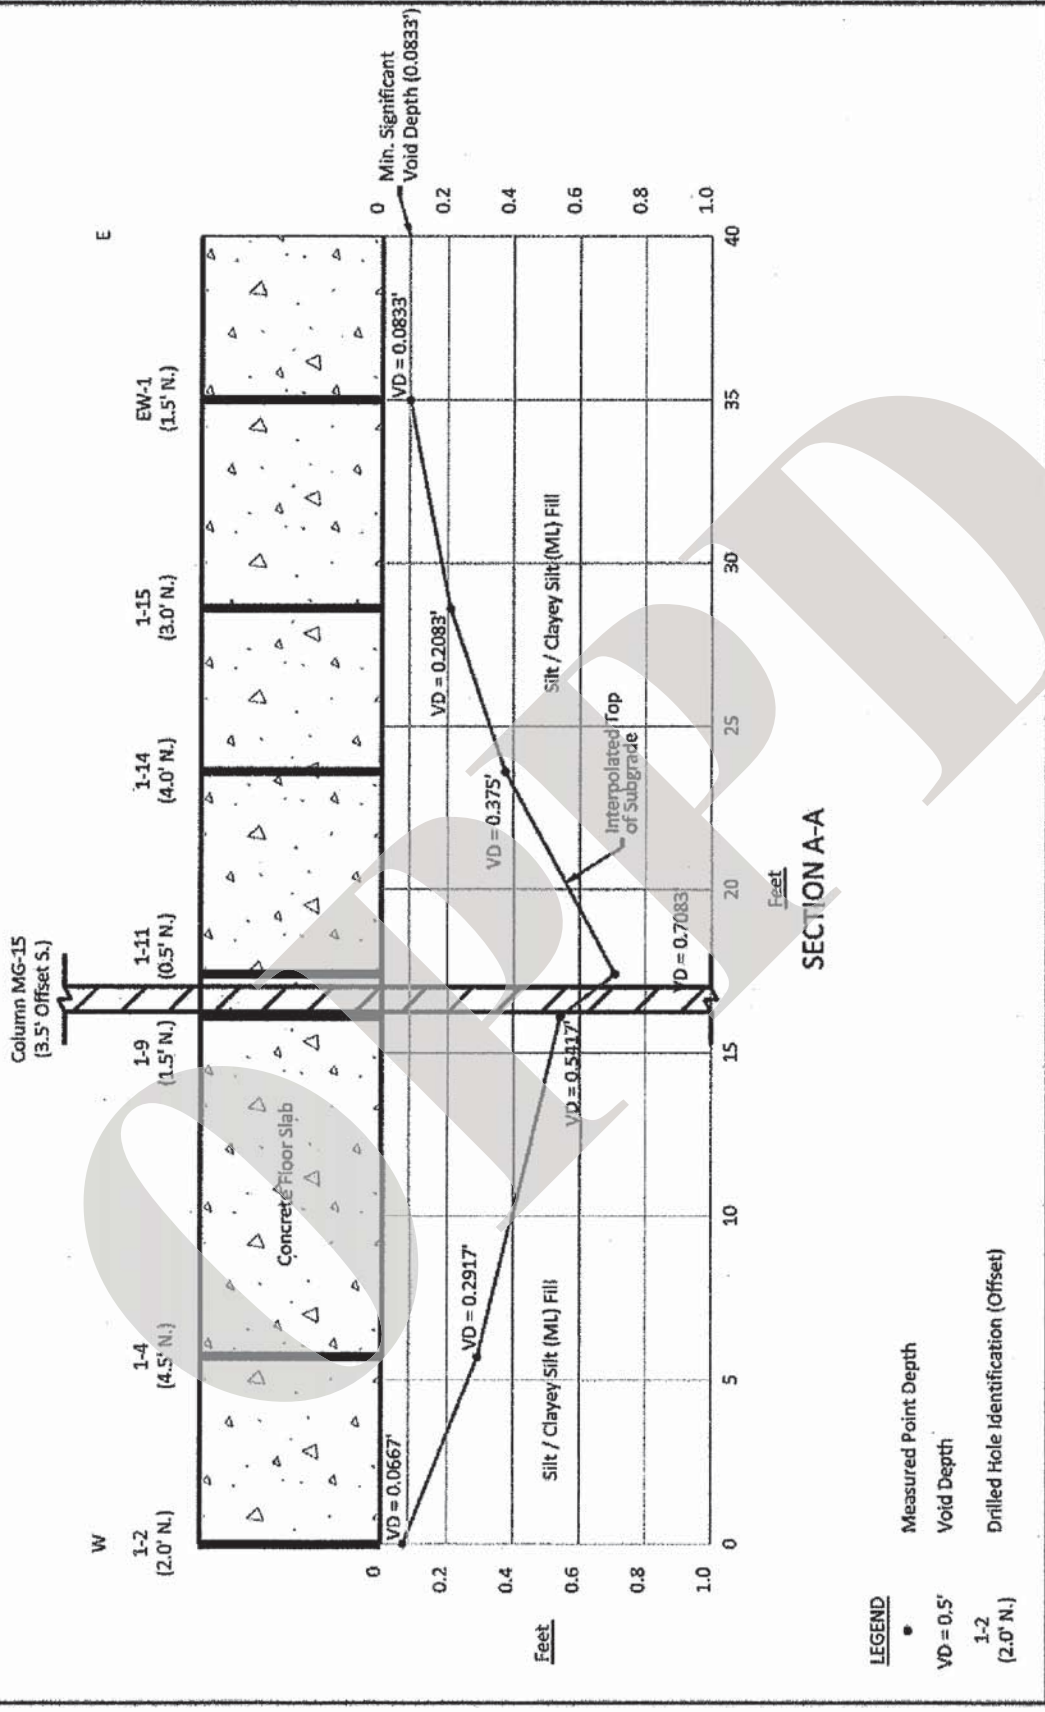
Maintenance Shop Drilling Locations
Cross Section A-A
Fort Calhoun Station
 Plant and Facility Geotechnical and Structural Assessment

The data also indicate that void space below the floor slab in the area investigated is greater nearer to the settled column, as follows:

The above statements related to void space are illustrated in cross sections A-A', B-B', and C-C', presented as Figures 4-14, 4-15, and 4-16. The cross section locations are shown in Figure 4-13.
