Maintenance Shop

To: Keith Kirchner, Pat Poepfel, Rick Niedergeses	
From: Cameron Collingsworth	Project: OPPD FCS 2011 Flood Inundation Structure Assessment OPPD Plant, Ft. Calhoun, NE
CC: Project File, David Rohan	HDR Project No: 164565, Dept. 134
Date: November, 9 th 2011	Field Report No: FR-087

**OPPD – FORT CALHOUN STATION
2011 FLOOD ASSESSMENT - GEOTECHNICAL CONDITION SURVEY**

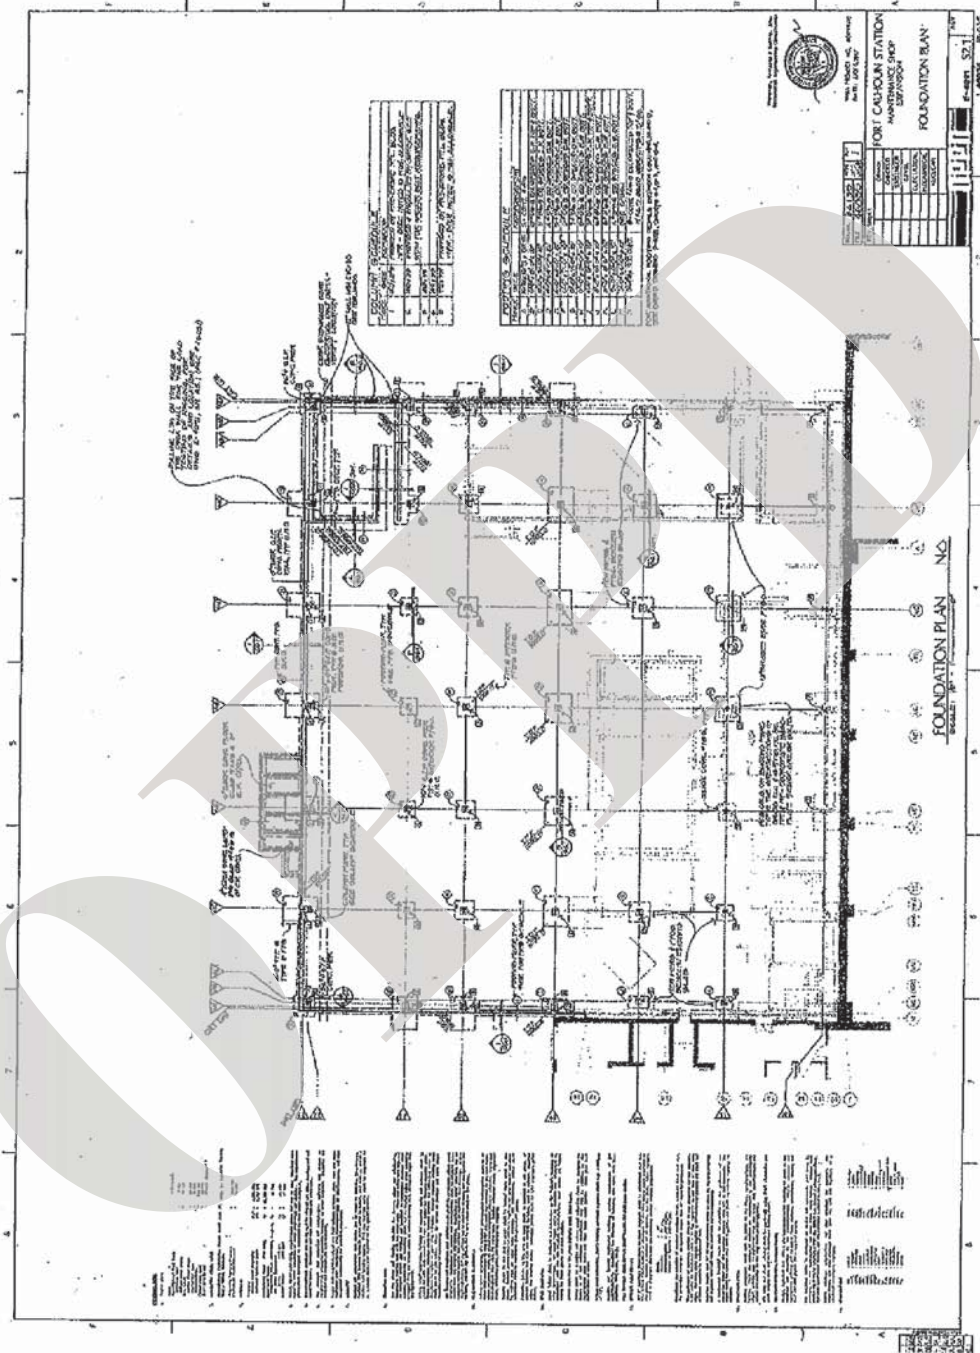
Drawings do not match conditions in field.
