Results of the Second Soundness Inspection of Unit 4 Reactor Building at Fukushima Daiichi Nuclear Power Station

August 30, 2012

Tokyo Electric Power Company

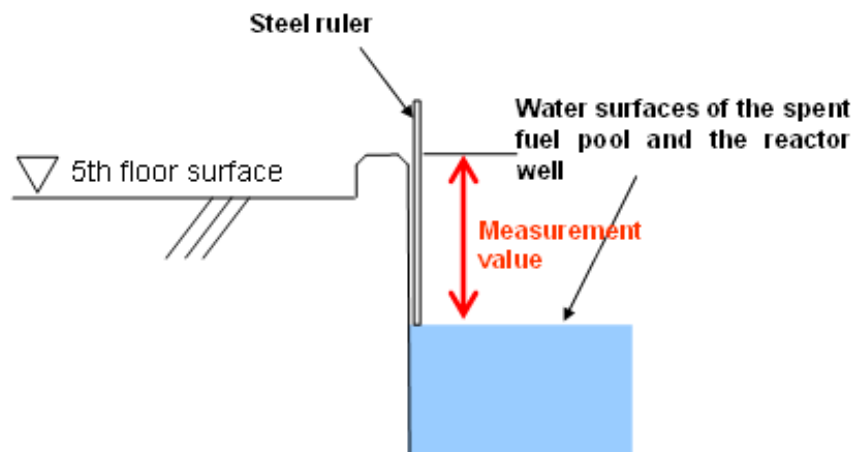
Considering that the measurement values on the four corners were about the same, it has been concluded that the 5th floor surface and the water levels of the spent fuel pool and the reactor well are parallel. (It has already been confirmed that the building is not tilted based on the measurement results acquired on February 7, April 12 and May 18, 2012).

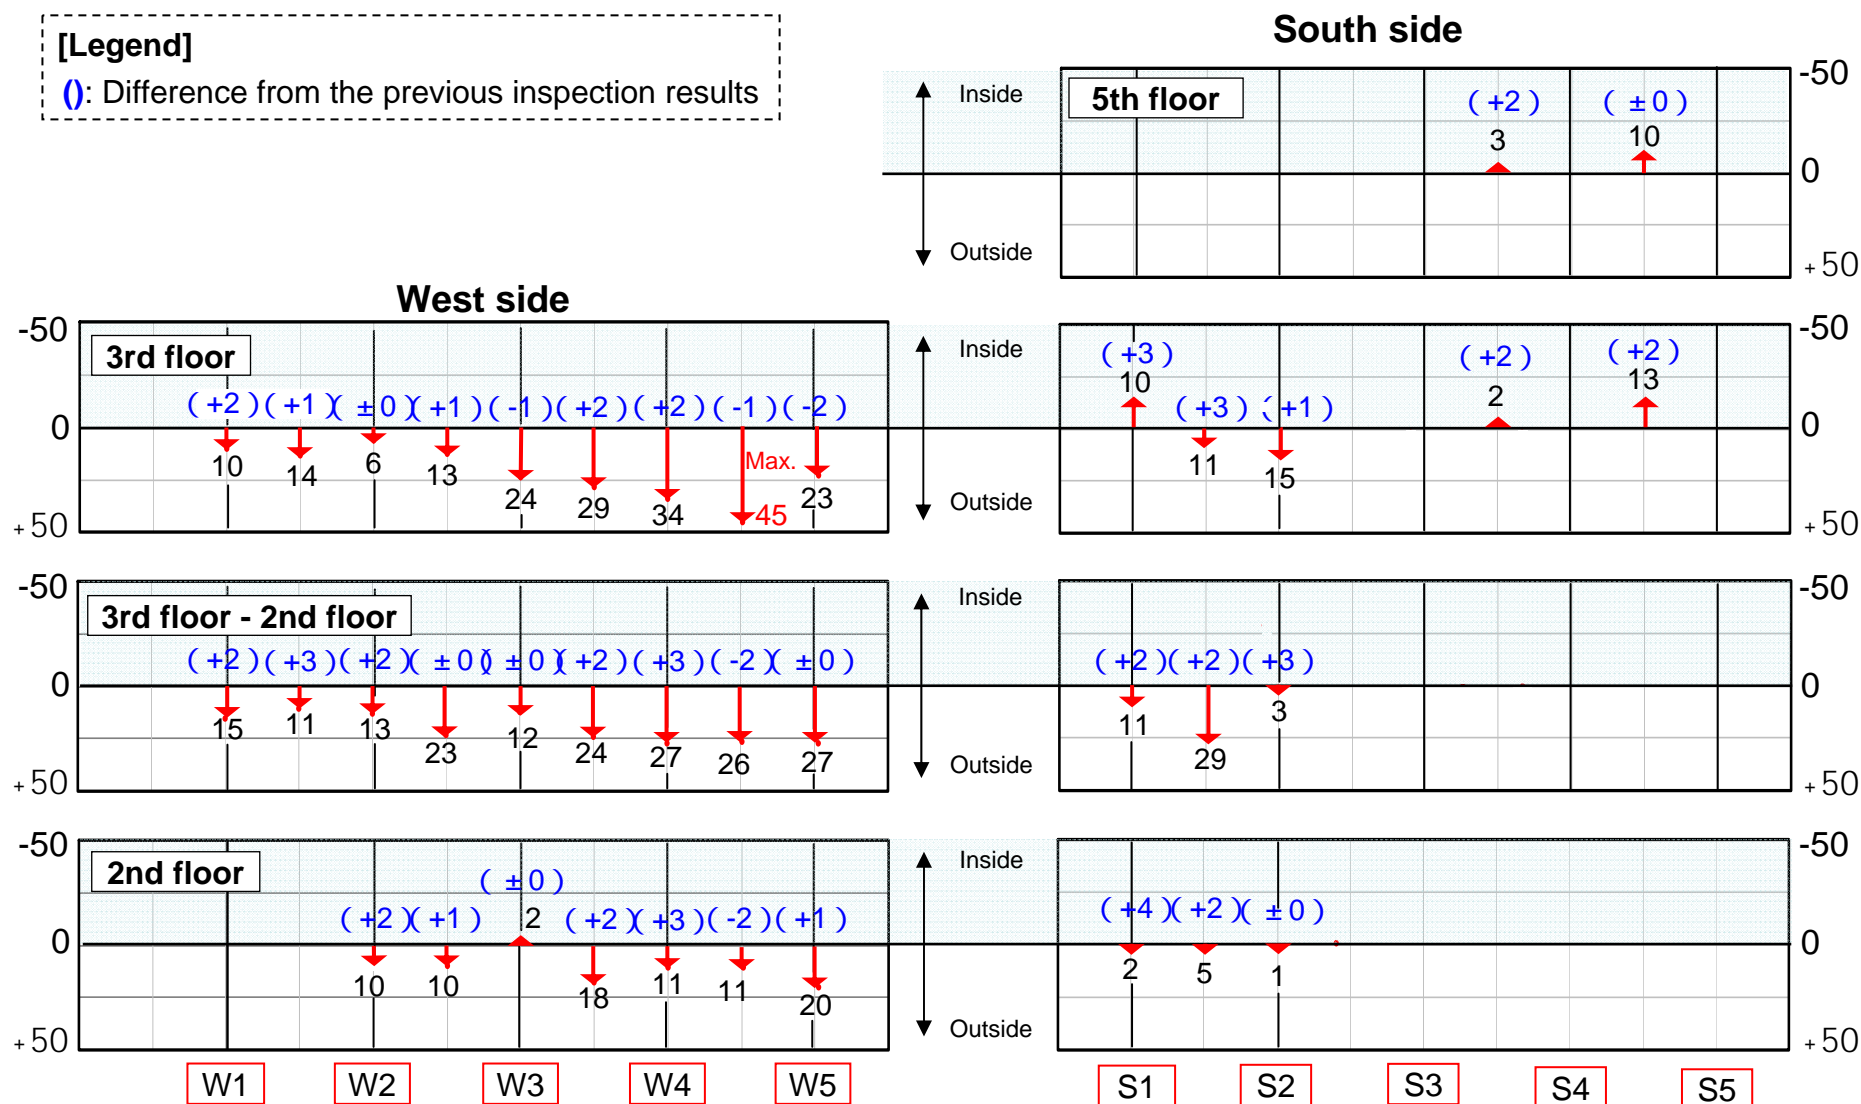
Horizontal difference*1 calculation results

- The horizontal differences measured this time were about the same as those in the first inspection (May 2012) and the detailed inspection of exterior walls (June 2012), and the deformation characteristics on the measurement points were also similar.

- The small difference from the previous measurement results may be due to factors such as error of the optical equipment (Measurement error of $\pm 2\text{mm}$ may cause approx. 4mm (Max.) error in horizontal difference) and thermal expansion of concrete (thermal expansion coefficient: Approx. $7-13 \times 10^{-6}/$) which may cause approx. 2-4mm error because of the difference of average monthly temperatures of May and July.

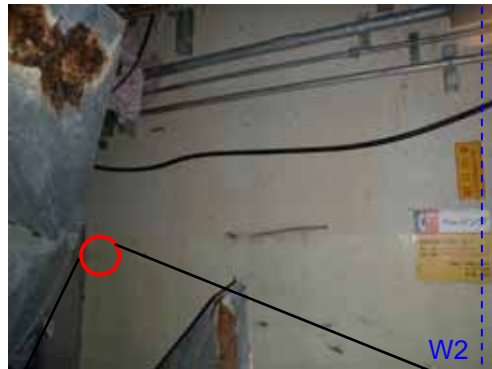
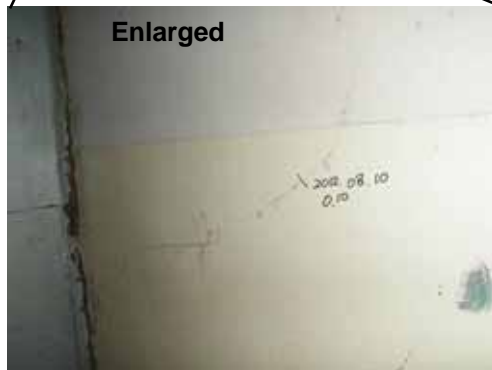
- During the detailed inspection for cracks on the second floor west exterior wall conducted in response to comments received at the public hearing*2, cracks of the maximum of 0.3mm wide were found (See the photos on the next page). However, the small cracks found this time should have no significant impact on the durability and strength of the building.

Though cracks of the maximum of 0.3mm wide were found on the second floor west exterior wall where partial bulge was found, the small cracks found this time should have no significant impact on the durability and strength of the building.

1. Inner surface of the second floor west exterior wall between W2 and W3 (Crack width: 0.1mm)

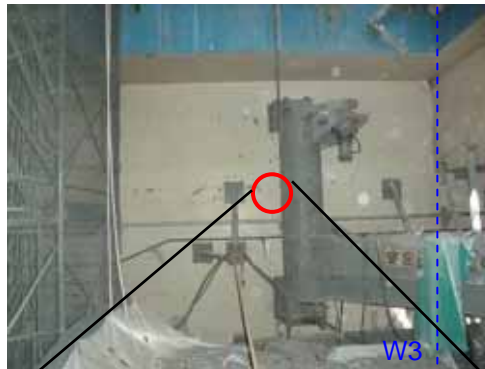
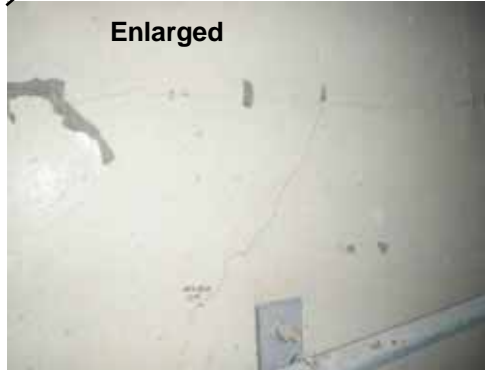
2. Inner surface of the second floor west exterior wall between W3 and W4 (Crack width: 0.3mm)

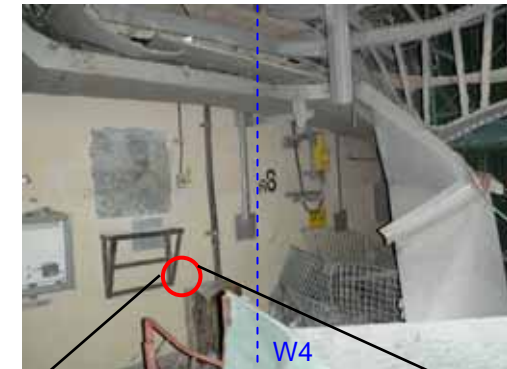
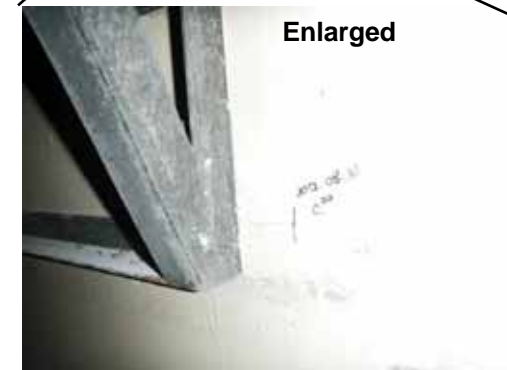
3. Inner surface of the second floor west exterior wall between W4 and W5 (Crack width: 0.2mm)

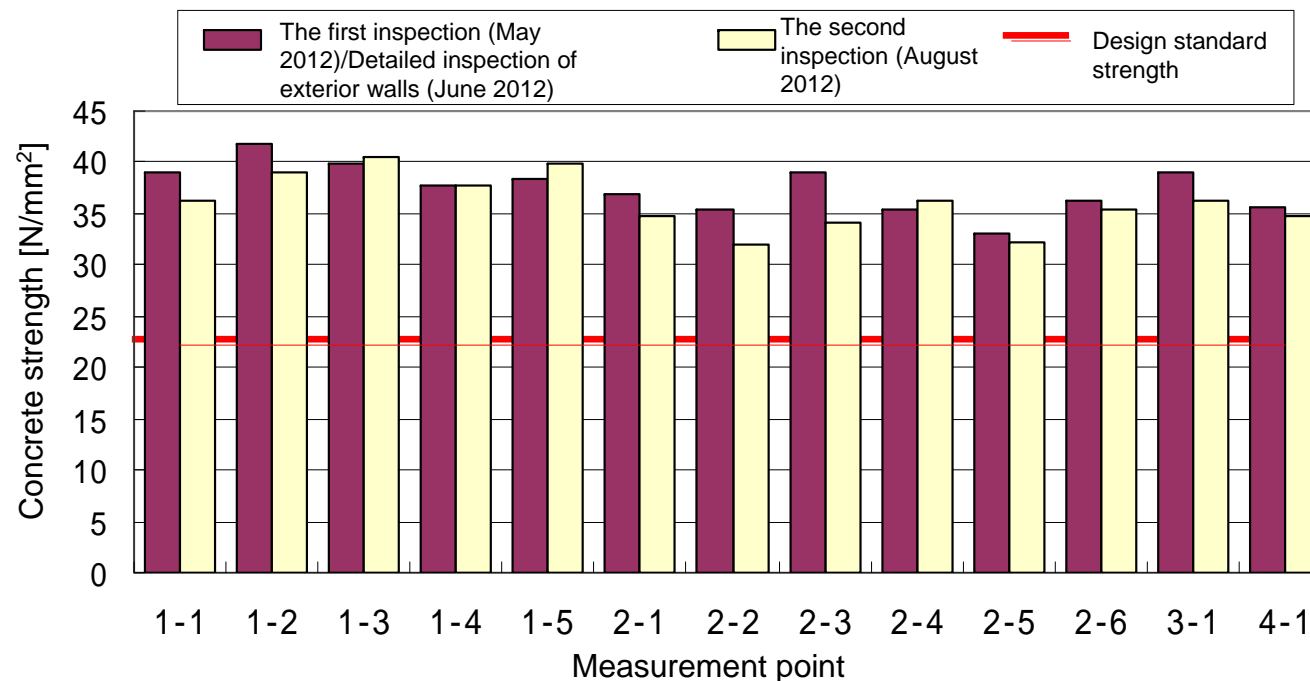
Concrete strength evaluation results

As a result of measurement, the concrete strengths on all the measurement points were above the design standard (22.1N/mm²) similarly to the past results. The results obtained this time are considered to be about the same as the previous results taking into consideration the error of Schmidt Hammer*¹ and that the measurement points were set at different locations from the previous ones. (The concrete strength fulfilled the design standard in the first inspection (May 2012) and the detailed inspection of the exterior walls (June 2012).)
