# DATA REPORT

## QUICK LOOK INSPECTION RESULTS

Prepared by:  
TMI-2 Technical Planning Department  
GPU Nuclear, Inc. - Bechtel National, Inc.

TPO/TMI-026

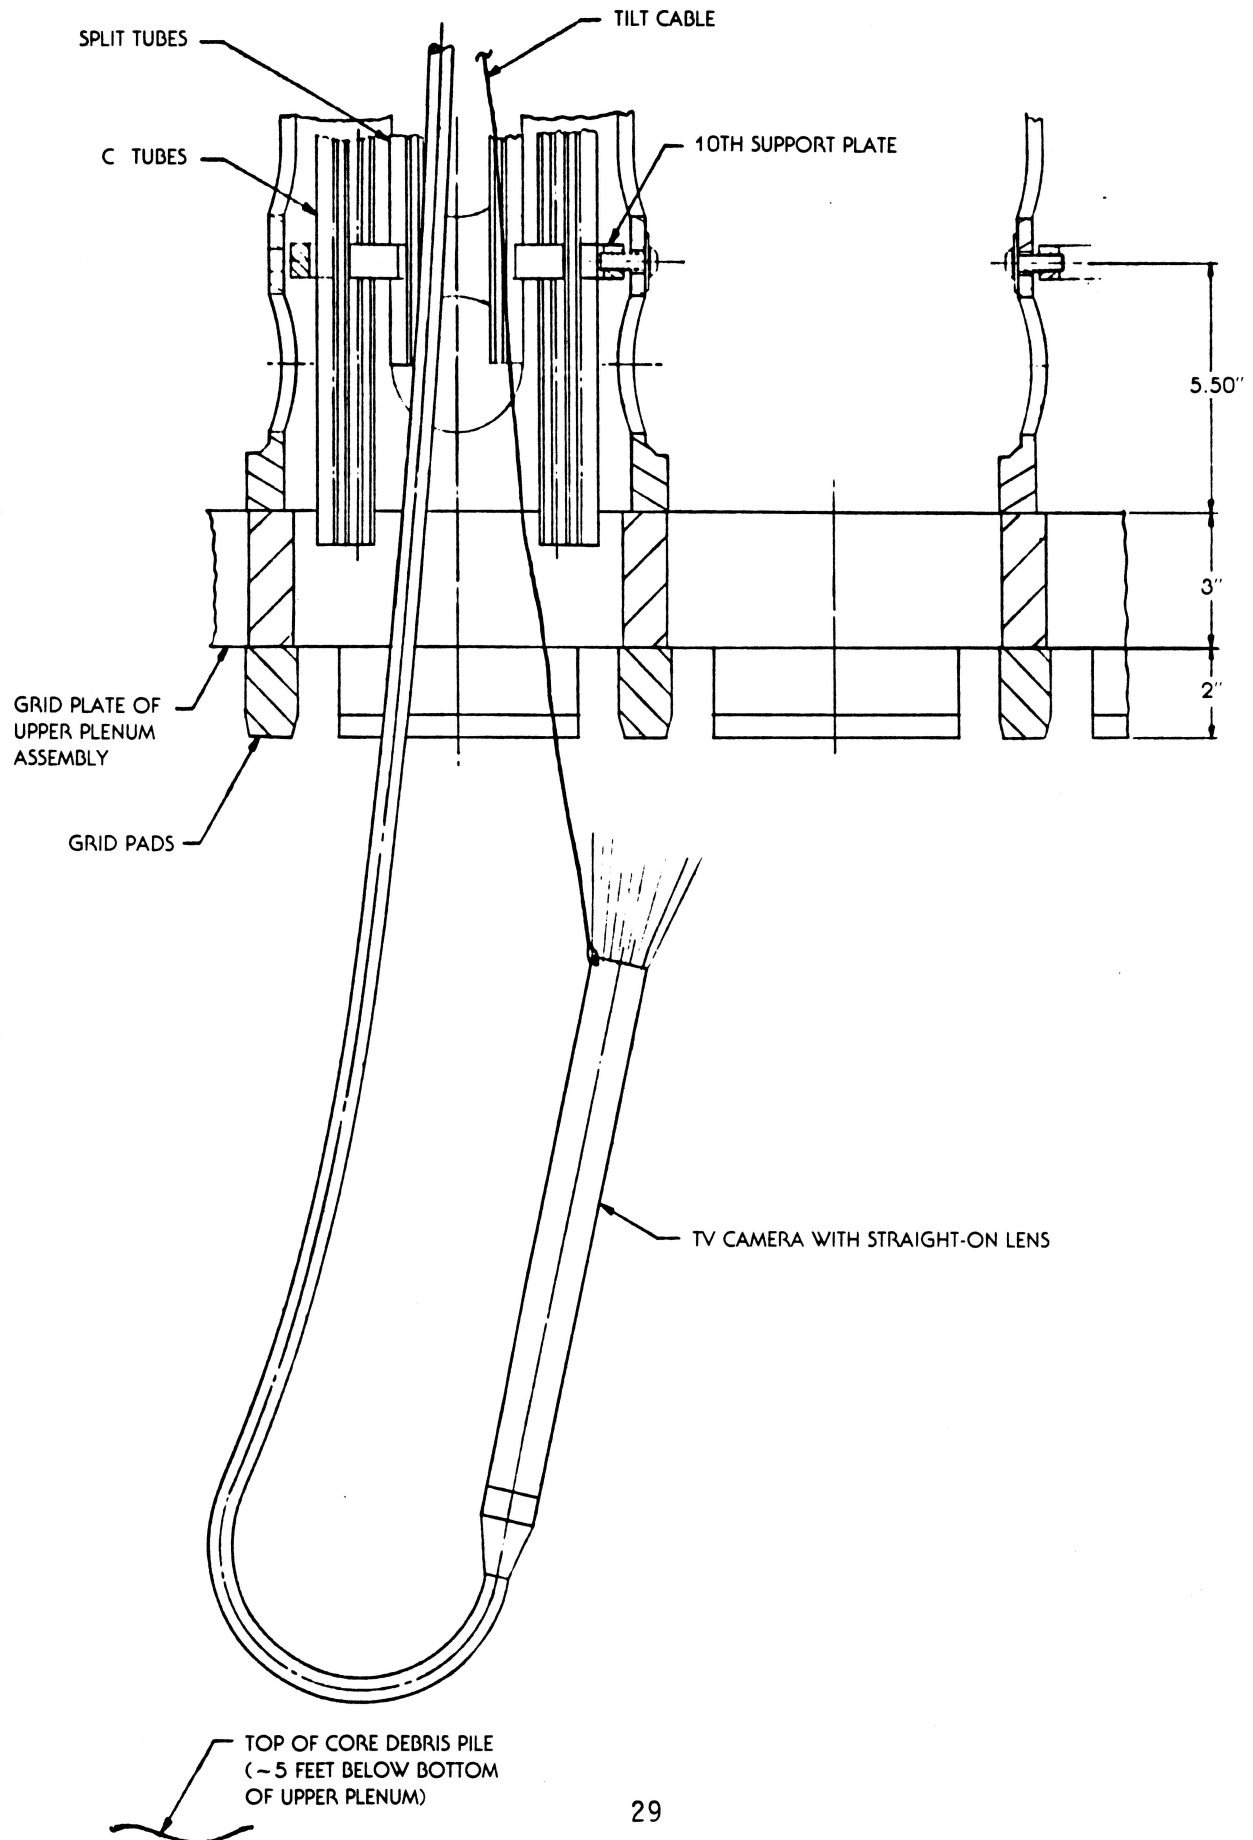
FIGURE 9  
LOOKING UP AT UNDERSIDE OF UPPER PLENUM ASSEMBLY  
AT H-8 CORE POSITION DURING QUICK LOOK 1

At H-8 a control spider was visible at a location slightly off center, resting on top of the debris bed. The portions of the spider that were visible appeared to be undamaged. The spider must have fallen when the leadscrew was uncoupled, since there was no upper end fitting to support it, and it was on top of the debris bed. No spider was found below the E-9 location.

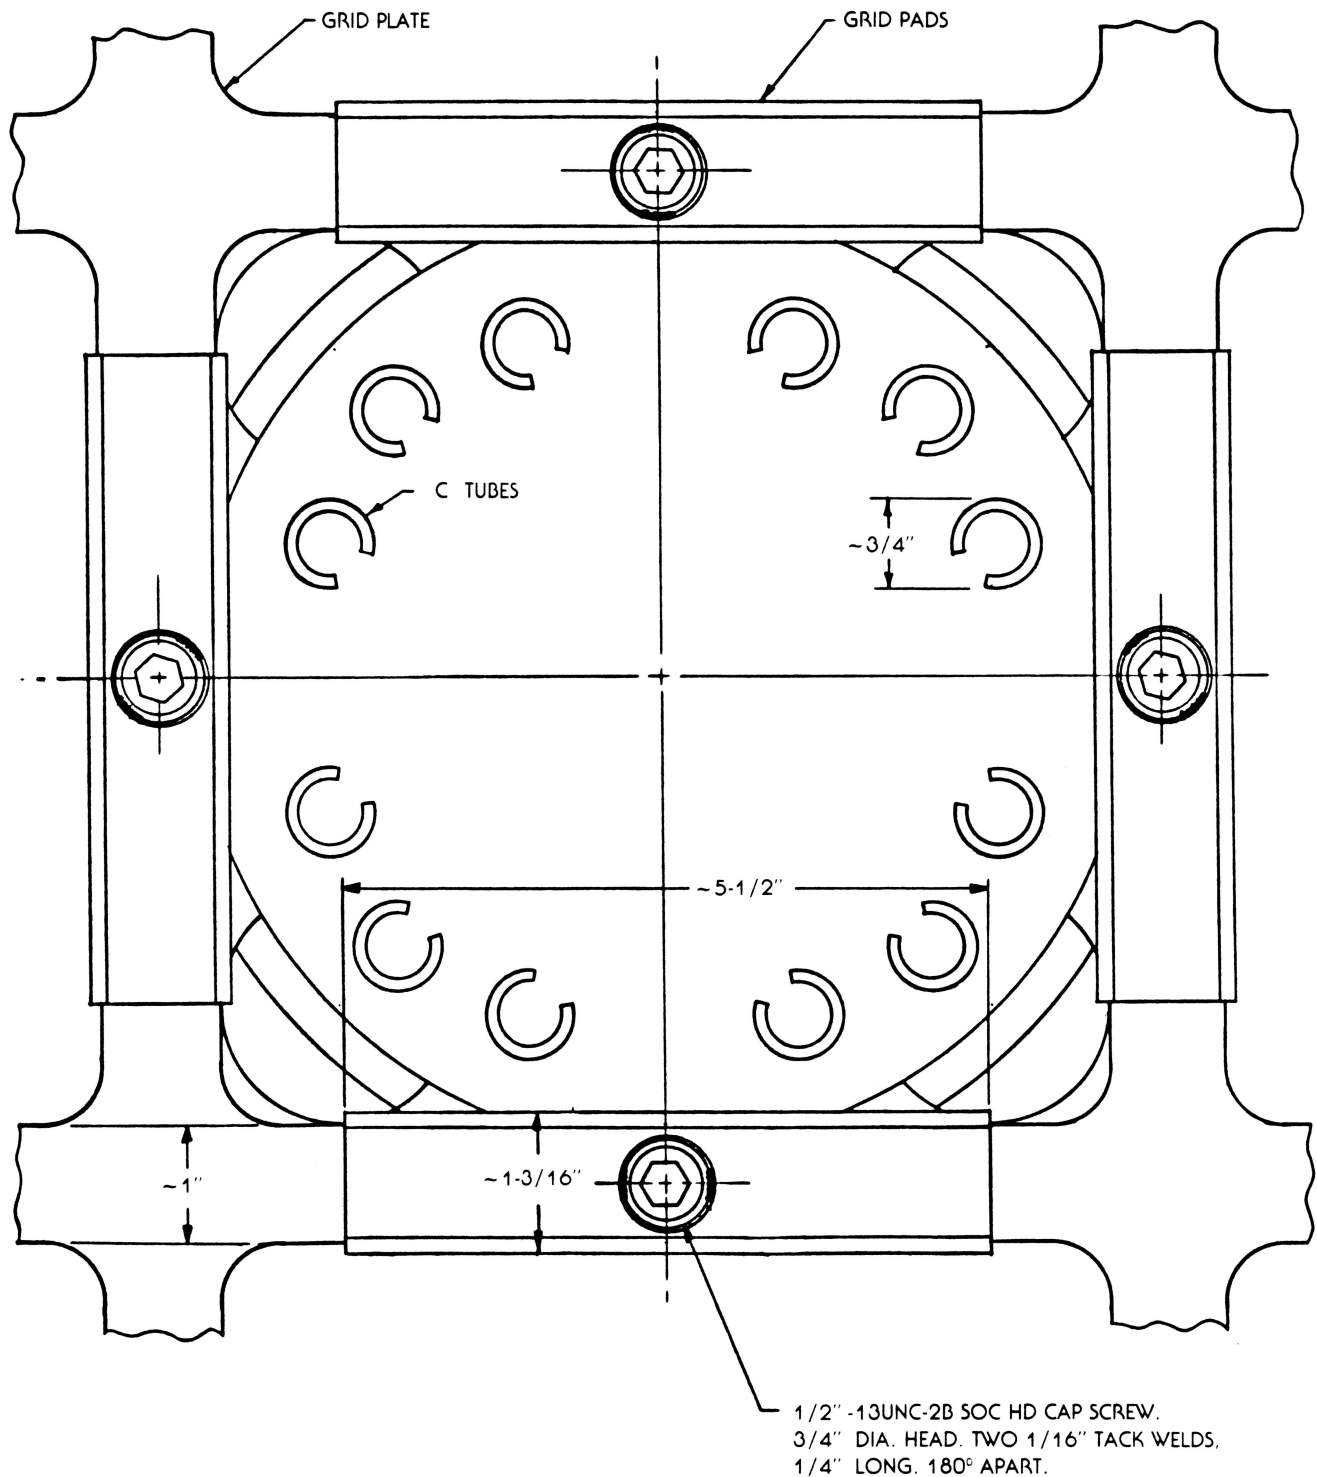
FIGURE 11  
 LOOKING VERTICALLY UPWARD AT UNDERSIDE  
 OF THE UPPER PLENUM ASSEMBLY GRID PLATE  
 (LIKE LOOKING INTO THE H-8 POSITION  
 OF QUICK LOOK 1 OF JULY 21, 1982)

At the H-8 location, the underside of the plenum assembly appeared to be in the normal configuration, which resembles the view shown in Figures 10 and 11. However, the field of view was not as large as that in the photograph. Two of the grid pads were seen and appeared to be in normal condition, except for linear surface patterns. These patterns could have been either cracks in a surface coating of fine debris, or fracture marks associated with spalling of the pad surface. It was not possible to determine which by looking at the video image. Gas bubbles appeared to collect on the underside of the grid pads.

The entire fuel element upper end was gone from the H-8 location. No upper end fittings were suspended at H-8 or at the adjacent locations visible (see Figure 11). Because of uncertainty as to the way the camera was pointed, it was not possible to determine which locations adjacent to H-8 were observed.

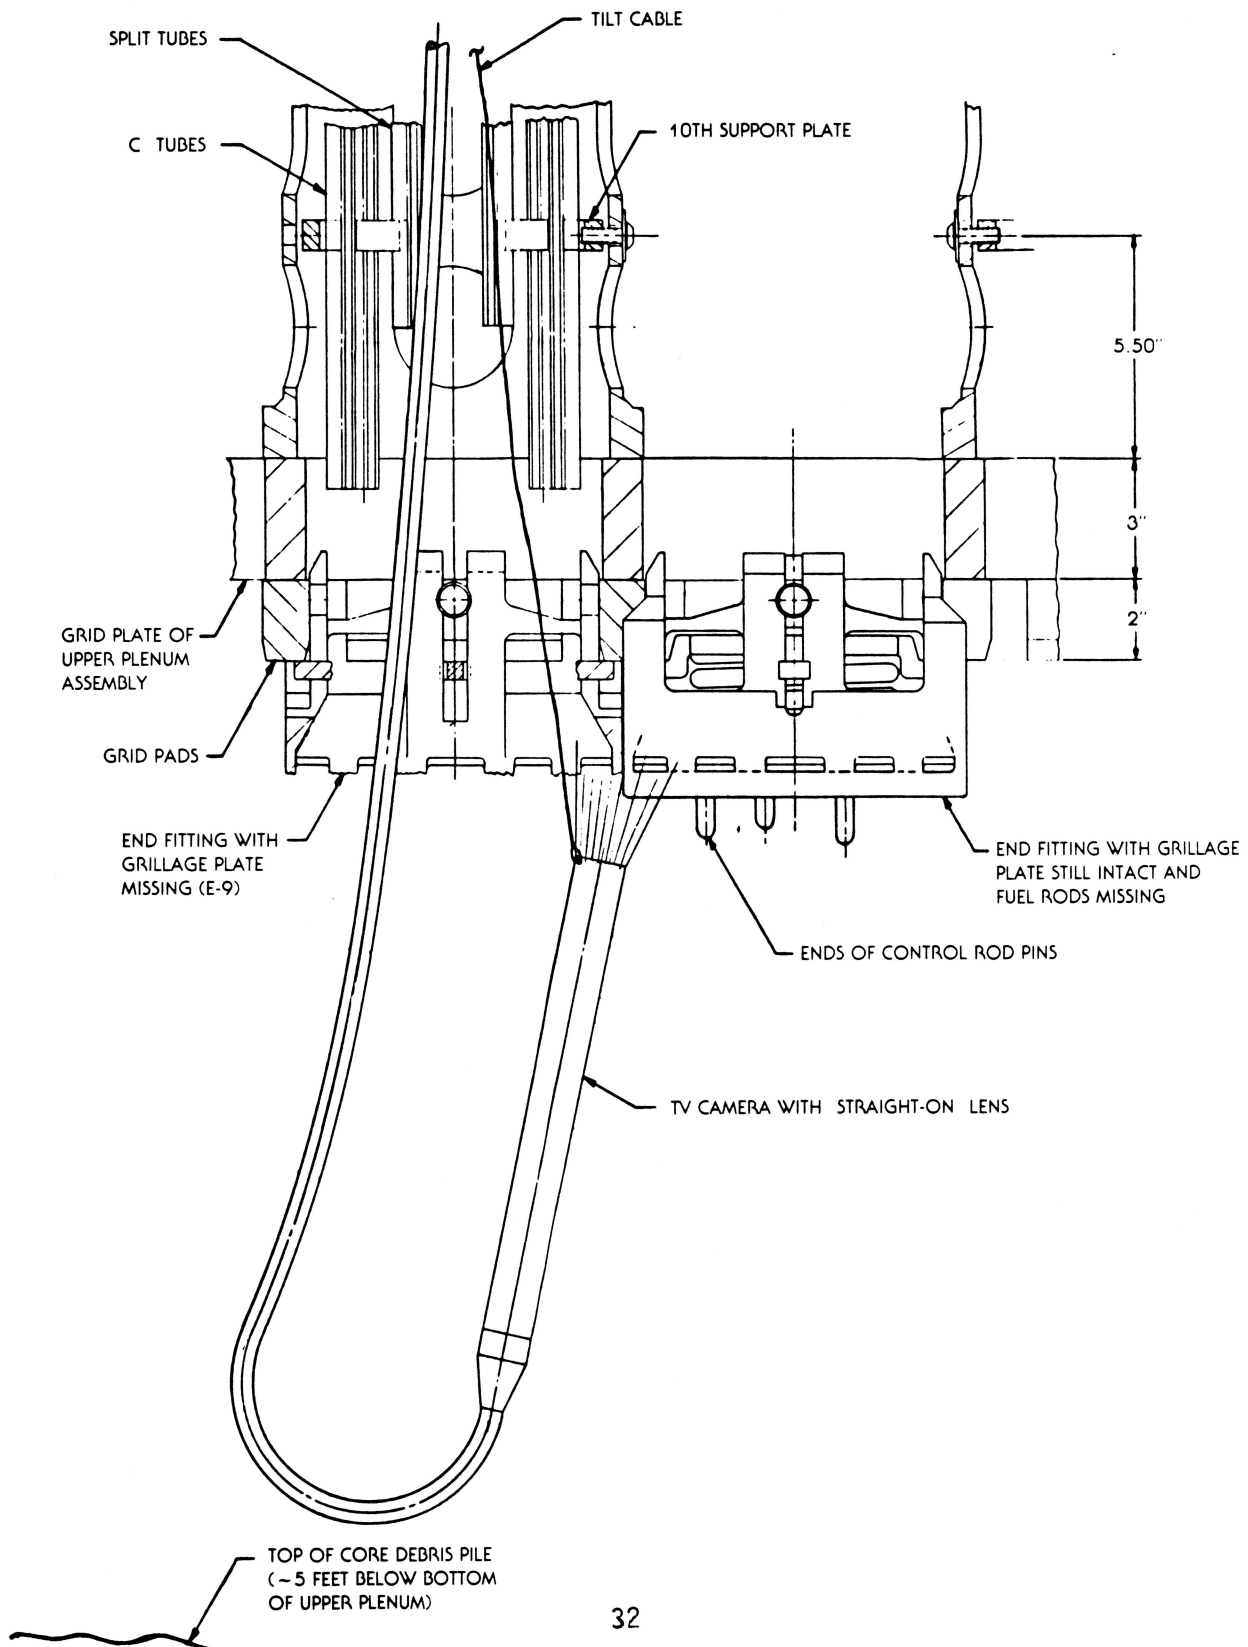
FIGURE 12  
 LOOKING UP AT UNDERSIDE  
 OF THE UPPER PLENUM ASSEMBLY WITH FUEL ASSEMBLY  
 END FITTINGS STUCK IN THE GRID PLATE  
 (THIS WAS VIEWED AT THE E-9 CORE  
 POSITION DURING QUICK LOOK 2 AND 3)

In addition to the partially damaged grillage, one of the upper end fittings (D-8) had additional identifiable components suspended from it. A portion of a spacer grid was visible, stubs of control elements protruded from the grillage, and partial fuel rods were suspended along one edge of the fittings. The fuel cladding was broken or eroded or melted away a few inches or less below the grillage. Several rods had portions of the internal springs protruding out the end of the cladding.

When the end fitting at E-9 was carefully scanned from the inside with the right-angle viewing lens, it appeared to be at the normal elevation with respect to the grid structure. Many chips and pieces of debris were found in the tight space between the centering tabs on the end fitting and the grid plate. This debris may be what is holding the end fittings in place, while the remainder of the fuel element is broken away.

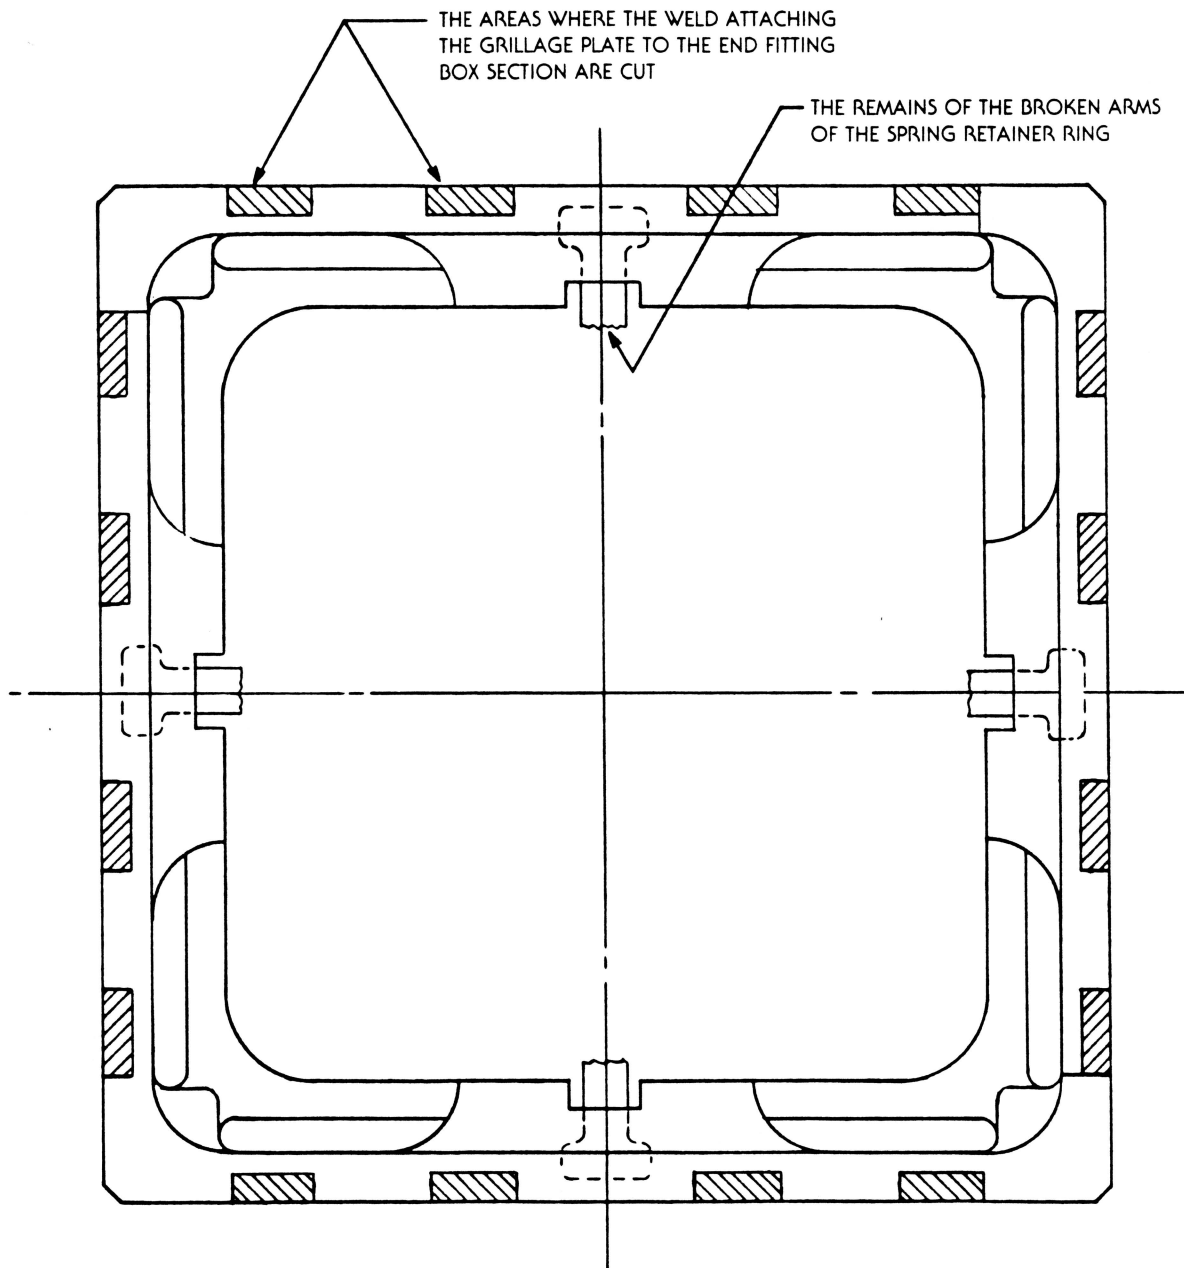
FIGURE 13  
LOOKING UP INTO THE BOTTOM  
OF THE FITTING POSITION E-9  
(E-9 END FITTING HAS LOST ITS BOTTOM GRILLAGE PLATE)

When the camera was lowered a bit, the juncture of four partial upper end fittings came into view (see Figures 13 and 14). These upper end fittings are part of fuel bundles, but their remains were suspended from the underside of the plenum. Their condition is described in detail in Section 3.1.2 of this report.

On the E-9 upper end fitting, the grillage is completely gone. The spider is also gone, as is the spring retainer and the spring (see Figure 13). On the other three visible upper end fittings, the grillage is still present, but partially damaged. The end fittings are retained in the plenum grid plate without any apparent support from below.

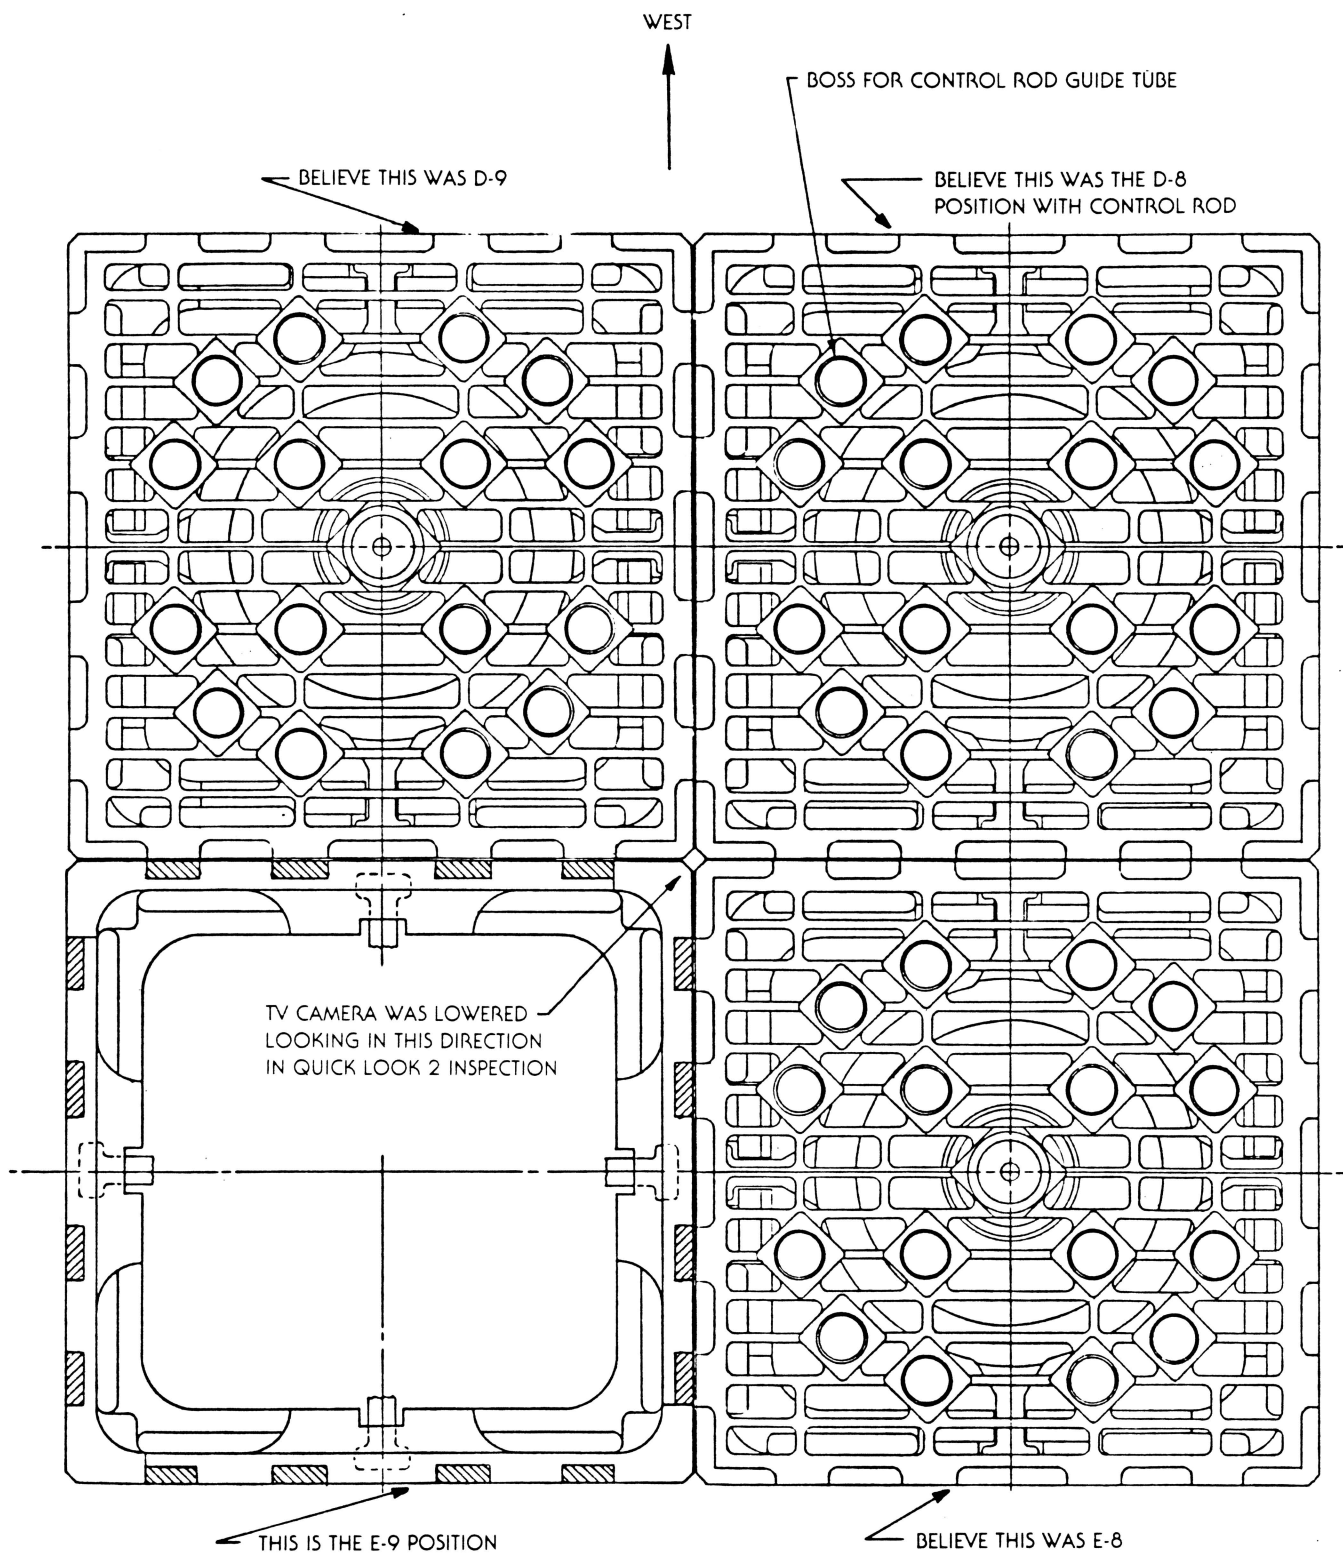
FIGURE 14  
 LOOKING UP FROM THE UNDERSIDE OF POSITION E-9  
 WITH THE GRILLAGE PLATE MISSING FROM THE  
 E-9 END FITTING  
 (AUGUST 6 AND 12, 1982)

At first glance, the parts of the grillage that are missing from D-8, D-9, and E-8 appear to have eroded away. But only a fraction of an inch away, there are other portions of the grillage that are in pristine condition, with sharply defined edges evident and no apparent damage or discoloration.

The Review Group concludes that some unexplained damage mechanism must have removed the missing portions of the grillage. It was suggested that the mechanism might have been steam cutting or perhaps abrasion by a mixture of coolant flow and core debris, or some other chemical/metallurgical mechanism related to the high temperatures and hydrogen concentrations present in this area when the core was uncovered and quenched.

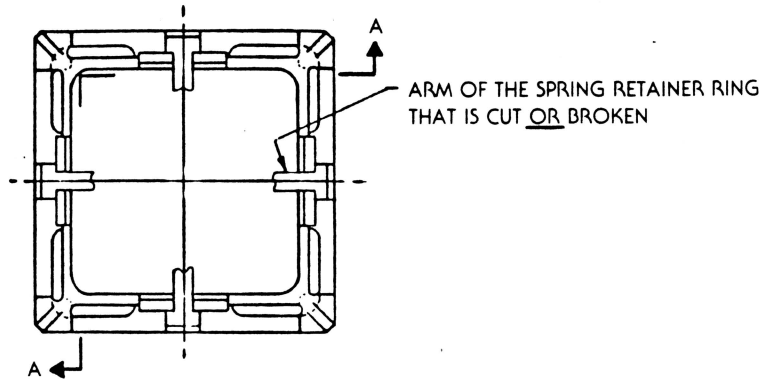
FIGURE 19  
EXPANDED VIEW OF THE E-9 END FITTING  
(GRILLAGE PLATE MISSING)  
(AS SEEN BY THE 90-DEGREE TV LENS ON AUGUST 12, 1982)

Portions of the upper end fitting at E-9 look similar to metal which has been cut by a torch. Adjacent to the cut areas, the metal appears to be in the as-manufactured condition. The cutting mechanism and why it is highly localized is not understood.
