Byron Station, Unit 2  
Facility Operating License No. NPF-66  
NRC Docket No. STN 50-455

Subject: Licensee Event Report (LER) 2000-001-00

| <b>TITLE (4)</b> Automatic Reactor Trip System Actuation Due to Off-Site Power Line Fault and Failed Air Circuit Breaker Load Rejection Contact | | | | | | | | | | | | | | | | | | | | | | | |

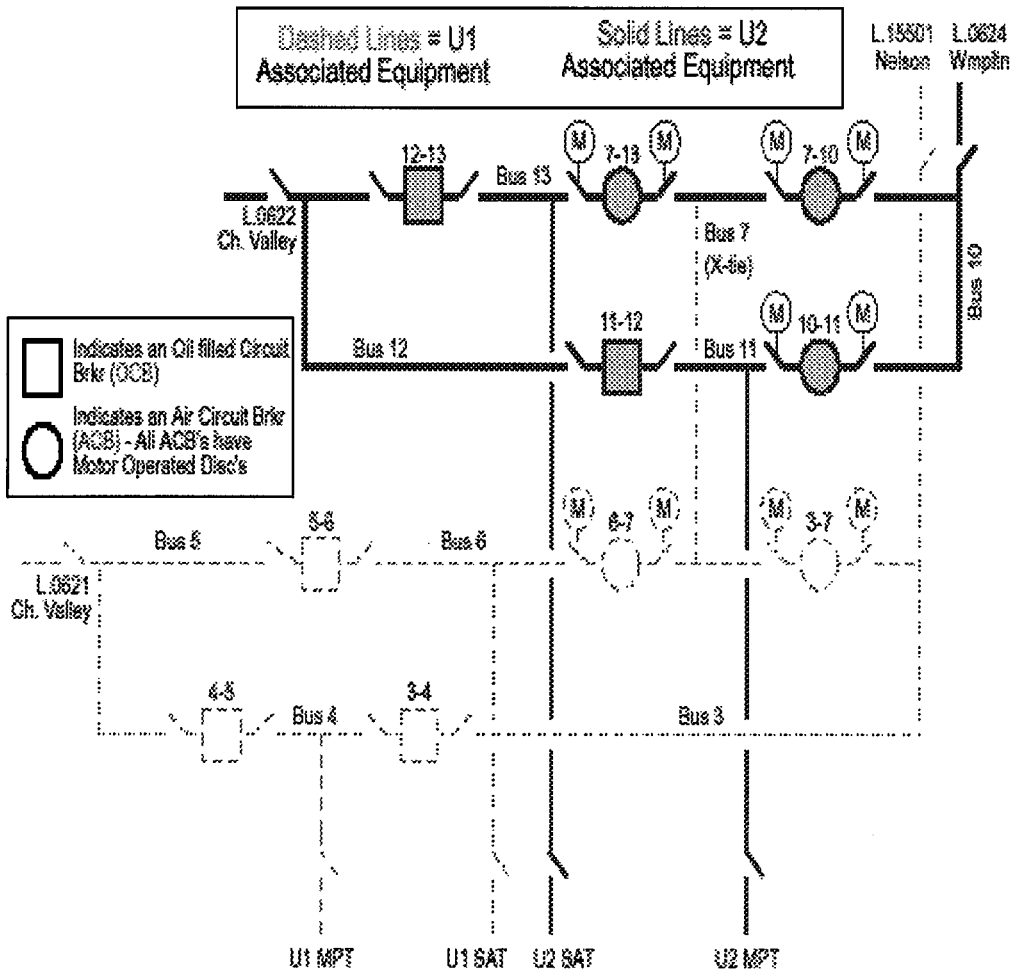
FIGURE 1 - LINE DIAGRAM OF BYRON STATION'S SWITCHYARD

The two Units at Byron Station have a common 345 Kv switchyard that is configured into two ring busses to afford reliability and redundancy of offsite power supplies. Figure 1 depicts a line diagram of Byron Station's switchyard. Two 345 Kv offsite transmission lines are connected to each unit's ring bus. The Unit 1 lines are numbered 0621 and 15501 and the Unit 2 lines are numbered 0622 and 0624. Line 0621 and 0622 are routed on the same transmission towers from the Cherry Valley substation into the Byron Station switchyard. Each line is provided with fault isolation capability from the ring bus through use of switchyard circuit breakers.

At 0059 hours on January 13, 2000, a static line on line 0621 broke and fell across the B phase of line 0622 thereby causing an electrical fault. Unit 2 received a line 0622 direct transfer trip alarm due to a phase B fault on line 0622. The direct transfer trip signal opened Oil Circuit Breakers (OCBs) 11-12 and 12-13 to isolate the line fault in the Byron Station switchyard. Due to the redundant offsite power supply (i.e., line 0624) the event should have terminated at this time without further interruption to unit operations. However, Unit 2 also received an unexpected Main Generator [TB] (MG) load rejection trip signal. The load rejection circuit provided a signal to actuate MG lockout relay 86G2A, which opened Air Circuit Breaker (ACB) 10-11 and automatically tripped the Unit 2 turbine [TA]. A turbine trip automatically generates a reactor trip above 30% power.
