Report of Japanese Government  
to the IAEA Ministerial Conference on Nuclear Safety  
- The Accident at TEPCO's Fukushima Nuclear Power Stations -

June 2011

Nuclear Emergency Response Headquarters  
Government of Japan

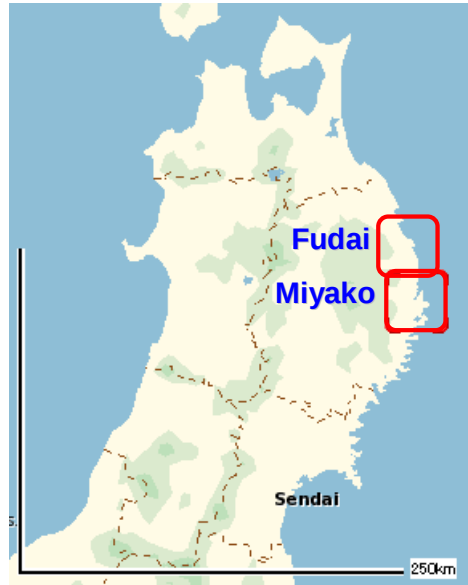
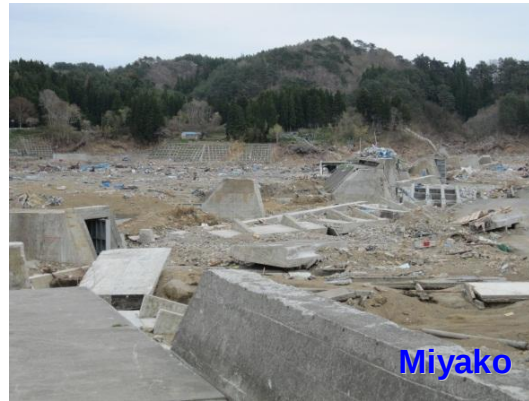
Fig. III-1-15 Damages of seawall and harbor installation due to the tsunami.

The 10m-high seawall was destroyed in Taro district, Miyako city, Iwate Pref.

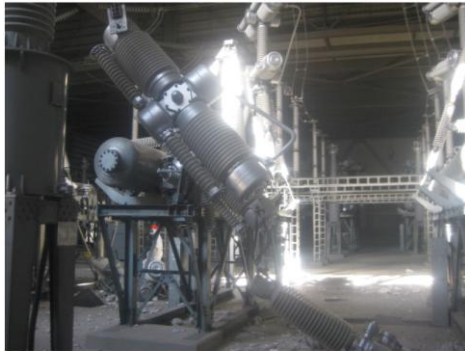
**Okuma line 1L (O-81)  
Circuit Breaker damaged**

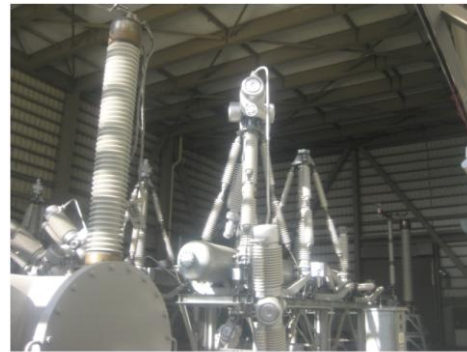
**Okuma line 2L (O-81)  
Circuit Breaker damaged**

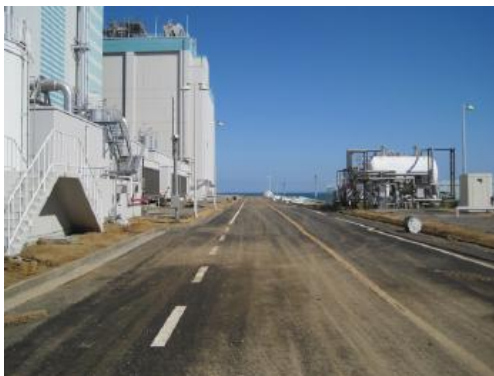
Fig. III-2-11(b) Damage of Fukushima Dai-ni NPS due to the tsunami.

Damages of reactor building and emergency diesel generator (Unit 1)
