## **8. DEBRIS RELOCATION SCENARIO**

J. R. Wolf and D. W. Akers, Idaho National Engineering Laboratory  
L. A. Neimark, Argonne National Laboratory

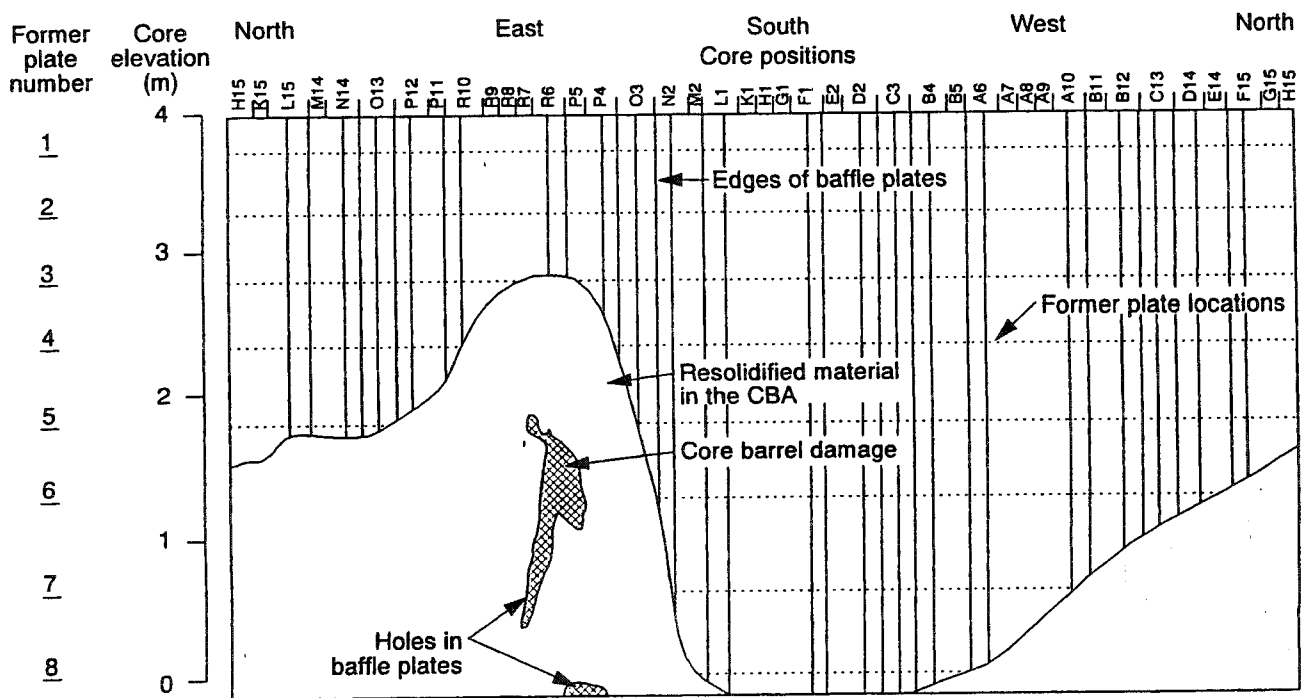
**Figure 8-2.** Fuel debris profile inside core former (laid flat).

Post-accident examinations of the eastern half of the core region and lower vessel internals confirmed plant instrumentation data and showed that relocation of the fuel debris to the lower head occurred in the eastern half of the vessel. Overall, approximately 19 metric tonnes of material reached the lower head. As discussed in Section 5, the relocated material was primarily a (U,Zr)O<sub>2</sub> ceramic. Visual examinations of this part of the vessel during defueling indicated that the primary path through the vessel was through a hole melted in the R6 vertical core former wall and then downward through the horizontal baffle plates. Figure 8-1 shows a cross section of the reactor vessel internal structure. Fuel melt was found in the P-5 and R-6 assemblies near the bottom of the fuel assemblies, which indicated that some liquified fuel had drained into these assemblies and solidified during the relocation. However, as no flow path was found through these assemblies to the lower head, the principal relocation path was identified as being through the damaged core former at the R-6/P-5 core locations. Three holes in the core former wall were identified. Dimensions of the holes through the former wall ranged from 23 × 3 cm to 20 × 7 cm.<sup>9,10</sup> The damage to the core former wall was about 140 cm from the bottom of the core or a little below the midpoint of the reactor core. The damage location is indicated in Figure 8-2.

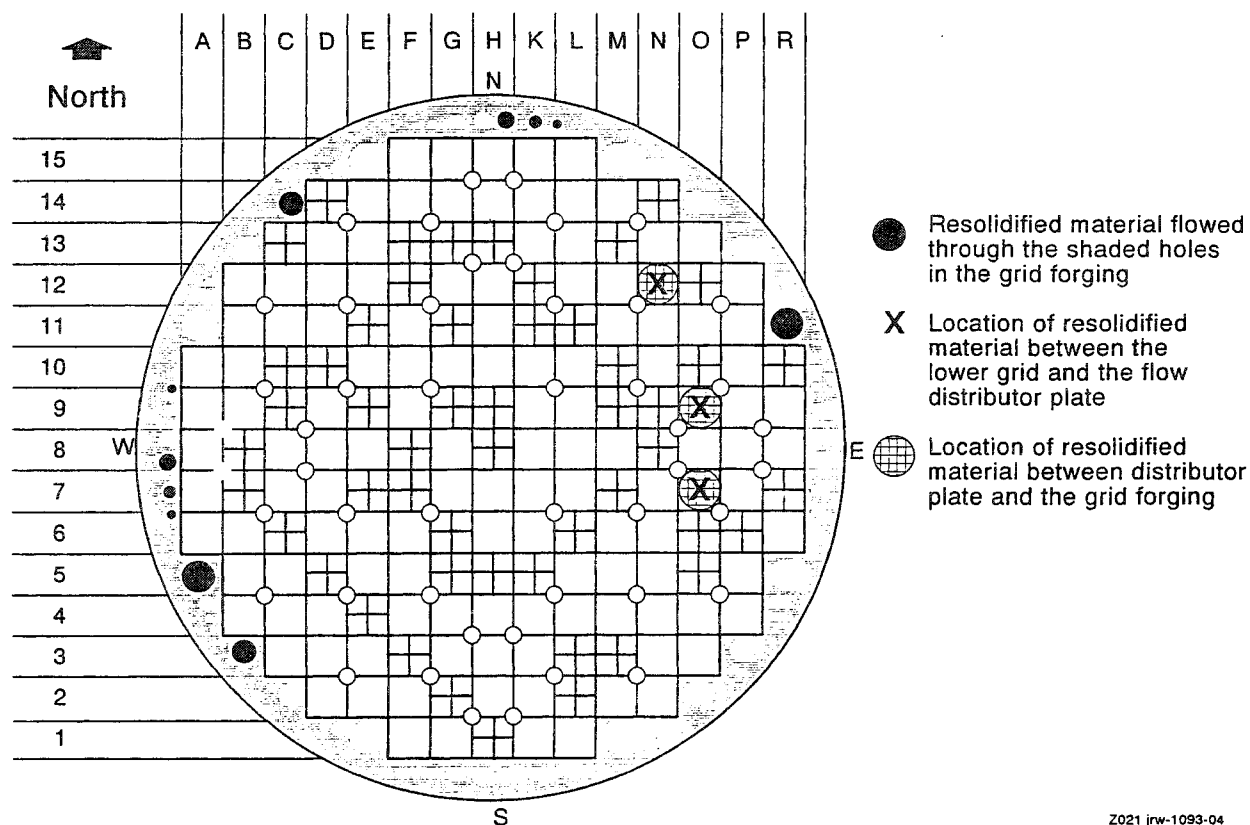
**Figure 8-4.** Solidified material in core support assembly.

Based on the locations of solidified material in the CSA as shown in Figure 8-4, it is postulated that the molten material flowed onto the elliptical flow distributor (EFD) from the same areas where plugged flow holes existed in the CSA. Figure 8-5 indicates the locations in the EFD where solidified material was observed in or above a flow hole.<sup>11,12</sup> As can be seen in the figure, these locations are in general agreement with the locations in Figure 8-4, where solidified material was observed in the CSA. As seen in Figures 8-4 and 8-5, many of the plugged flow holes line up quite well, which indicates that the flow moved vertically downward and covered much of the periphery of the CSA structure as it followed the flow hole alignment pattern onto the EFD. For example, the plugged holes near locations H-15, K-15, and L-15 shown in Figure 8-4 are near plugged locations H-15, K-15, and K-14 shown in Figure 8-5. Also, the plugged holes in location C-14 shown in Figure 8-4 are near the plugged holes in locations D-13 and D-14 shown in Figure 8-5.

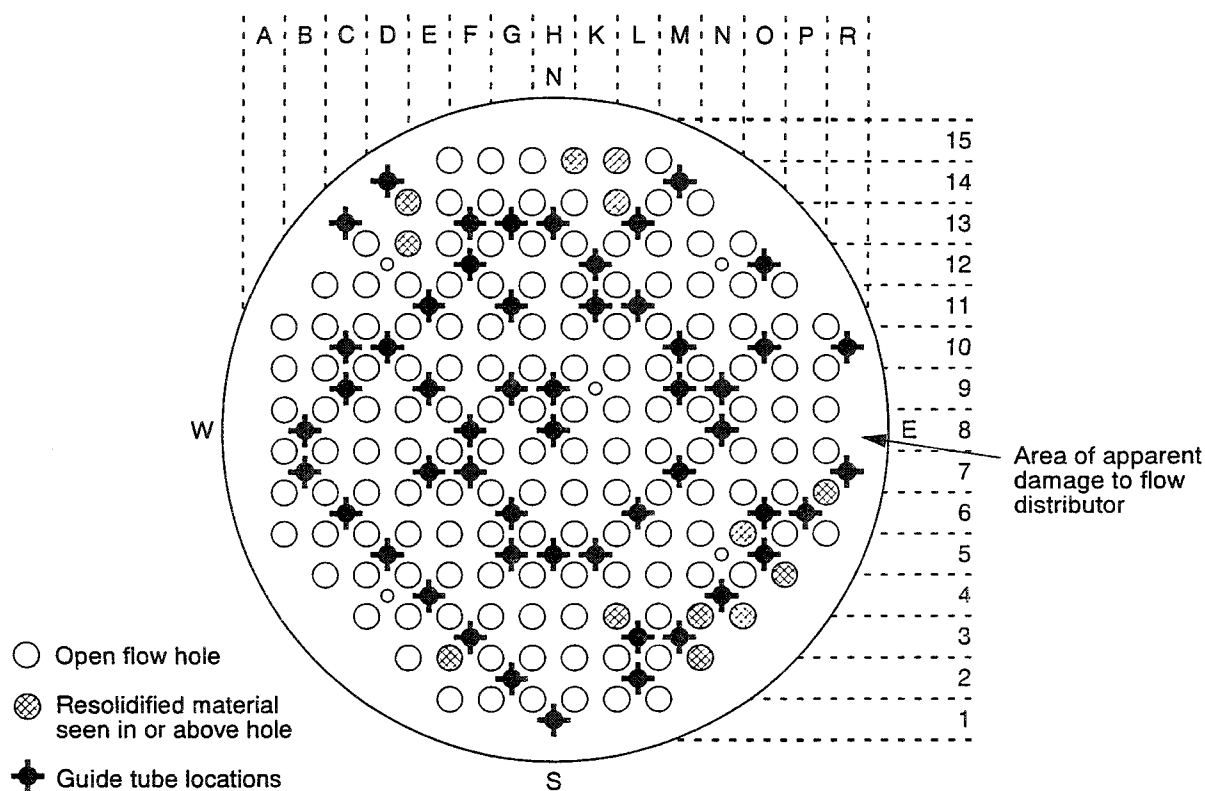
**Figure 8-5.** Solidified material in the elliptical flow distributor.

Some of the molten material solidified on the EFD and formed plugs in the flow holes at locations shown in Figure 8-5. The subsequent flow of material was probably diverted by the plugged holes and dropped onto the lower head from several different locations around the periphery of the EFD.

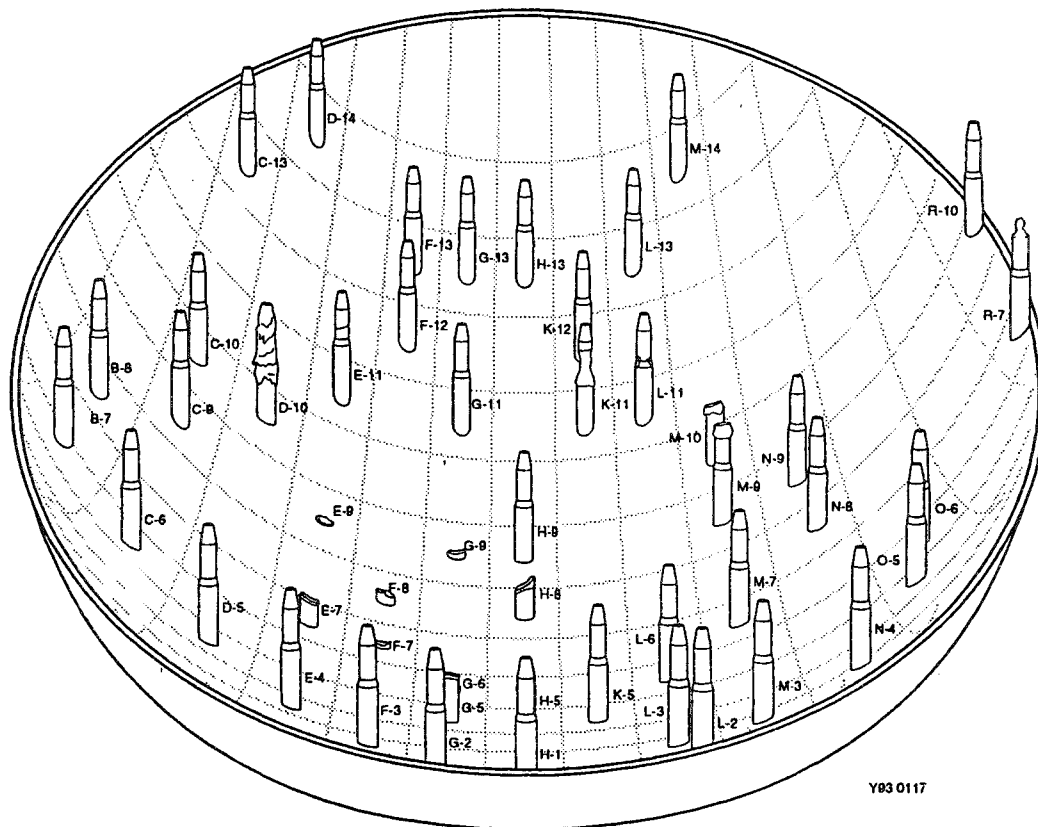
**Figure 8-6.** Nozzle damage profile.

The pattern of nozzle degradation observed at elevated levels for several nozzles is shown in Figure 8-6 and indicates the extent of the insulating ceramic debris layer that formed in the lower head and protected many of the nozzles and the lower head from extensive thermal damage. As the flow moved on top of the initial insulating debris layer, newly exposed molten fuel came in contact with the nozzles at elevated levels. These nozzles were melted at an elevation that is thought to be representative of the bottom of the molten fuel flow. Since the molten material flowed on top of the initial debris layer, this height is also representative of the thickness of insulating material that protected the lower head and the lower portions of many nozzles. As an example, examinations showed that the nozzle damage at M-9 was at about 25 cm above the lower head, and the damage to H-5 was about 15 cm above the head. Damage to nozzles around the M-9 and H-5 core locations, which have damage at elevations above the base of the nozzles, suggests that the insulating layer was approximately 25 cm thick at the M-9 location and 15 cm thick at H-5.

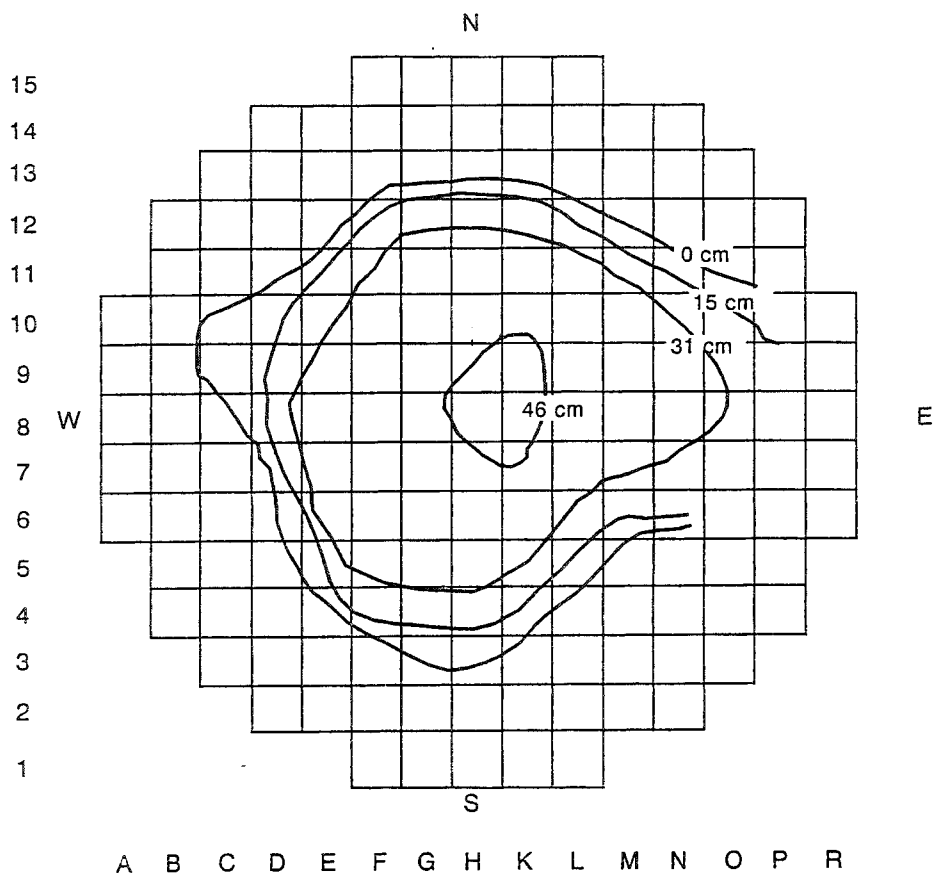
**Figure 8-7.** Hard layer debris depth. (Contour lines represent incremental increases, with the outside line equal to 0 cm and the inside equal to 46 cm.)

As the hotter molten material flowed across the top of the insulating ceramic debris layer, the cup-shaped structure that had initially formed on the lower head began to be filled. In the end, this resulted in what is known as the "hard debris layer," which is shown in Figure 8-7.<sup>15</sup> The debris depths shown in this figure were determined from mechanical probing of the hard layer during the defueling operation.

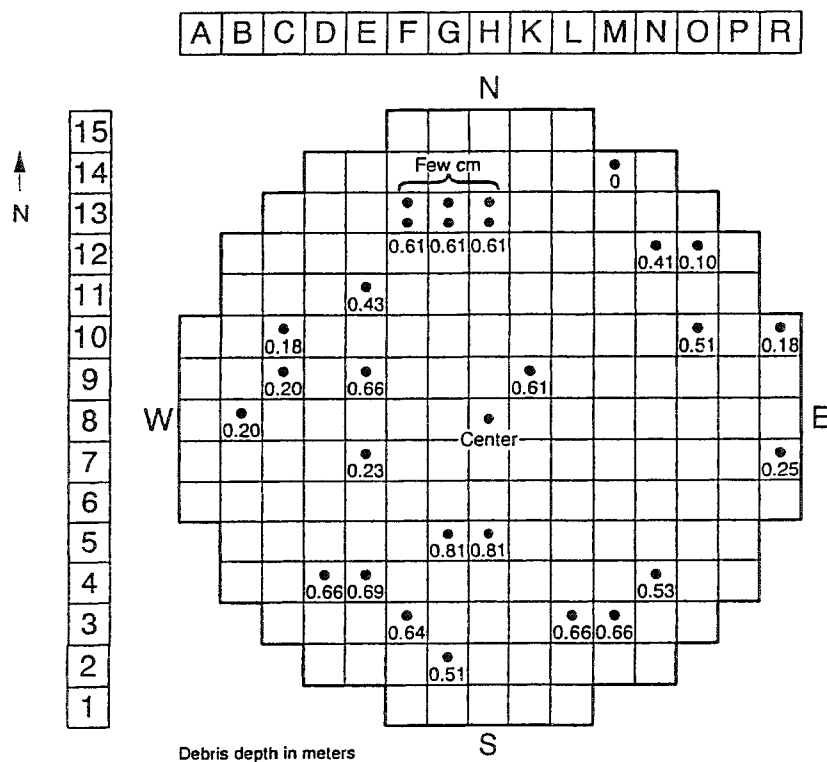
**Figure 8-8.** End state hard and loose layer debris configuration.

The last material to flow onto the lower head was what is known as the "loose debris layer." The depths of the loose debris layer are shown in Figure 8-8 and were determined before the defueling effort began.<sup>16,17</sup> The depths were determined by probing examinations and by analysis of video tapes taken of the lower head debris. Figures 8-9, 8-10, and 8-11 show cross sections of the hard debris layer thickness at several representative locations. As shown in these figures, there are relatively steep cliff-like areas along the periphery of the debris bed, and both full length and damaged nozzles are embedded in the debris.

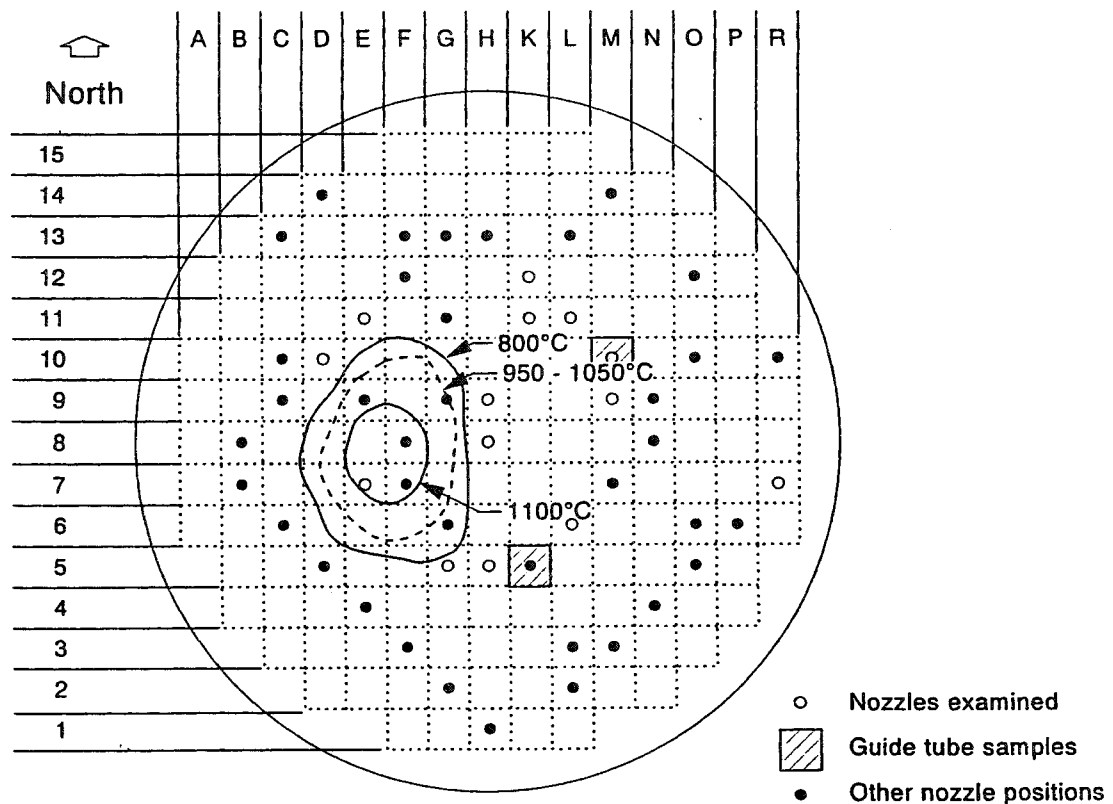
**Figure 8-12.** Lower head hot spot and nozzle/guide tube locations.

In addition to damaging the nozzles on the lower head, the flow of the hotter molten material may have also resulted in the formation of the localized lower head hot spot. It is postulated that as the hotter material flowed down the sides of the cup-like shape that was formed by the initial insulating crust towards the bottom of the vessel, the insulating layer crust became progressively thinner. Eventually, the flow of hotter material reached an area where the basal crust thickness was insufficient to adequately insulate the lower head, and a localized hot spot formed. The location of the hot spot on the lower head is shown in Figure 8-12.

The hypothesis that the hot spot was occurred beneath a crust that was of insufficient initial thickness to protect the lower head is consistent with the observation that the deepest debris was found in other locations of the vessel rather than over the hot spot. A progressively thinner crust was also indicated by data from the nozzle examinations, which showed that more of the nozzle length was melted in the vicinity of the hot spot. The region where the most severe nozzle damage occurred was consistent with the location of the hot spot and indicated that the insulating layer was thinnest in this area.
