II. Further developments of the nuclear accident since that time

1. The Tohoku District-Off the Pacific Ocean Earthquake and the resulting tsunamis

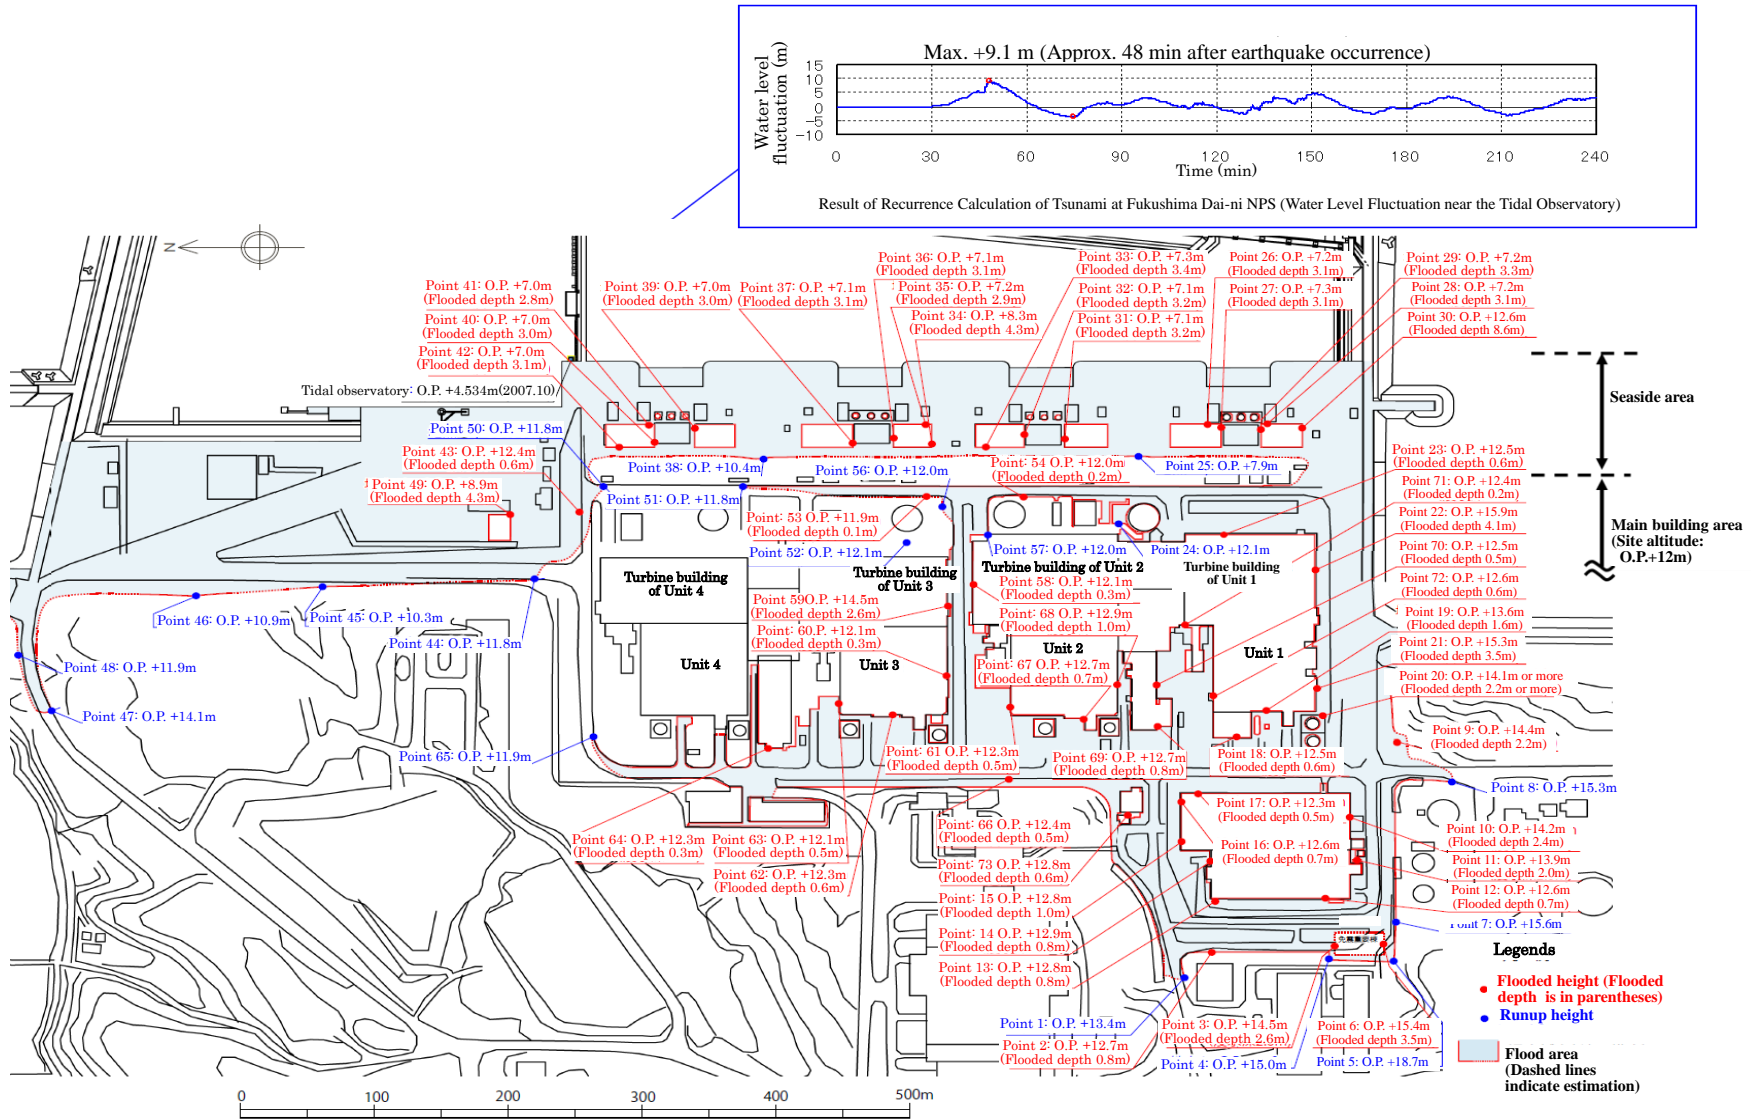
Figure II -2 -106 Flooded Height, Flooded Depth, and Flooded Area at Fukushima Dai-1 NPS

Fig. II-2-106 shows the height, depth and area of submersion caused by the tsunamis.

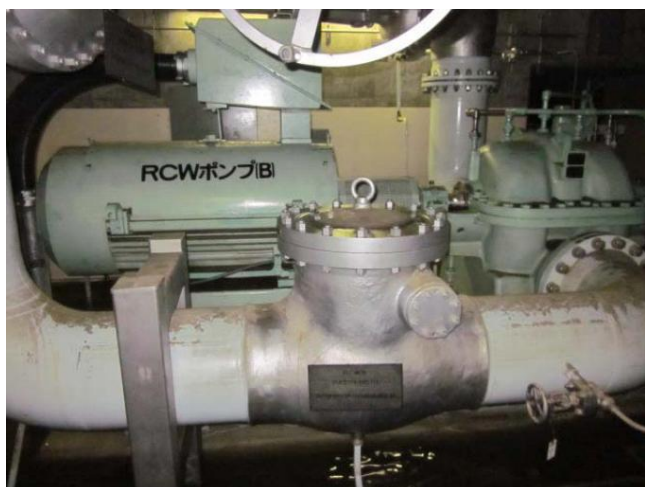
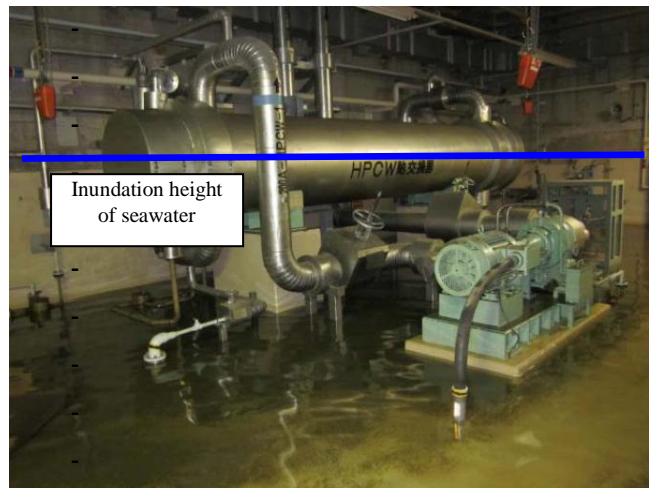
- Fig. II-2-143 Seawater flooding condition

RCW pump (B) (after seawater was drained)

Seawater flooding in the HPCW heat exchanger chamber

- Repair work has been undertaken on penetrations for pipes and cable trays from the seawater pump room to the trench.
- In the future, the water-tightness of building doors will be improved and tide embankments/barriers will be constructed.

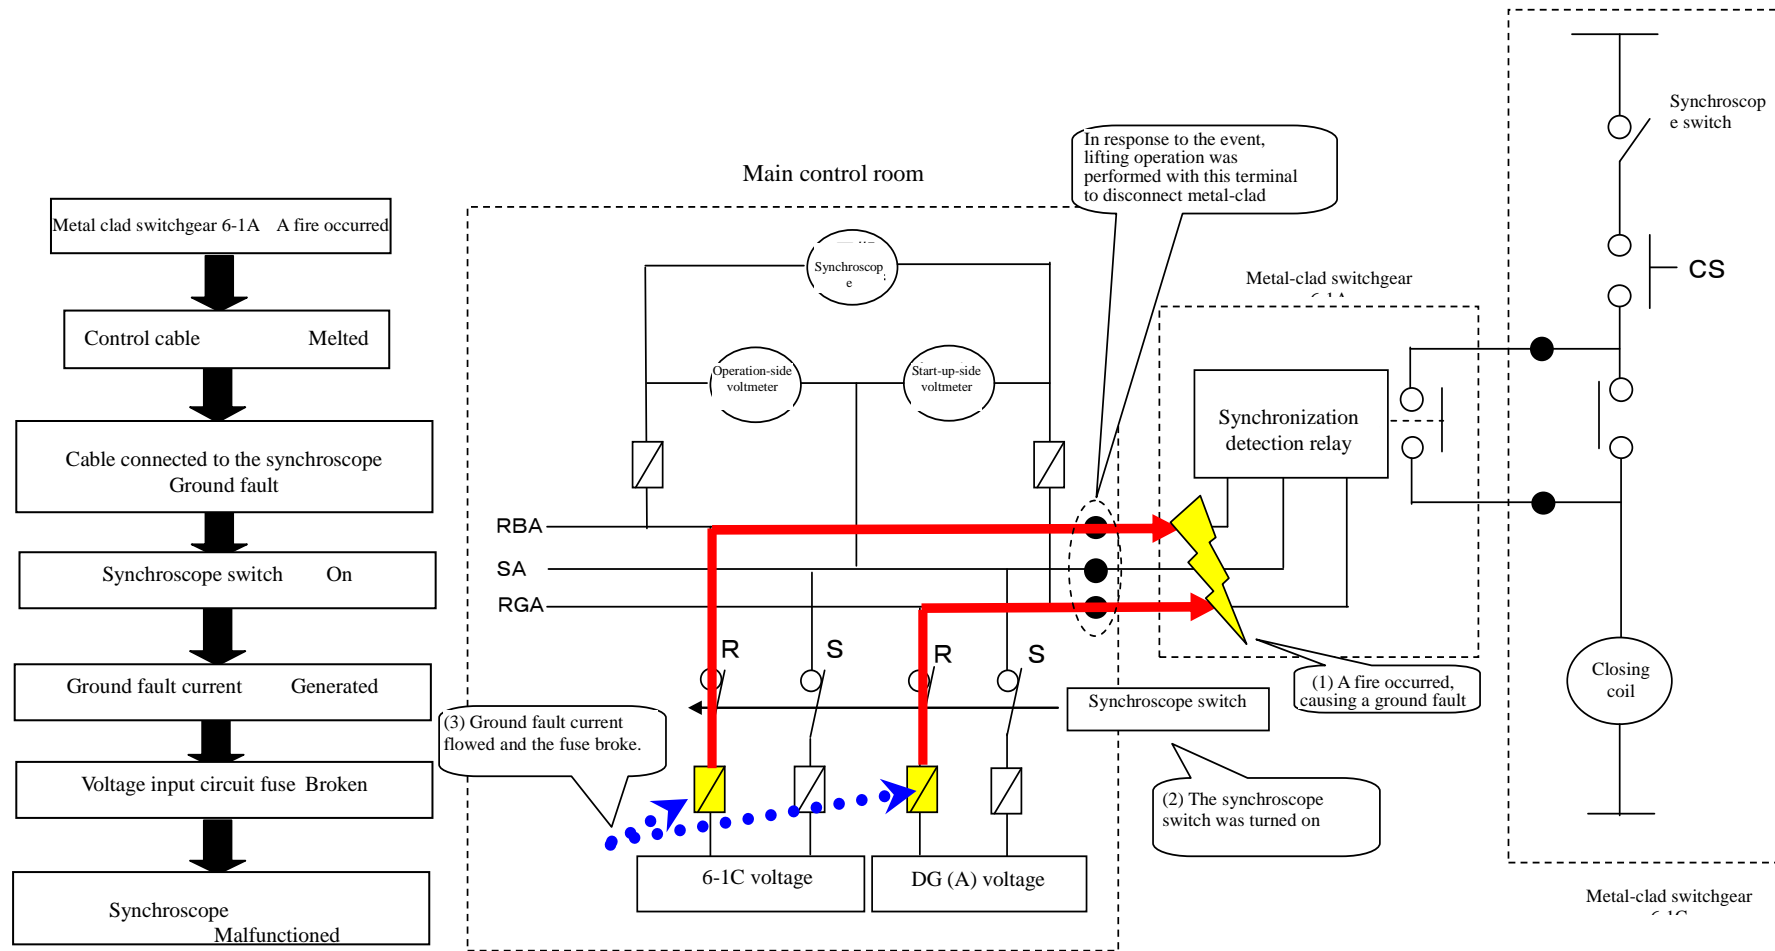
Fig. II-2-152 How the synchroscope malfunctioned

\* 2 out of 12 diodes (6 pairs) short-circuited.

Output circuits of synchronization detection relays have been designed to be separated from the normal system via relays. However, with a view to improving reliability of the emergency DGs against cables' damages and melting due to fire and other causes, output circuits of the synchronization detection relays are to be separated at all times, and switches and other devices will be installed so that connection can be established only when it is necessary to make connection for manual start-up tests of the emergency DGs.
