***Dominion  
North Anna Power Station  
Restart Readiness***

***October 21, 2011 Briefing***

# ***Dominion Assessment***

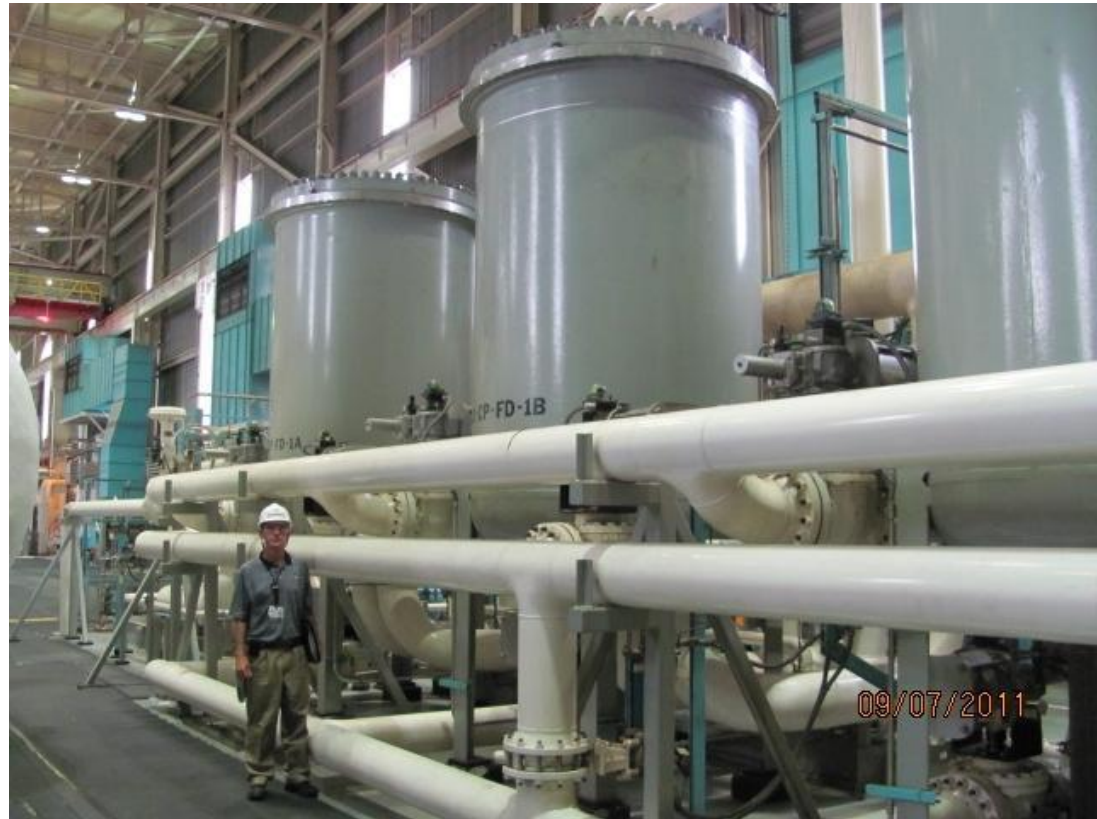
# ***Unit 2 Turbine Building***

Non-Safety  
Related  
Powdex  
Demineralizer  
Tanks

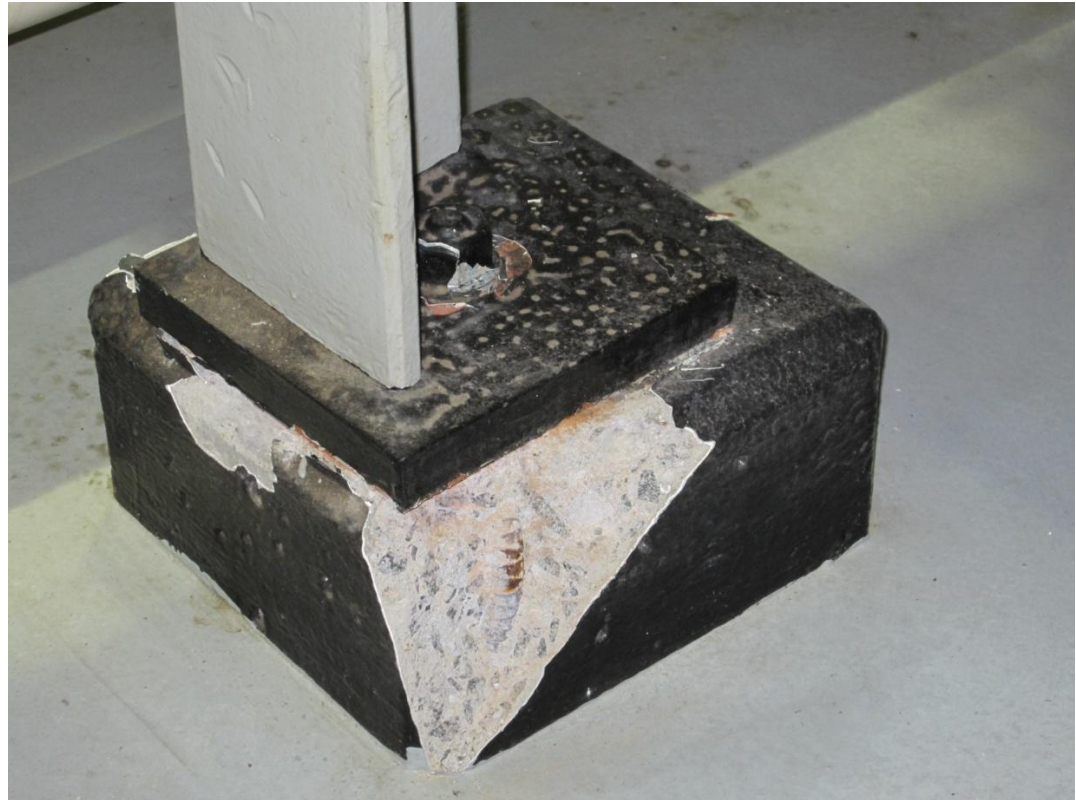
# ***U2 Turbine Building***

Powdex  
Demineralizer  
Tanks Base  
Pedestal

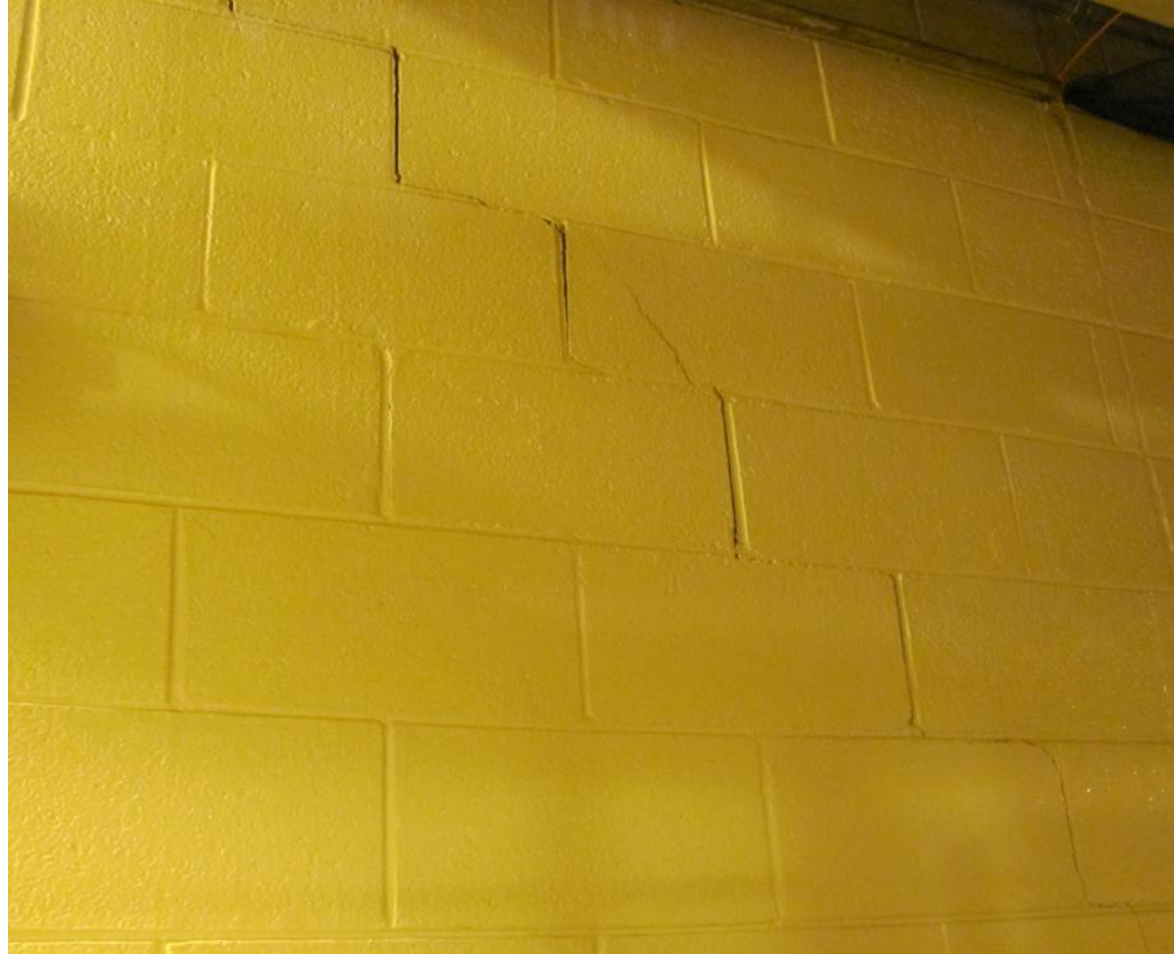
# ***Turbine Building Hallway***

Crack In  
Unreinforced  
Non–Safety  
Related  
Block  
Wall

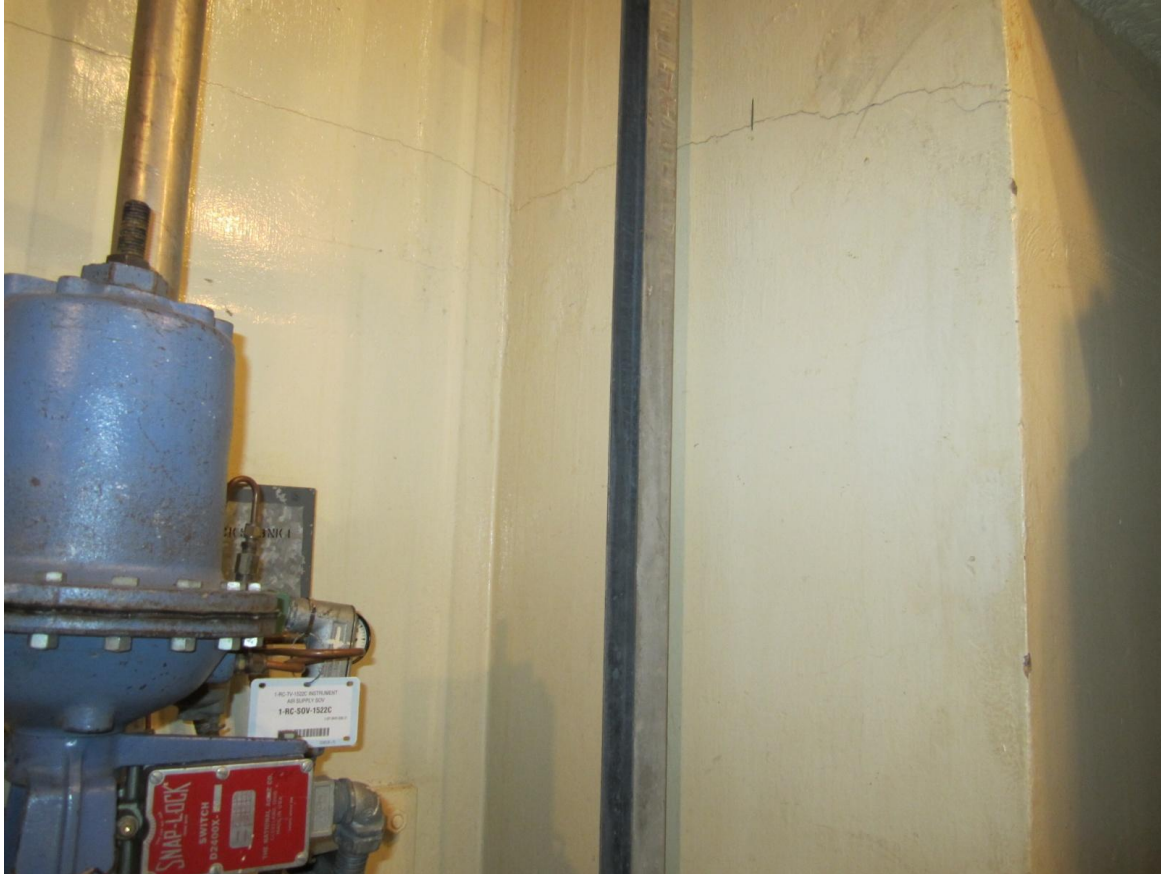
# ***Unit 1 Containment***

Surface Crack In Interior Containment Wall

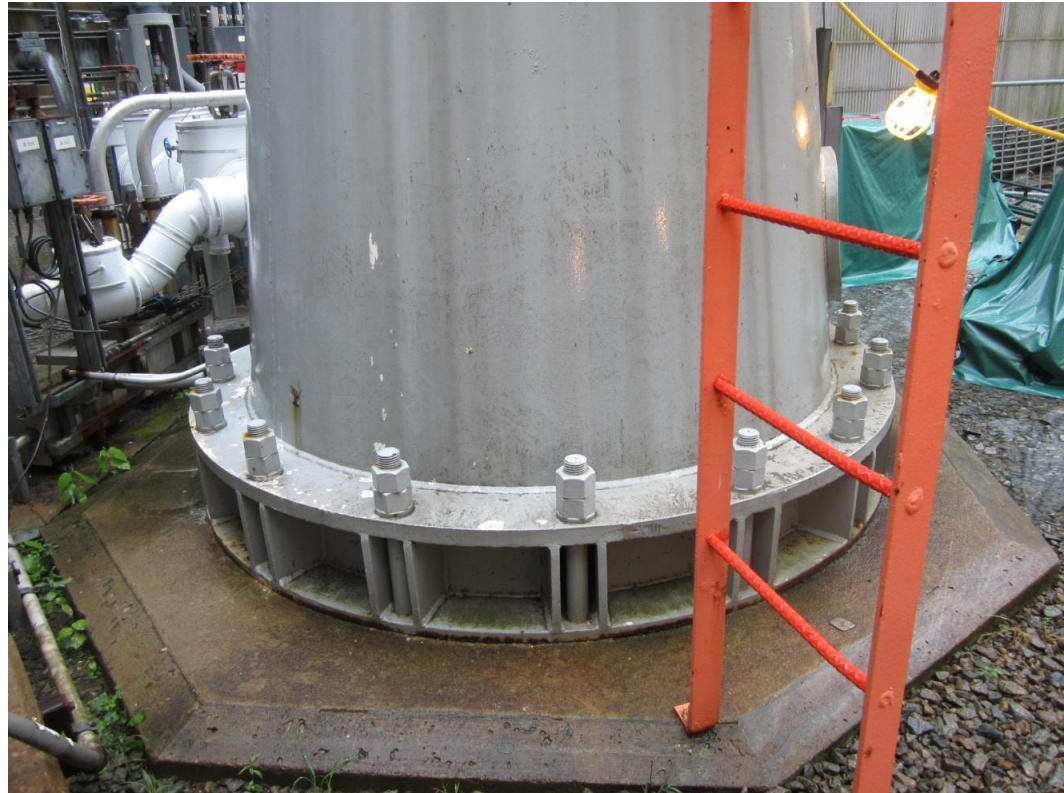
# ***Chemical Addition Tank***

HCLPF value  
= 0.19  
No seismic  
damage  
identified

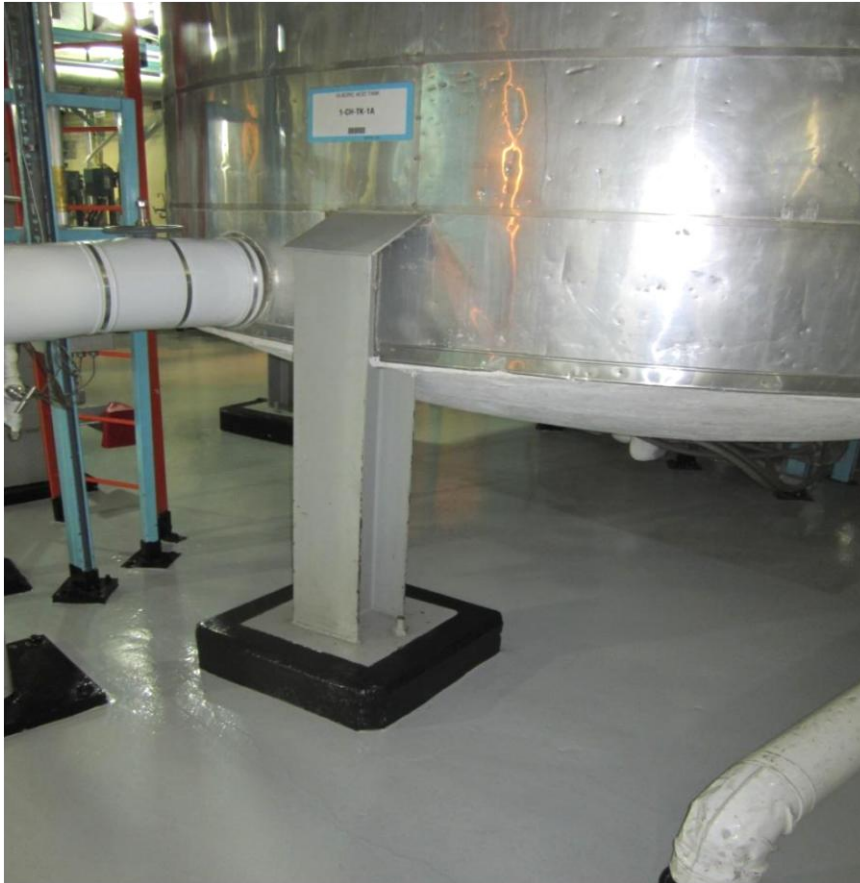
# ***Boric Acid Storage Tank***

HCLPF value  
= 0.21  
No seismic  
damage  
identified

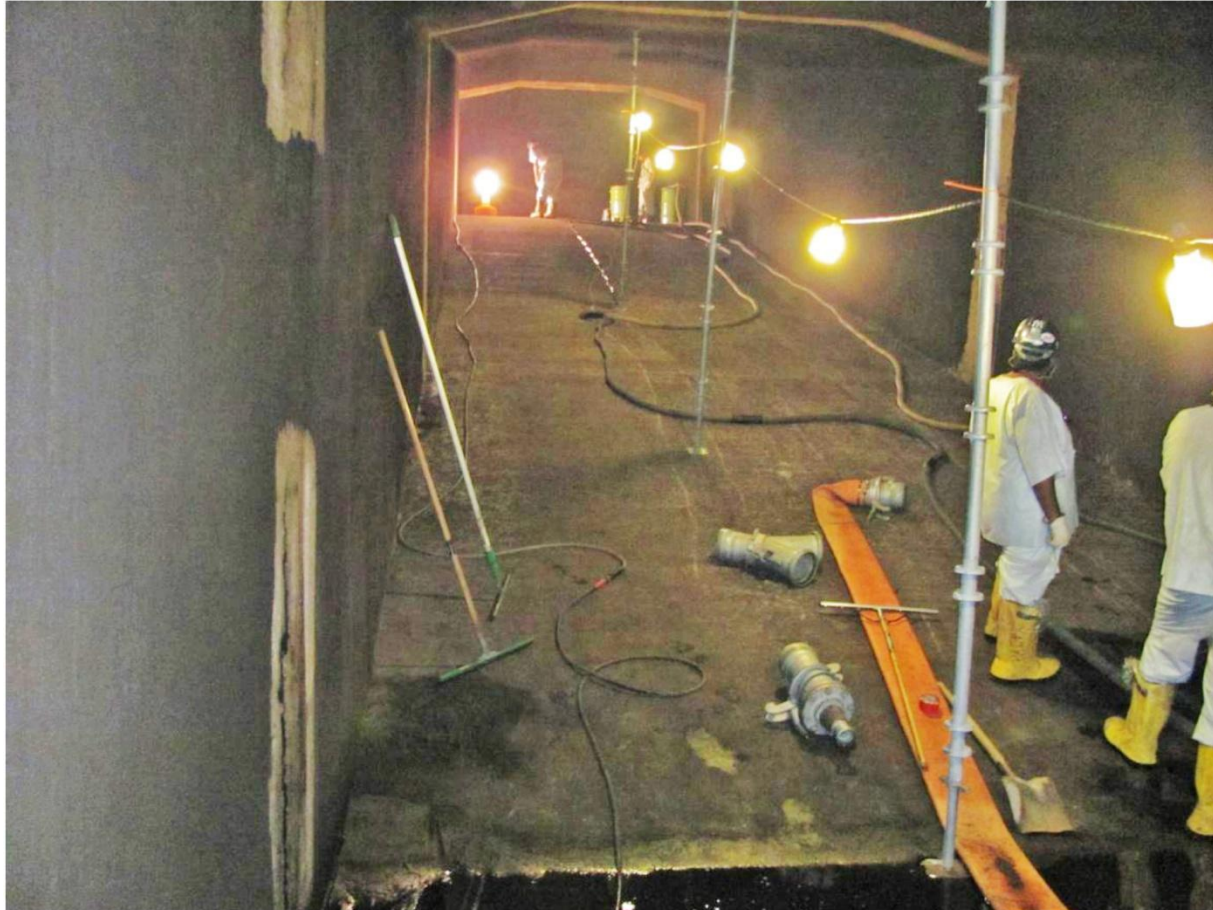
# ***Circulating Water Discharge***

Unit 2 Tunnel Inspection

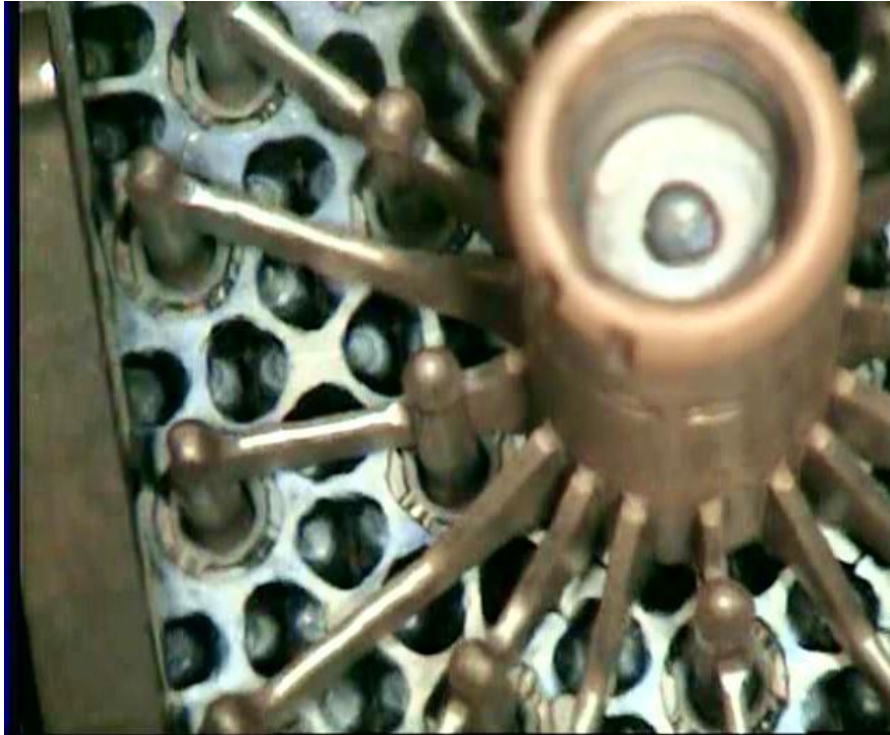
# ***Fuel Inspections***

Visual inspection of RCCA hubs

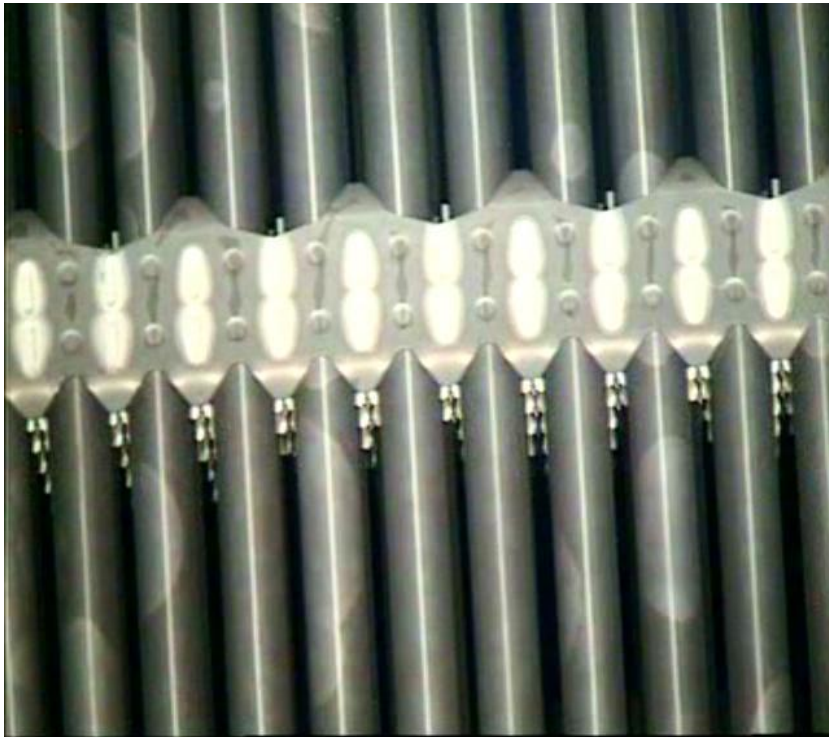
Examining the underside of  
a mid-span mixing grid

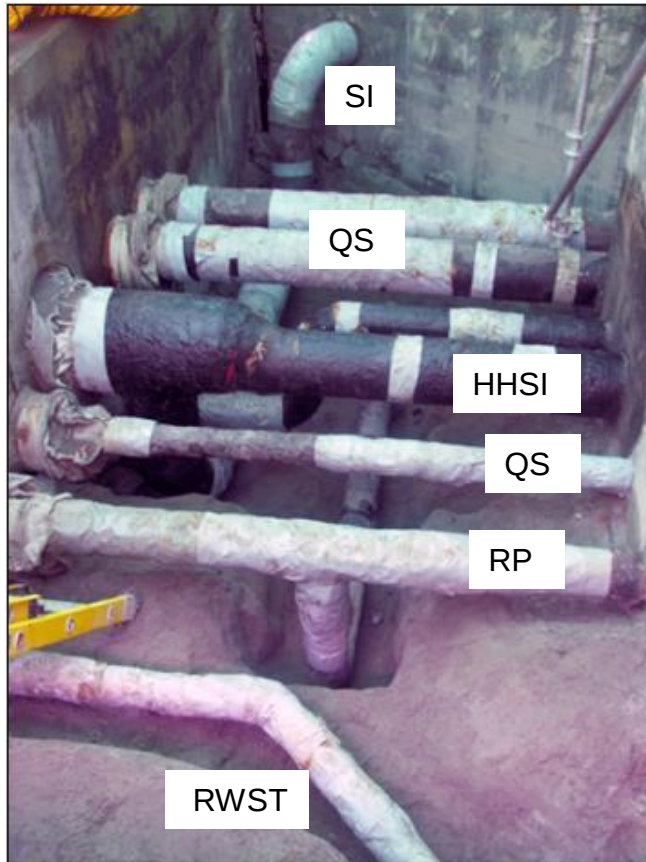
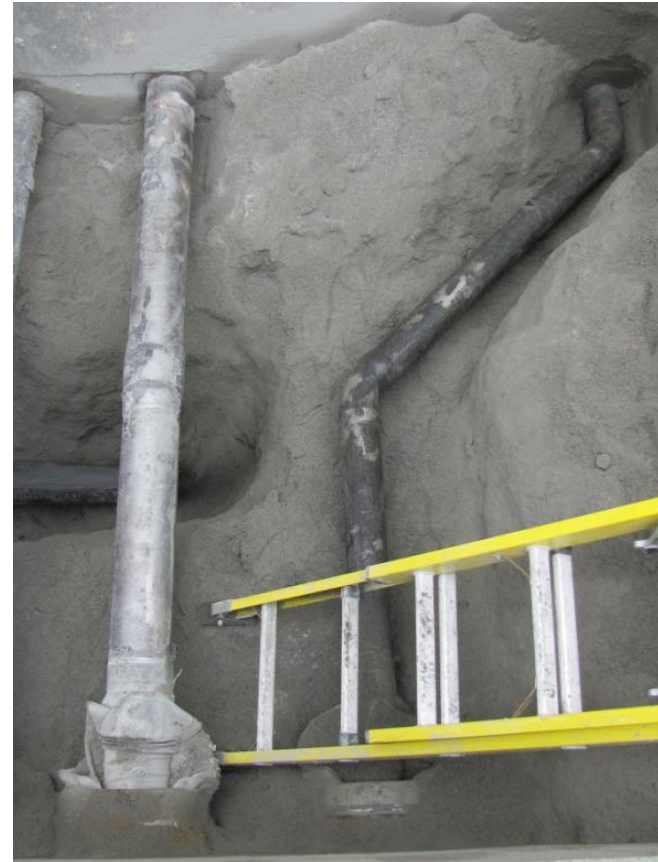
# ***Buried Piping***

~ 100 ft of safety related buried pipe visually inspected  
with wall thickness verified by UT

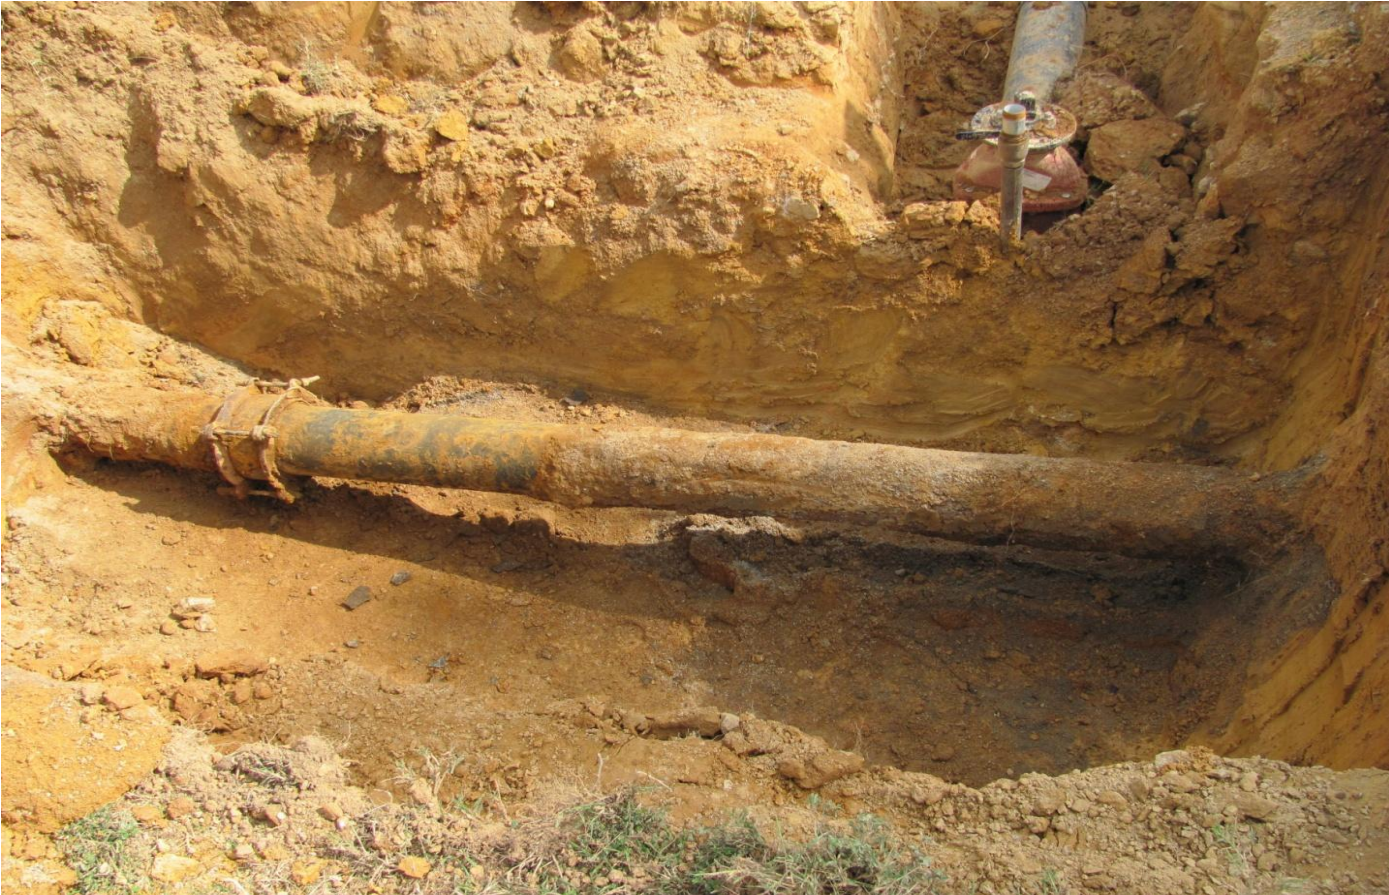
# ***Buried Piping***

~ 50 feet of Fire Protection piping visually inspected
