Regarding the Assessment of a Report on Maintaining Water Injection  
into Units 1, 2 and 3 Reactors at Fukushima Dai-ichi Nuclear Power Station,  
Tokyo Electric Power Co., Inc.

August 4, 2011  
Nuclear and Industrial Safety Agency

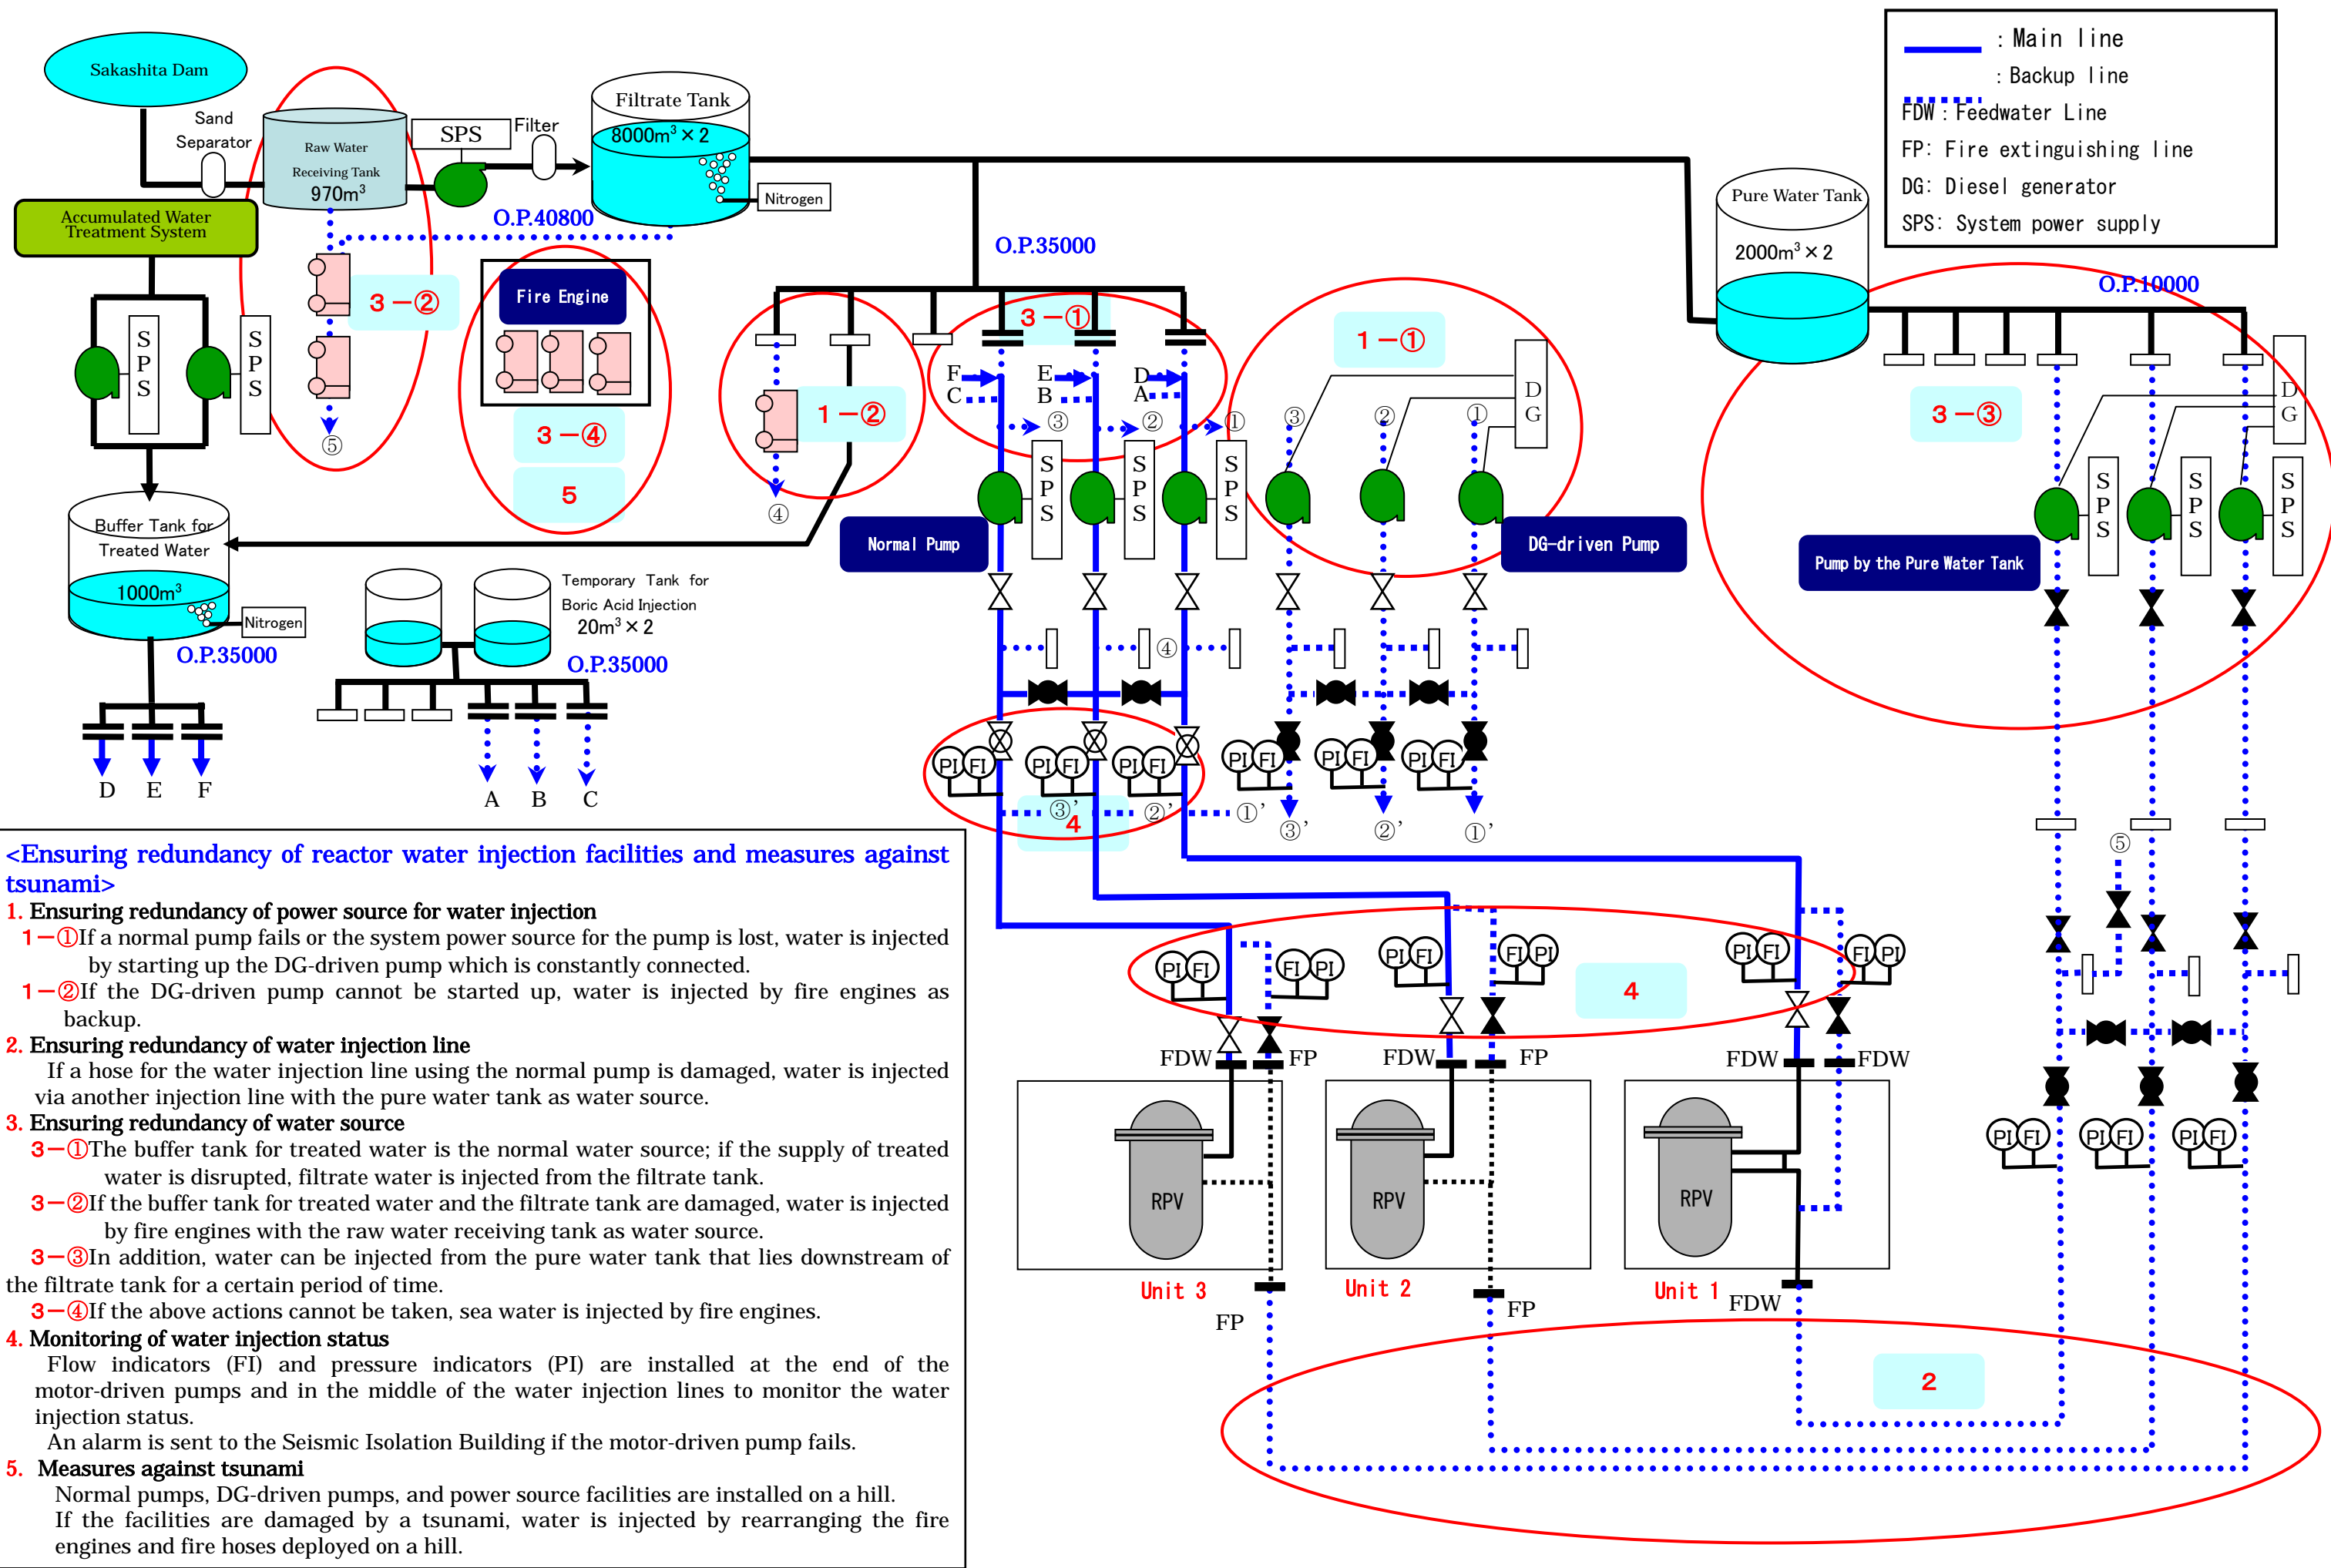
**<Ensuring redundancy of reactor water injection facilities and measures against tsunami>**

- 1. Ensuring redundancy of power source for water injection**
  - 1-① If a normal pump fails or the system power source for the pump is lost, water is injected by starting up the DG-driven pump which is constantly connected.
  - 1-② If the DG-driven pump cannot be started up, water is injected by fire engines as backup.
- 2. Ensuring redundancy of water injection line**

If a hose for the water injection line using the normal pump is damaged, water is injected via another injection line with the pure water tank as water source.
- 3. Ensuring redundancy of water source**
  - 3-① The buffer tank for treated water is the normal water source; if the supply of treated water is disrupted, filtrate water is injected from the filtrate tank.
  - 3-② If the buffer tank for treated water and the filtrate tank are damaged, water is injected by fire engines with the raw water receiving tank as water source.
  - 3-③ In addition, water can be injected from the pure water tank that lies downstream of the filtrate tank for a certain period of time.
  - 3-④ If the above actions cannot be taken, sea water is injected by fire engines.
- 4. Monitoring of water injection status**

Flow indicators (FI) and pressure indicators (PI) are installed at the end of the motor-driven pumps and in the middle of the water injection lines to monitor the water injection status.

An alarm is sent to the Seismic Isolation Building if the motor-driven pump fails.
- 5. Measures against tsunami**

Normal pumps, DG-driven pumps, and power source facilities are installed on a hill.

If the facilities are damaged by a tsunami, water is injected by rearranging the fire engines and fire hoses deployed on a hill.
