## Site Photographs of Fukushima Daini Nuclear Power Station

Since the occurrence of Tohoku-Chihou-Taiheiyou-0ki Earthquake we have disclosed site photographs mainly of Fukushima Daiichi Nuclear Power Station. These are photographs of Fukushima Daini Nuclear Power Station as the reference material of "The impact of Tohoku-Chihou Taiheiyo-0ki Earthquake to Nuclear Reactor Facilities at Fukushima Daini Nuclear Power Station" released on August 12.

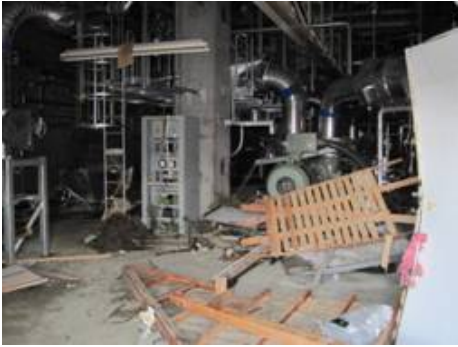
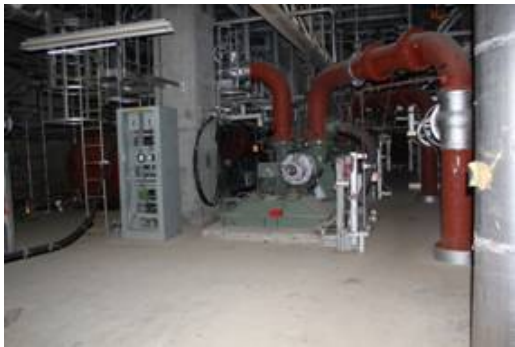
Situation after the disaster	Current situation
<u>1 . [Inundated] Inside of Heat Exchanger Building</u>

<p>Date 2011/3/13            Location R H R C pump (C) at 1st floor of Heat Exchanger Building, Unit 4            Photo by TEPCO Staff</p>	<p>Date 2011/8/26            Location R H R C pump (C) at 1st floor of Heat Exchanger Building, Unit 4            Photo by TEPCO Staff            Facility Status Restoration underway</p>
<u>2 . [Inundated] Inside of Heat Exchanger Building</u>

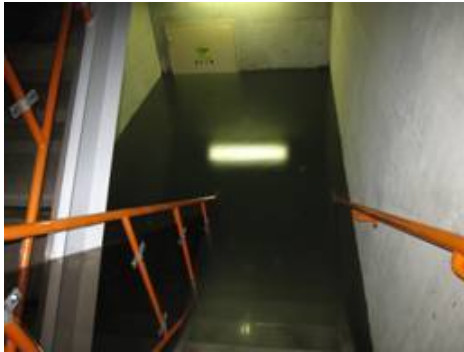
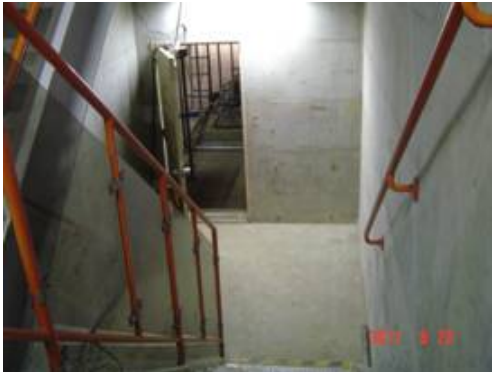
<p>Date 2011/3/16            Location Stairs between 1st floor and B1 of Heat Exchanger Building, Unit 3            Photo by TEPCO Staff</p>	<p>Date 2011/8/29            Location Stairs between 1st floor and B1 of Heat Exchanger Building, Unit 3            Photo by TEPCO Staff</p>
<u>3 . [Inundated] Pump of Equipment Cooling Water System</u>

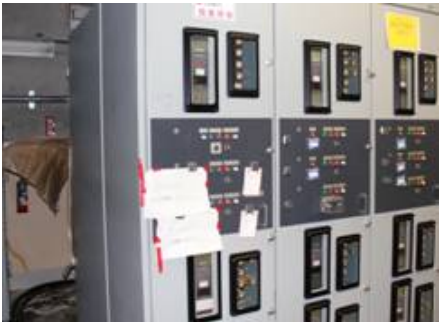
<p>Date 2011/4/2  Location P / C Power Panel at 1st floor of Heat Exchanger Building, Unit 3  Photo by TEPCO Staff  Facility Status In operation</p>

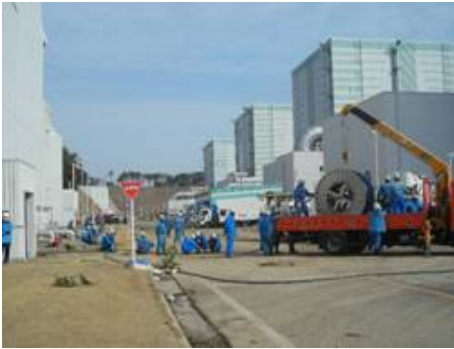
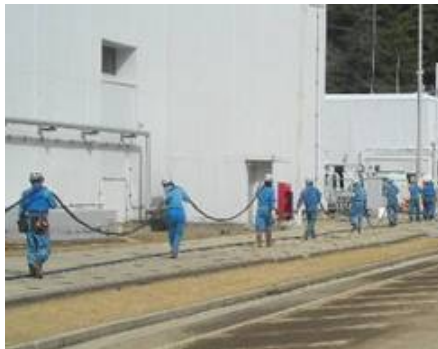
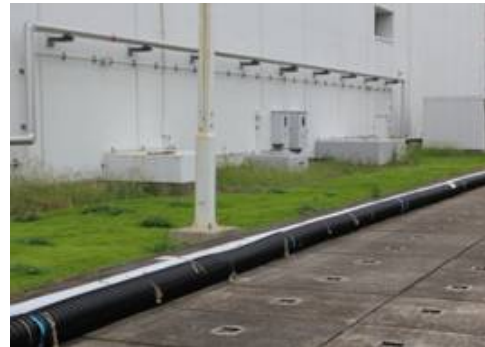
7 . Installation of Temporary Cables from Waste Treatment Facility

Date 2011/3/13  
Location East Side of Waste Treatment Facility  
Photo by TEPCO Staff

Date 2011/8/26  
Location East Side of Waste Treatment Facility  
Photo by TEPCO Staff

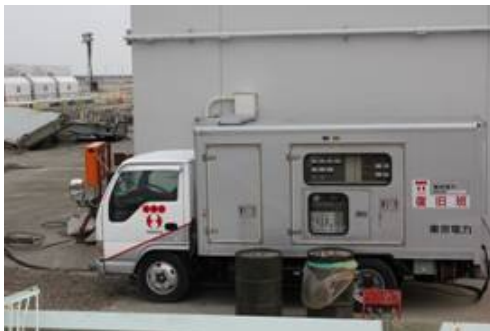
8 . Powered by High Voltage Power-Supply Car

Date 2011/4/2  
Location North Side of Heat Exchanger Building, Unit 4  
Photo by TEPCO Staff  
Facility Status Powering lights and drain pumps

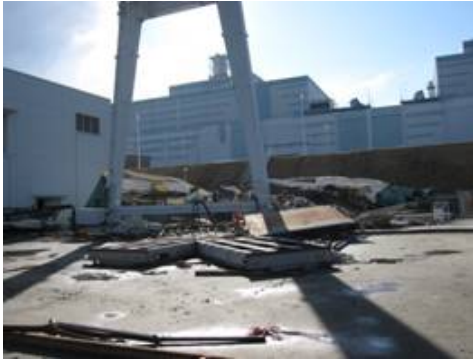
9 . Debris scattered by Tsunami

Date 2011/3/16  
Location Between Heat Exchanger Buildings,  
Unit 3 and 4  
Photo by TEPCO Staff

Date 2011/8/29  
Location Between Heat Exchanger Buildings,  
Unit 3 and 4  
Photo by TEPCO Staff  
Facility Status Debris removed

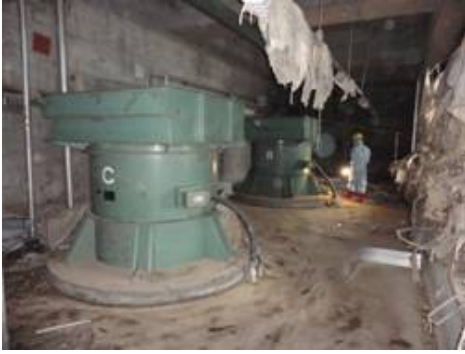
12. [Inundated] Emergency air blower for Emergency DG

Date 2011/3/20  
 Location Emergency air blower for Emergency DG, Unit 1  
 Photo by TEPCO Staff

Date 2011/8/26  
 Location Emergency air blower for Emergency DG, Unit 1  
 Photo by TEPCO Staff  
 Status Under restoration

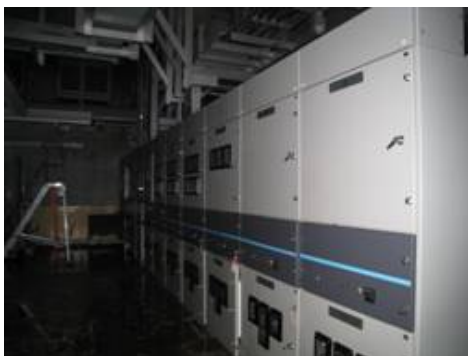
14. [Inundated] M/C power panel (Unit 1)

Date 2011/4/2  
 Location M/C power panel, Unit 1  
 Photo by TEPCO Staff

Date 2011/8/26  
 Location M/C power panel, Unit 1  
 Photo by TEPCO Staff  
 Status Under restoration

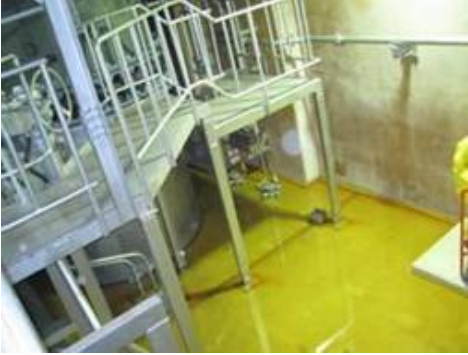
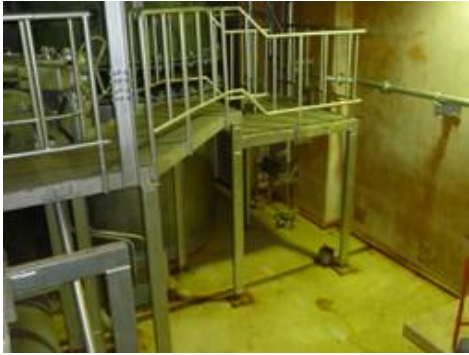
<p>Date 2011/3/20            Location Condansate pump on the first basement, Unit 1            Photo by TEPCO Staff</p>	<p>Date 2011/8/26            Location Condansate pump on the first basement, Unit 1            Photo by TEPCO Staff            Status Drainage completed, To be overhauled</p>
<u>18. [Inundated] Turbine Building</u>

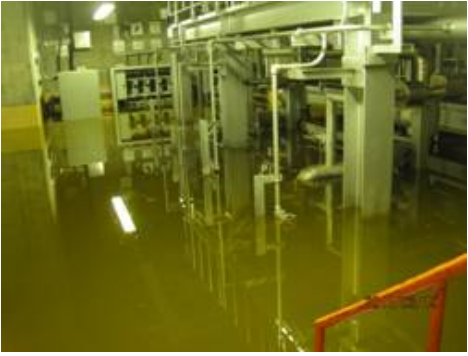
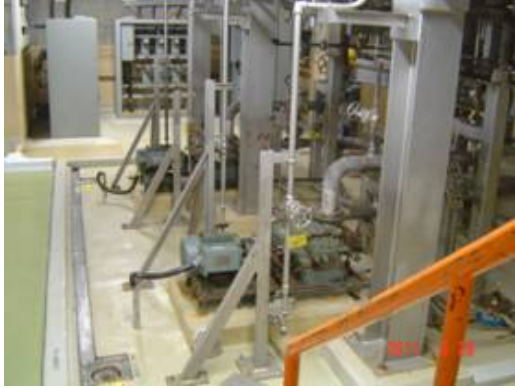
<p>Date 2011/3/19            Location HSCR condensate water transfer pump on the second basement, Unit 3            Photo by TEPCO Staff</p>	<p>Date 2011/8/29            Location HSCR condensate water transfer pump on the second basement, Unit 3            Photo by TEPCO Staff            Status Drainage completed, To be overhauled</p>

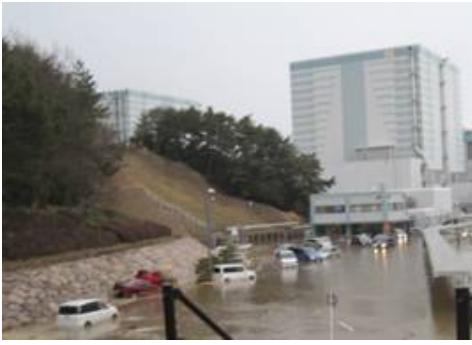
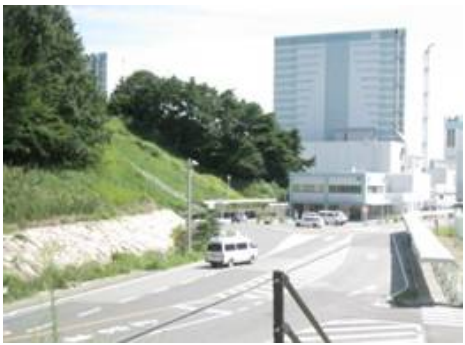
<p>Date 2011/3/11  Location North side of Main Anti-Earthquake Building  Photo by TEPCO Staff</p>	<p>Date 2011/8/29  Location North side of Main Anti-Earthquake Building  Photo by TEPCO Staff  Facility Status Completed Removal of vehicles</p>
<p>28. The situation of facilities which symbolizes the damage by tsunami (Shallow Draft Quay)</p>

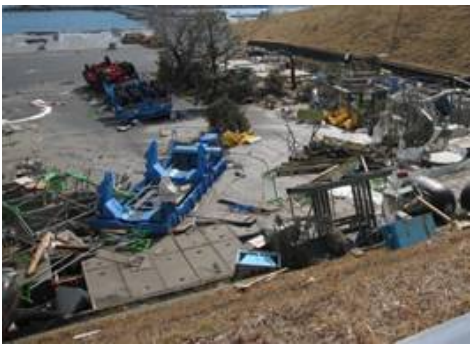
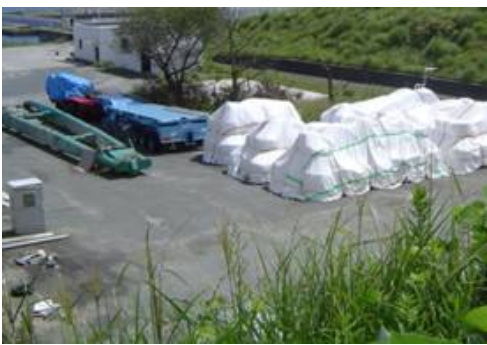
<p>Date 2011/03/16  Location Shallow Draft Quay  Photo by TEPCO Staff</p>	<p>Date 2011/08/31  Location Shallow Draft Quay  Photo by Employess  Facility Status Completed rubble removal</p>
