# Fukushima Spent Fuel Pond Failure Analysis

by W.Christoph Müller

Revision 3, 27.Oct. 2011

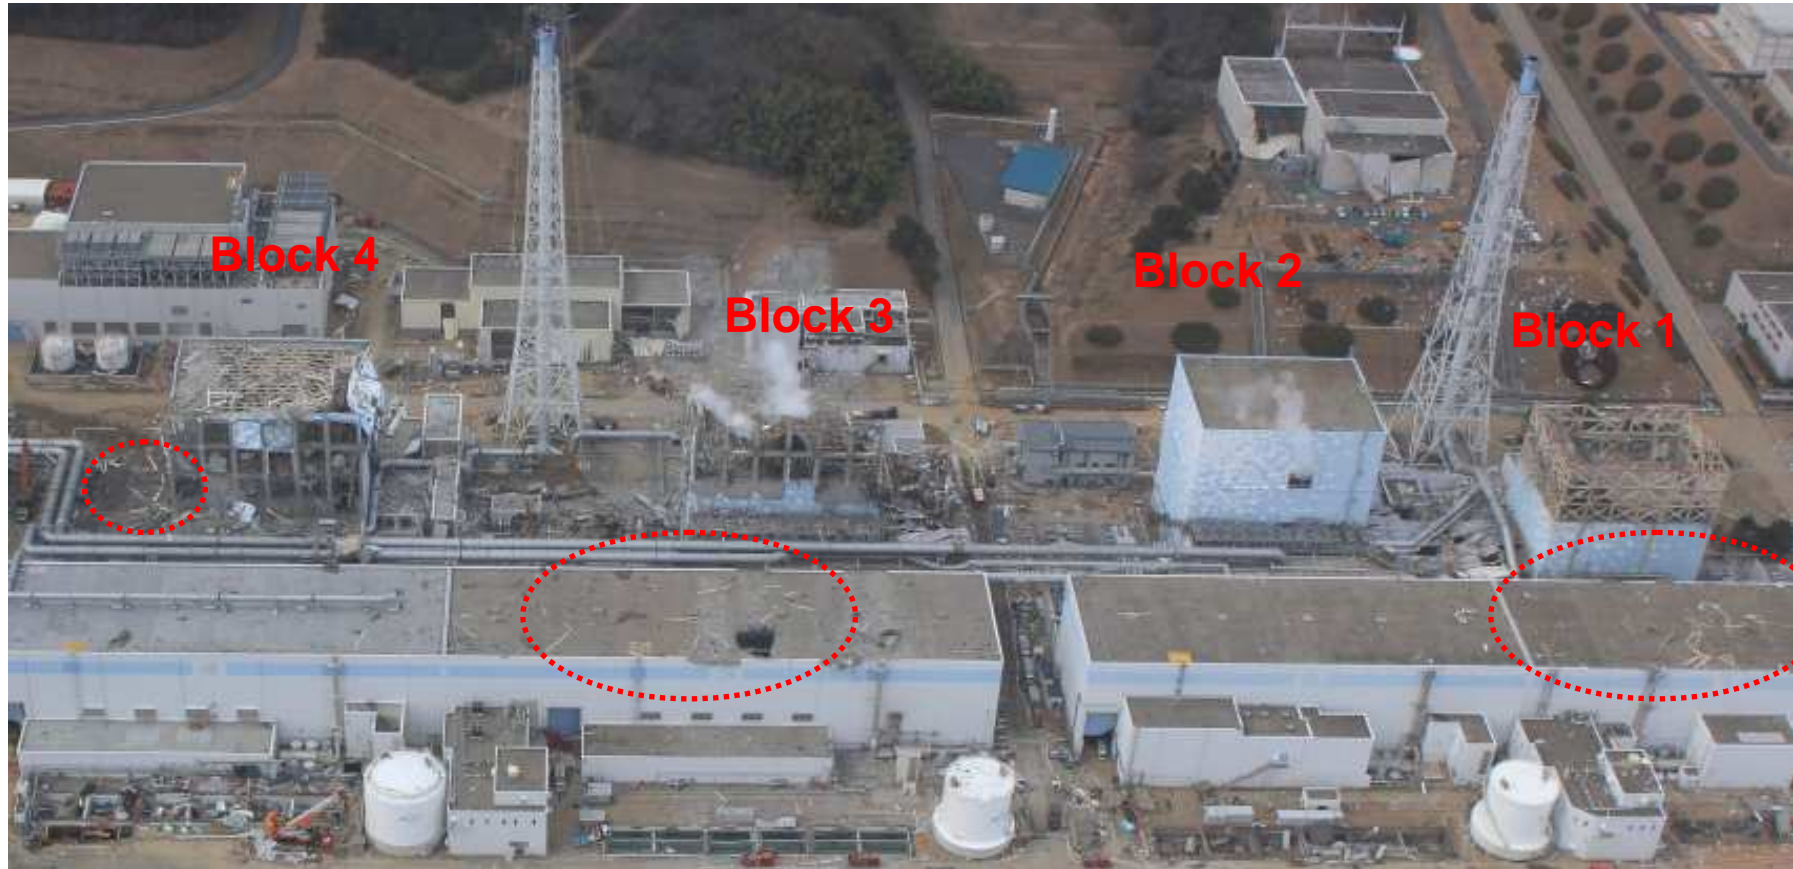
**The visual destruction is limited to the upper part of the reactor building which consists of a light weight beam and plate reinforced concrete construction.**

**From the picture it can be concluded that block 1 and 3 have experienced a detonation which caused a substantial destruction of the upper structure. Parts of the building structure were scattered over a large area and debris can be found on the roof tops of the adjacent buildings (dotted circles).**

**Block 2 shows only minor damage: Just one plate of the upper structure has been relocated. Looks like it opened like a rupture disk.**

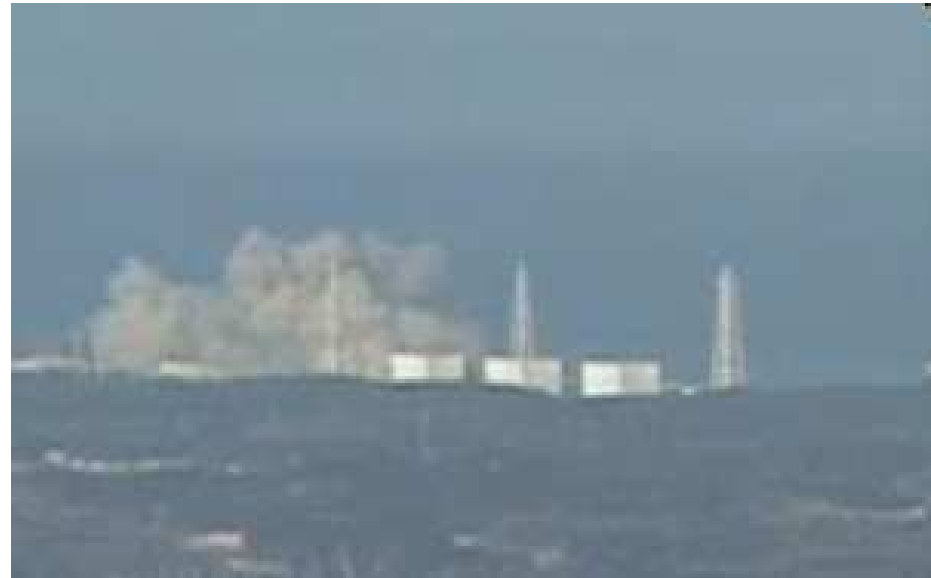
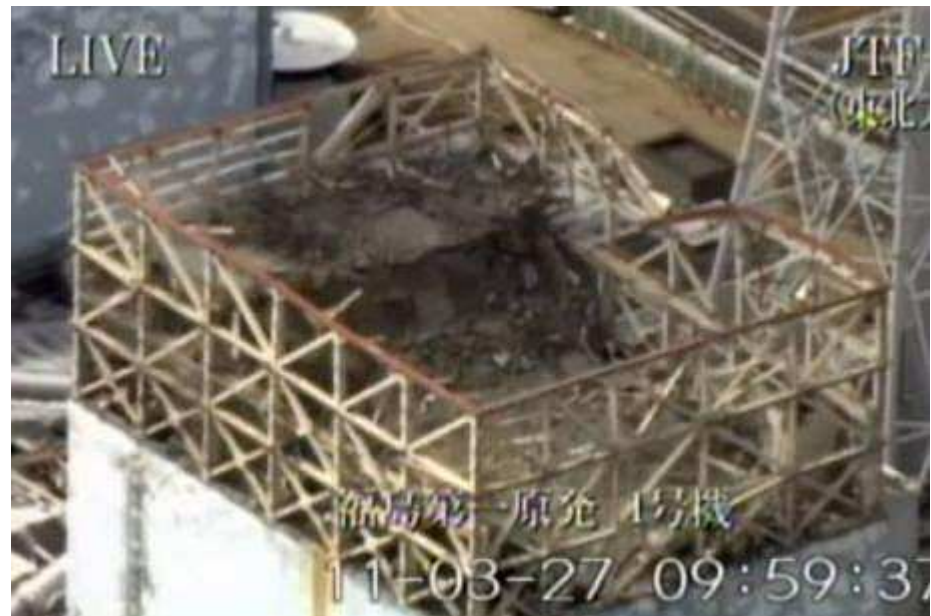
**All plates and the roof were blown away while the vertical beam remained in place. From the debris and the type of destruction it can be concluded that block 1 experienced a hydrogen detonation.**

**Since the vertical plates were blown away the roof was lifted and fell back into the building forming a large amount of debris.**

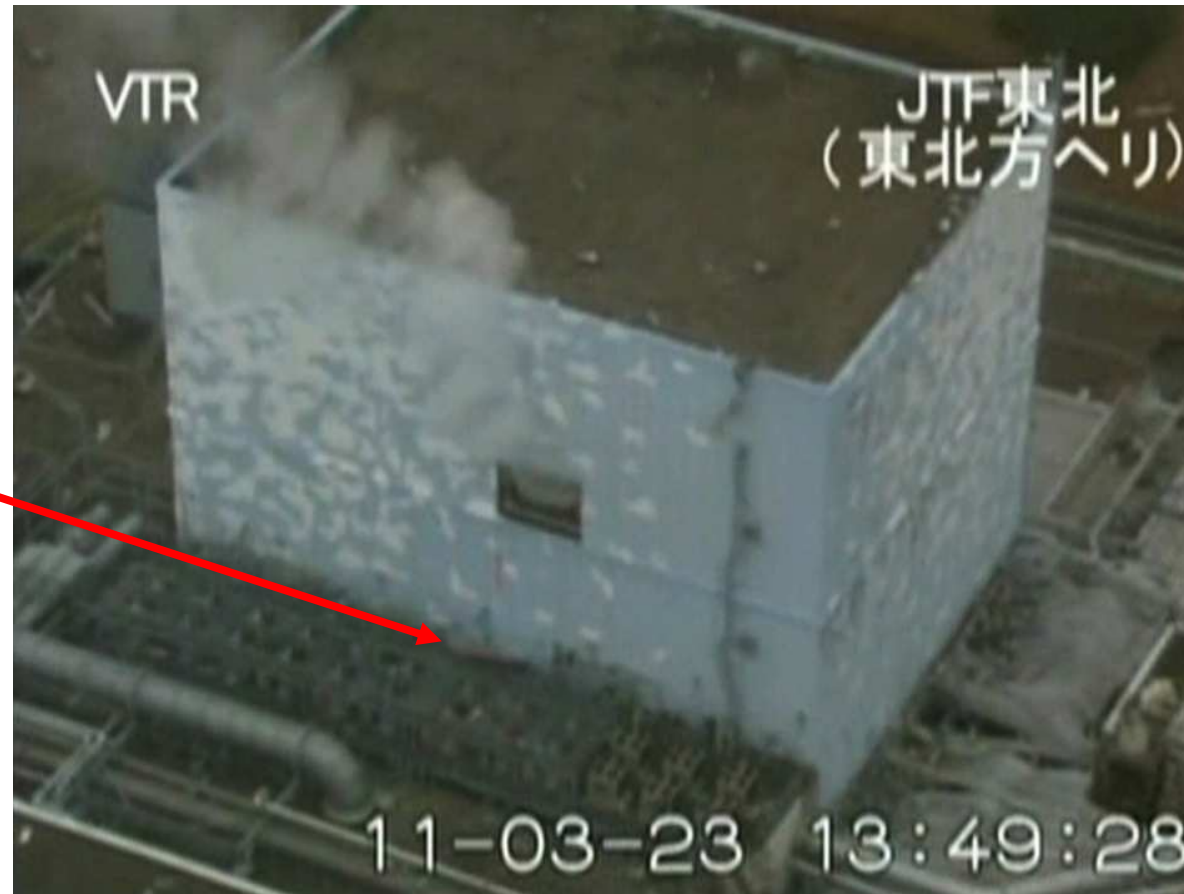
**Block 2 shows only little damage.**

Only one plate was blown out and is lying below the hole (red arrow). The formation of the hole in block 2 was not observed and no explosion noise was heard that was directly connected to the hole.

Basically it looks like it has been designed to fail in case of overpressure in the reactor building in order to avoid the complete failure of the building. It looks it was designed as a “rupture disk”.

This kind of destruction can only occur when the pressure build up is slow. So hydrogen deflagration is the best guess.

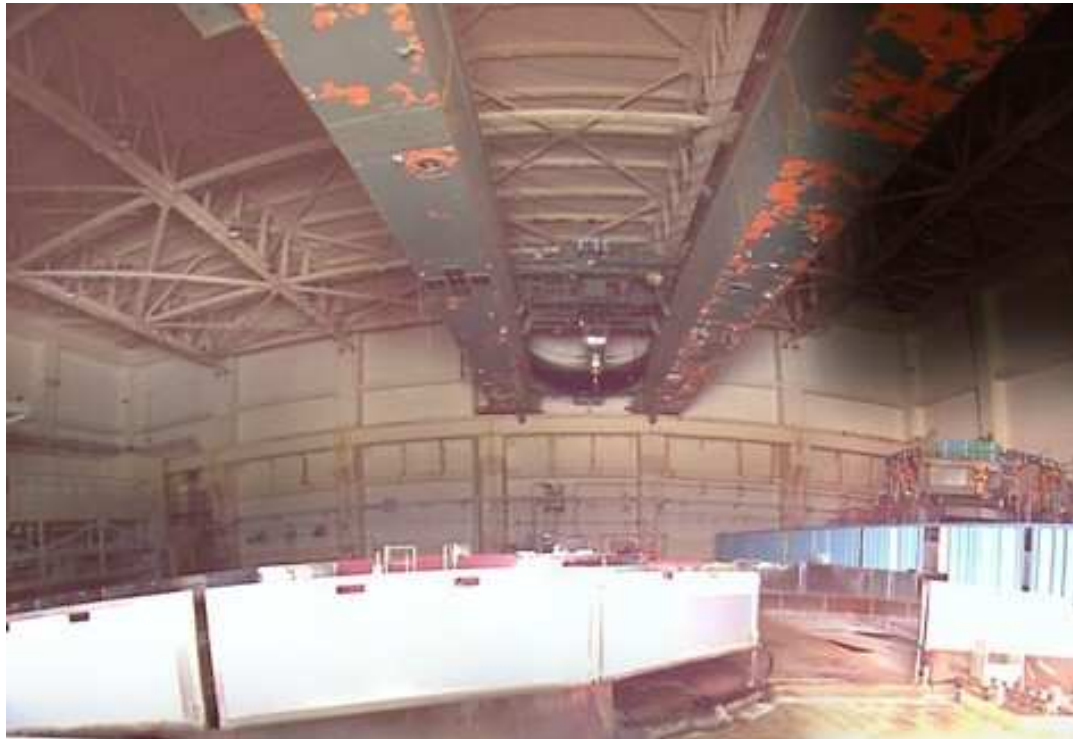
**Photo of Block 2 floor 5, published by TEPCO, shows no explosion damage.**

The picture below taken in October 2011 does not show any structural damage. An explosion including a substantial pressure wave would have blown away the metal sheets around the spent fuel pool, which are still standing and showing no impact of a pressure wave at all.

The dark green crane shows the impact of heat, which has partly destroyed the dark green painting. This strongly suggests that a heat wave has occurred, caused either by hydrogen deflagration or hot steam that was generated during reflooding of the spent fuel pool.

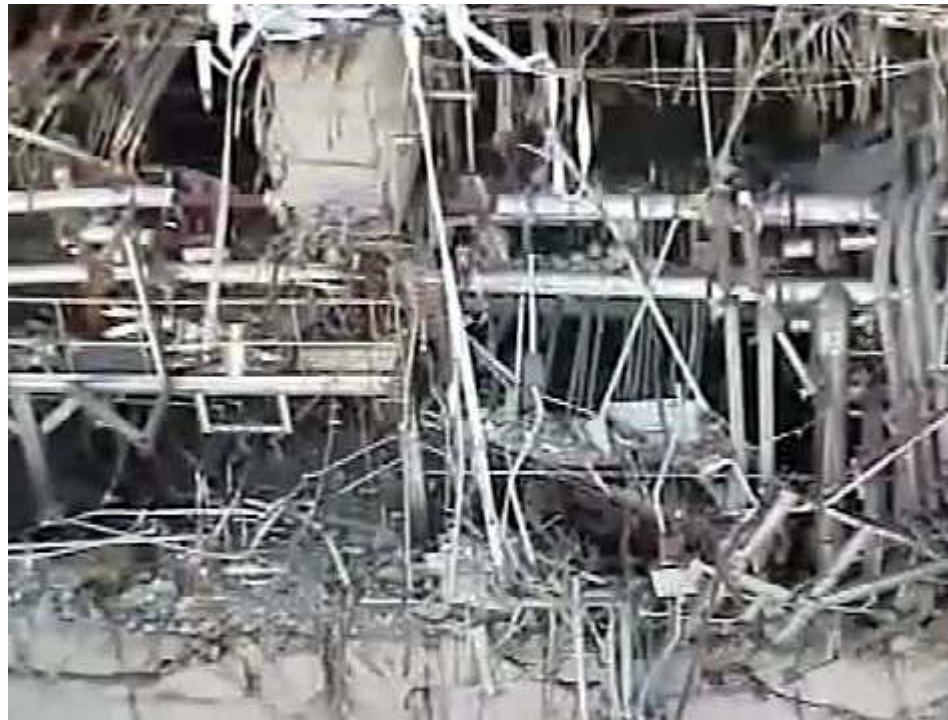
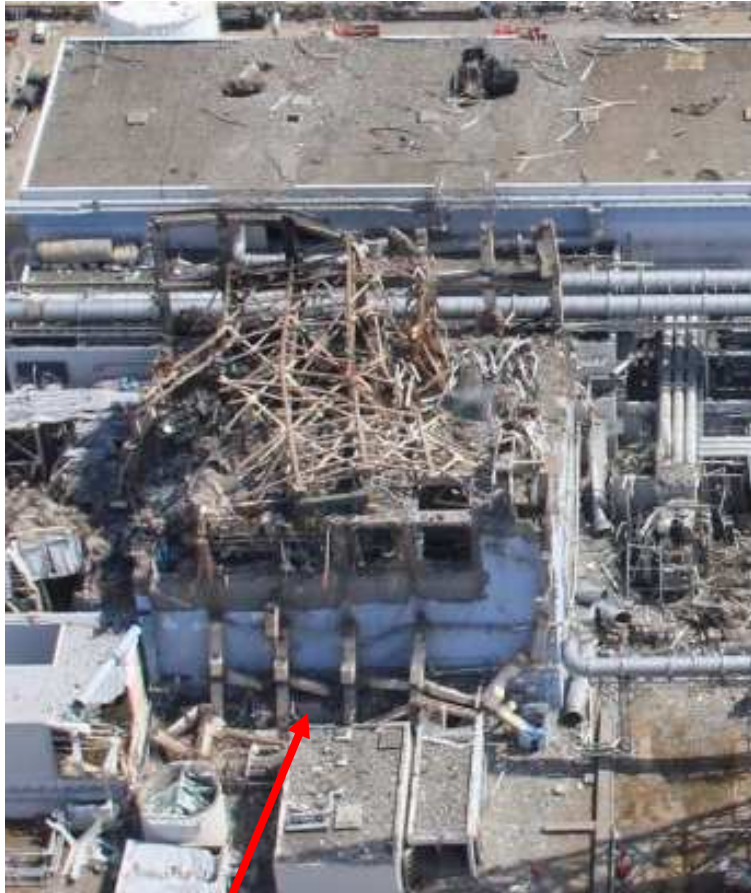
**Block 3 experienced a severe hydrogen detonation which was captured by the surveillance camera. It shows all signs a destruction by shock wave. It was converted into typical debris with the concrete and the reinforcement steel bar fully demolished**

**Even the strong beam structure has collapsed and the heavy beams were relocated as can be seen in the picture. (red arrow). The plates were destroyed to debris and rubble while the beam structure of the roof fell back into the building.**

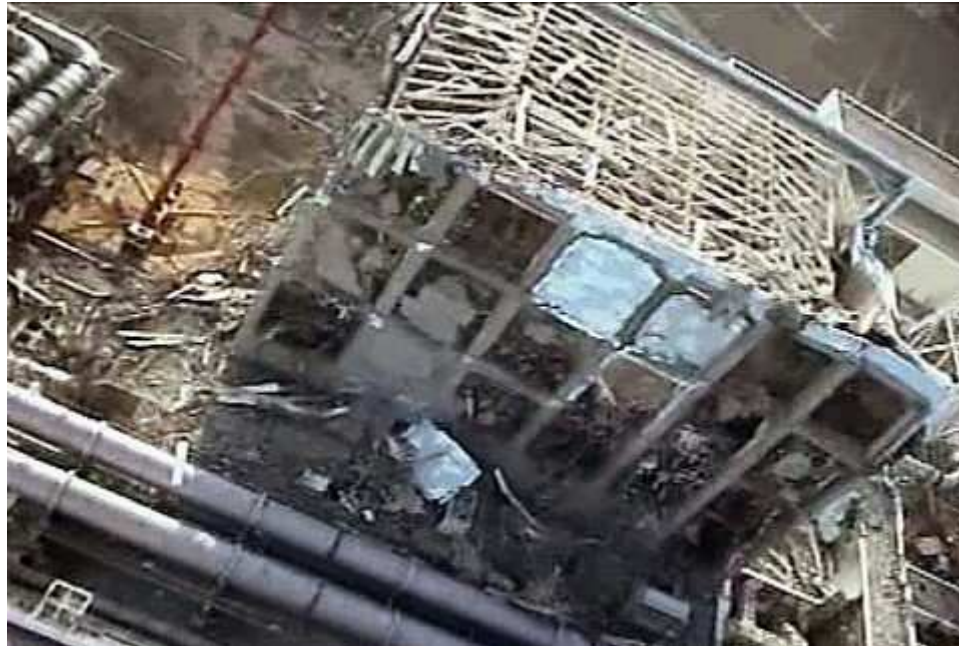
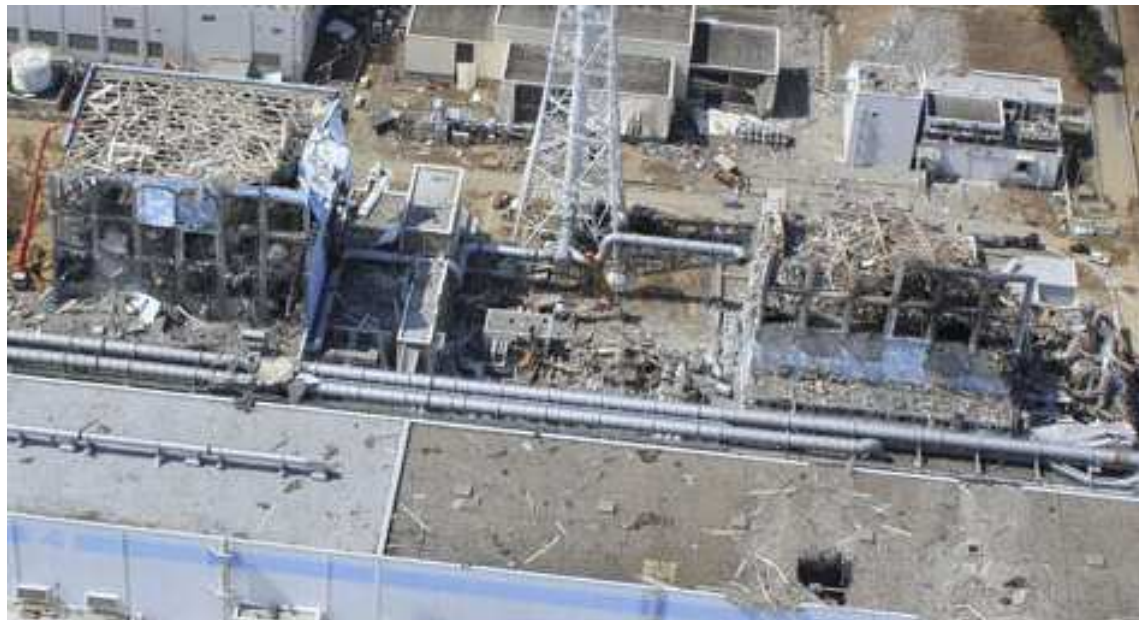
**The destruction of the upper structure of block 4 was not observed but an explosion noise was heard that was connected to the destruction of the 4th floor.**

**Most of the beam structure of block has remained in place -though deformed - and some of the plates also have remained in place. There is a clear contrast between block 3 and block 4.**

**It has to be concluded that block 4 was destroyed by a pressure surge caused either by a hydrogen deflagration or a rapid evaporation of water coming suddenly into contact with hot fuel elements.**

**The destruction is most severe close to the spent fuel pond.**

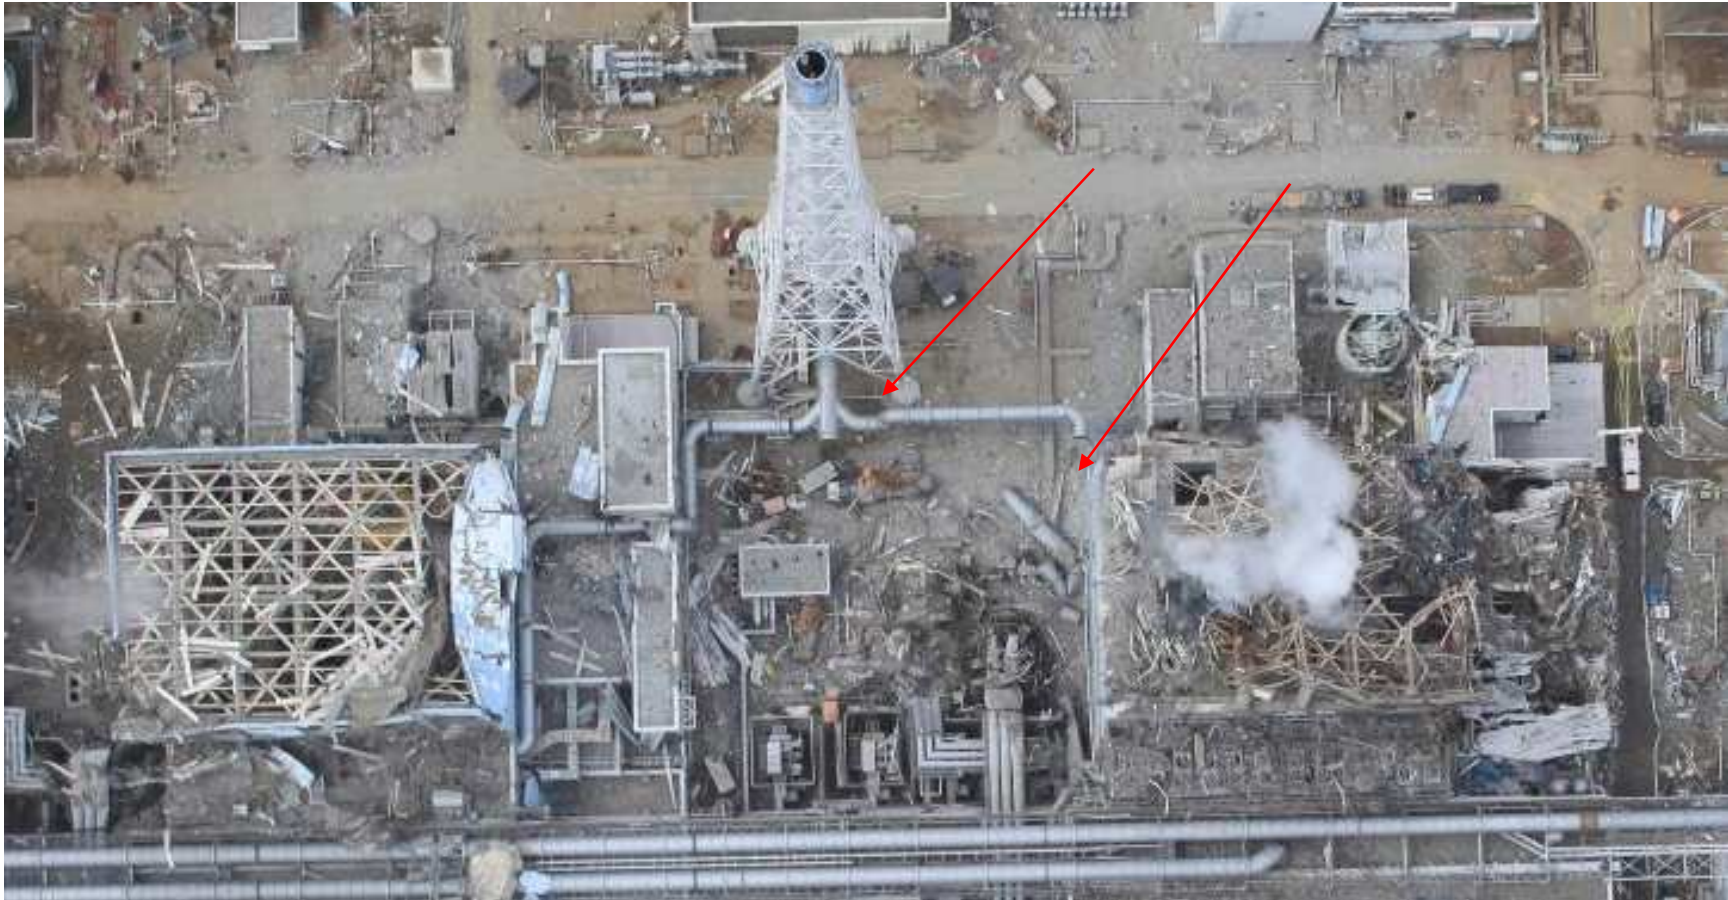
This figure, taken shortly after the explosion of unit 3 – which is not in the IAEA report – clearly shows that the standby gas treatment pipe from unit 3 was destroyed in the explosion which occurred 19 hours before the explosion in unit 4.

This means that the hydrogen gas mixture in unit 4 had 19 hours time to mixed well due to diffusion and explosive hydrogen pockets can be excluded. It also had time enough to depressurize to ambient pressure through the open path to the destroyed line from unit 3.

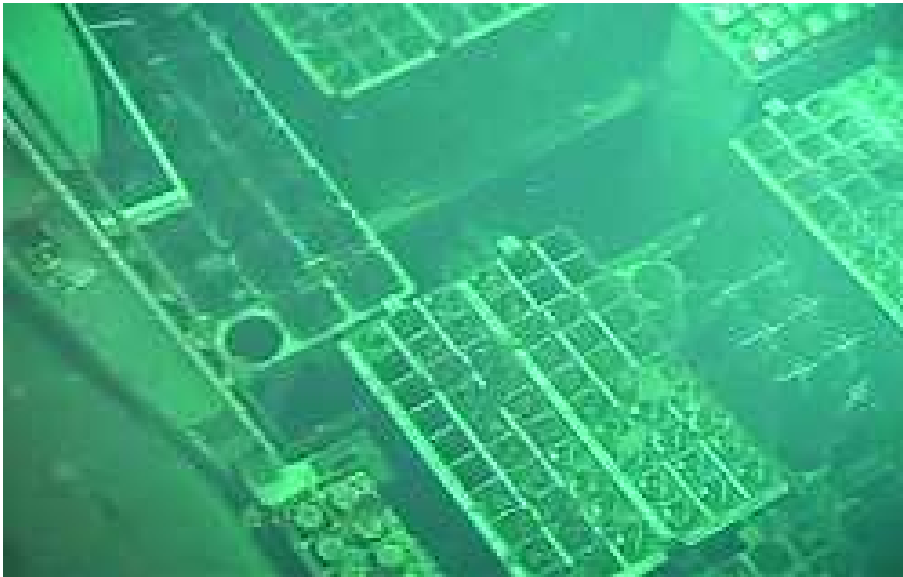
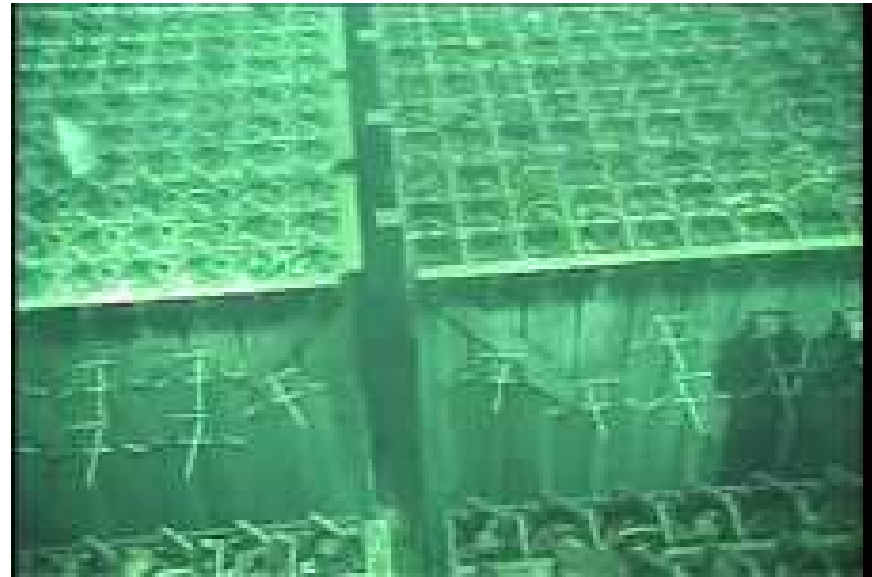
One puzzling observation in the SFP of block 4 is the lack of observable fuel damage as shown in the picture published by TEPSO in support of the hypothesis that the hydrogen explosion in block 4 was caused by hydrogen from block 3.
