SimplyInfo.org Fukushima Daiichi Unit 2 Report 2015

February 23, 2015

Unit 2 Timeline Narrative

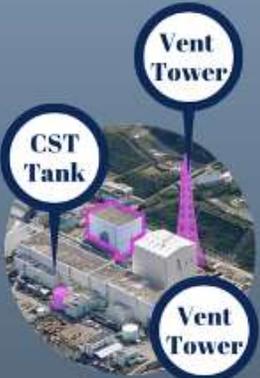
CST Tank

The CST tank provides water to the RCIC until empty. The RCIC then draws water off the suppression chamber

At 4:20am March 12, workers had to switch the RCIC system from drawing water off the Condensate Storage Tank (CST) to the SC (suppression chamber), mostly likely due to the tank running out of water. This is a critical change in the process. The water inside the SC is needed to cool steam releases from the RPV. Without sufficient cooling water in the SC they would lose the ability to relieve RPV pressure. The suppression chamber can quickly reach a saturation point where the internal temperature and pressure can no longer cool incoming steam from the RPV via the SRVs and the hot steam discharge from the RCIC turbine. Without the RHR system to cool the water in the suppression chamber heat can build up quite fast. This over heating of the water in the suppression chamber can also create a situation where the water once released from the contained space turns to steam. In a situation such as a suppression chamber routed emergency venting of the reactor to the environment, the over heated water would escape as steam vapor along with the radioactive gasses and fission products out the vent stack. The suppression chamber reaching this saturation point means that it can no longer provide filtration for the vent releases. A BWR mark 1 reactor, like units 1-5 at Fukushima Daiichi has the potential to scrub 80% of the non gas isotopes out of venting releases in an optimal situation where the suppression chamber has water inventory and is cool enough.

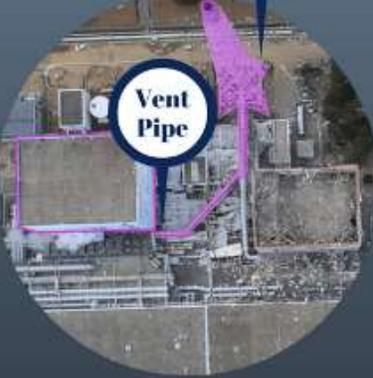
Vent Pipe

The vent pipe exits the suppression chamber to the vent tower

Two vent valves were opened (MO-271 and AO-205) and a venting was commenced at 11:20am on March 13. This venting may not have actually worked as the reactor containment pressure continued to climb.

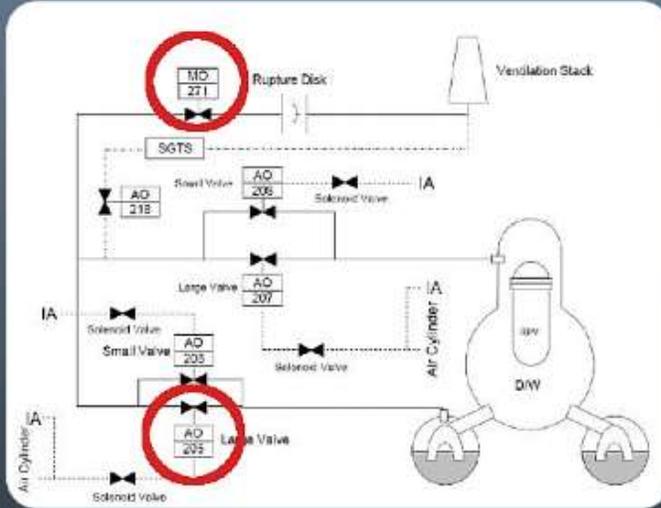
• Vent valves MO271 and AO205 •

• Both were implemented to try to vent unit 2 •

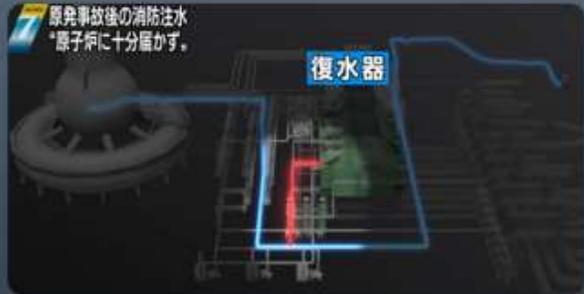
- March 14th sea water injection by fire truck is ordered
- 30 metric tons per/hr sea water was injected via the fire line into unit 2. Only 1 ton per/hr made it to the reactor
- One of these per minute
- Most of the injected water flowed backwards into the condenser in the turbine building

At 16:34 an SRV was opened to relieve pressure in the RPV and seawater injection was started. The problem now was that the fire line system used to inject water lacked back flow limiter valves. This meant that all or much of the water being desperately injected through the fire line may not have made it to the RPV but instead flowed backwards into the condenser in the turbine building. At this time the office at Daiichi informed the disaster office at TEPCO's HQ in Tokyo that they need to vent the reactor containment and not doing so could cause them to be unable to inject water. Since the ability to effectively suppress steam pressure was now lost with the saturation of the SC, venting became more crucial.

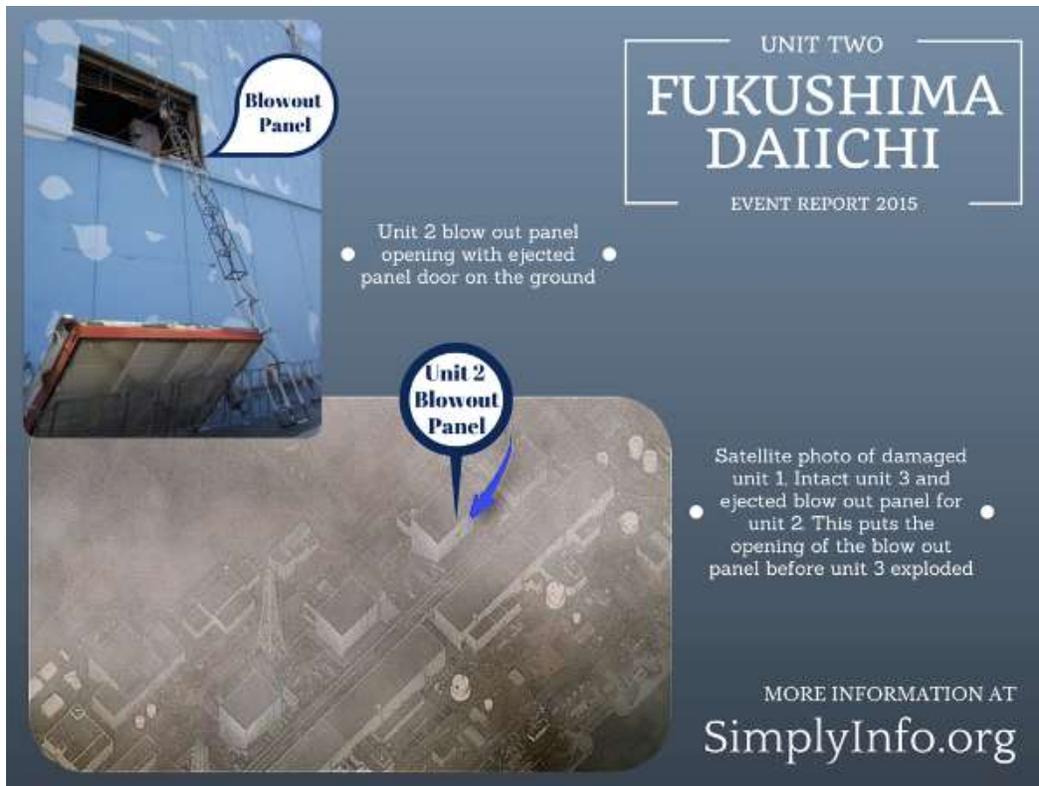
When unit 3 exploded it damaged both the fire engine water injection line and the AO-205 SC vent valve. The RPV water level had now dropped to 2950 mm above the top of the fuel. By middle of the day on the 14th plant manager Yoshida had contacted the TEPCO home office asking for ideas how to relieve hydrogen from unit 2 fearing it would explode as units 1 and 3 had. What they were unaware of at the time was that the unit 1 explosion seemed to have removed the blow out panel of unit 2. Satellite photos showed it was ejected before unit 3 had exploded. This may have created a safe route for hydrogen to escape the building, preventing an explosion of the building. Workers were still trying to establish a fire line to inject sea water into the reactor. Reports warned that the RCIC system would soon run out of available water, leaving the workers with no available way to inject water.

At 13:25 on March 14th the RCIC system finally failed. Reactor water level was 2400 mm above the top of the fuel and drywell pressure continued to rise. By 14:00 it was reported that the SC had reached the saturation point. It could no longer provide water for the RCIC cooling system and could no longer provide steam relief to the SRV system from the reactor. TEPCO reported the RCIC system as going out around this time but did not specifically tie it to the heat up of the suppression chamber as they used other means to determine the RCIC had stopped.

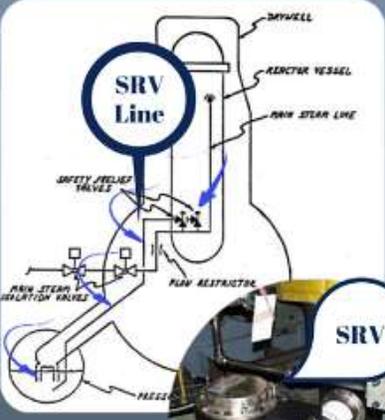
- The SRV ties into the main steam lines then routes steam to the suppression chamber
- An SRV in a US reactor for reference
- Sea water injected by fire truck mostly flowed backwards into the condenser in the turbine building

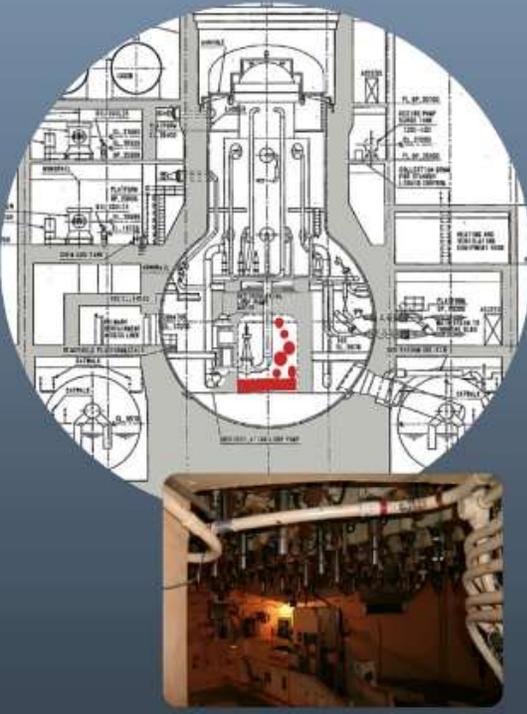
- Melted fuel will eventually burn through the bottom of the steel reactor vessel ●
- Melted fuel will collect in the pedestal below the reactor vessel ● then eventually burn down into the basemat or flow out into the containment floor ●
- Image of the pedestal interior from a pre-disaster photo of unit 5 ●

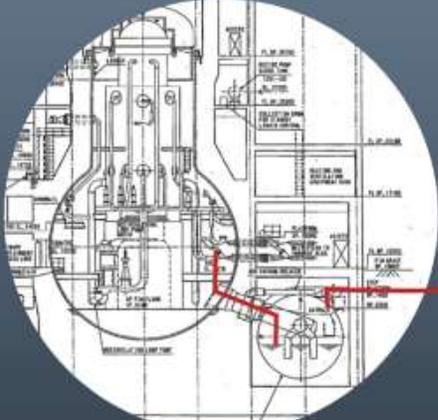
- SRVs vent to suppression chamber
- Suppression chamber vents to tower (when opened in an emergency)
- No water was in the suppression chamber during this venting
- Melted fuel is already assumed to be outside the reactor vessel

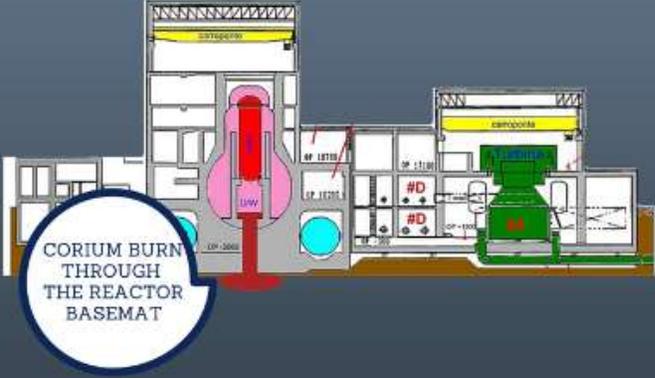
The time estimates for corium to burn through the reactor basemat varies greatly and are still in need of more research

If corium burns through the basemat there is nothing to stop it from leeching contamination into the groundwater that flows beneath the plant

WECHSEL computer model estimates for a BWR reactor. The WECHSEL code estimates 2.5 to 2.7 days from the start of concrete ablation until the corium mass would burn through the entire basemat of concrete.

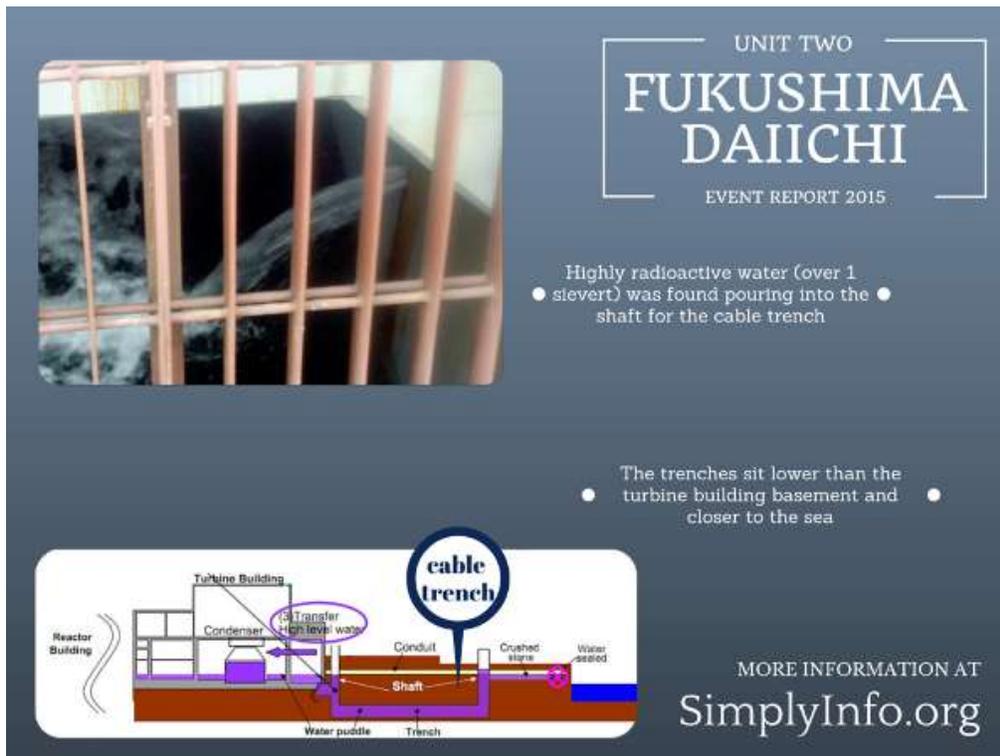
Highly radioactive water (over 1 sievert) was found pouring into the shaft for the cable trench

The trenches sit lower than the turbine building basement and closer to the sea

Reactor Building, Turbine Building, Condenser, High level water, Conduit, Shaft, Crushed stone, Water added, Water puddle, Trench, cable trench

On March 26th, 1 sievert/hour radioactive water was discovered in the unit 2 turbine building basement. Later the same day some power was restored to the turbine building and control room for unit 2. On March 27th 1 sievert/hour radioactive water was found in the unit 2 cable trench. Water was leaking in through a crack in the concrete wall of the trench.

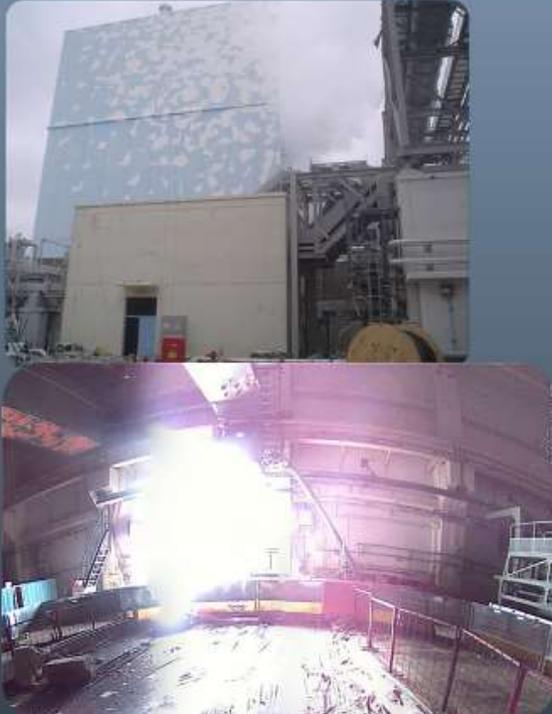
- Steam found pouring out the open blow out panel of unit 2. March 2011 photo date ●
- This 2012 photo taken by a robot shows steam under pressure still coming out of the edge of the reactor well near the blow out panel ●

At 8:25 am workers discovered large amounts of white smoke leaving the unit 2 blow out panel on the refueling floor. This could have been going on for longer, this point was the first sighting of the problem. Workers were limited to the time and locations they could be outside and were seriously limited in ability to see at night without any functional lighting systems at the plant. By 10:15 radiation levels had reached 8837 uSv/h then gradually dropped over the remaining morning.

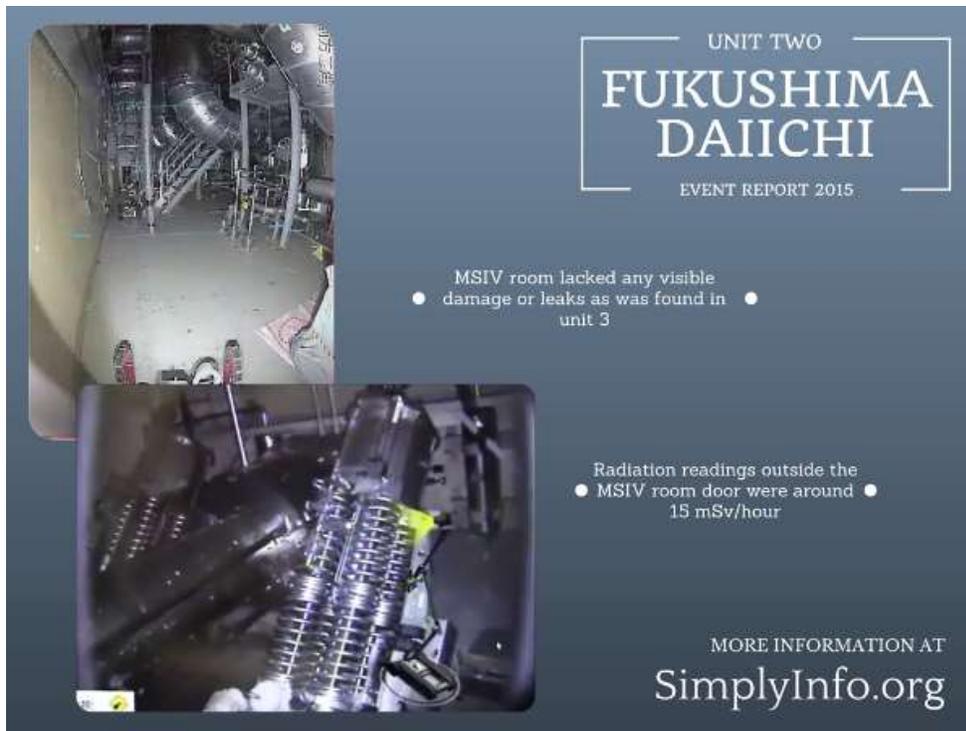
MSIV room lacked any visible
● damage or leaks as was found in ●
unit 3

Where radioactive contamination is found in relation to unit 2 can also give some hints about the failures in this reactor. Highly radioactive water was found in the unit 2 turbine building basement soon after the disaster unfolded. The assumed leak path for such a thing would be the suppression chamber room as it has some interfaces into the turbine building. But the suppression chamber room lacks this kind of highly contaminated water or high radiation levels that would indicate its involvement. So this expected path to the turbine building is obviously not in play. The main steam isolation valves are another concern. This room was inspected by robots and was found to be almost pristine and without damage, high radiation levels or contaminated water leakage.
