# **Activities for Effective Aging Management and Safe Long-Term Operation Implemented at Fukushima Dai-ichi Nuclear Power Plant**

**Takeyuki Inagaki**  
**Tokyo Electric Power Company**  
**[inagaki.takeyuki@tepcoco.jp](mailto:inagaki.takeyuki@tepcoco.jp)**

# Fukushima Dai-ichi Nuclear Power Plant (1F NPP)

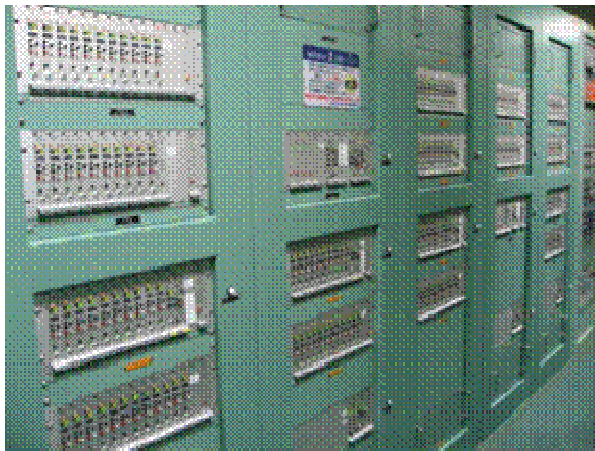
New Neutron Monitor  
Control Board

- All I&C equipment/components important to safety and plant reliability (process computer, neutron monitoring, etc) are replaced every 15-20 years.
- Electricity power source switch gears are being replaced after 30 years of operation.

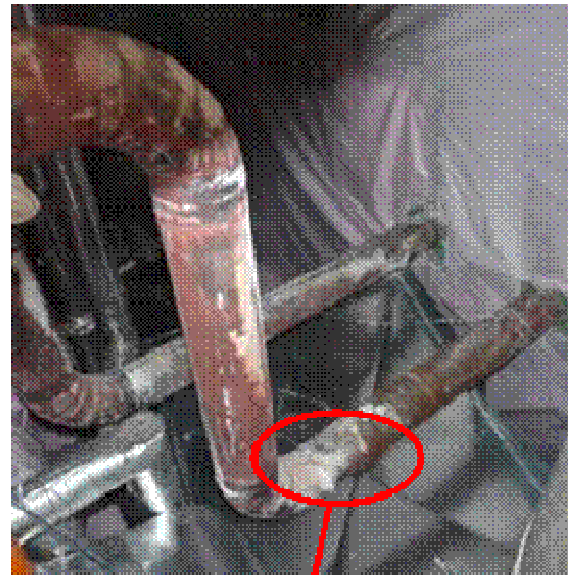
# Lessons Learned from Recent Replacement (2)

Rapid loss of material due to **liquid drop impingement**. (Material: Low Alloy Steel (Cr-Mo))

Increase of drain after the turbine replacement.

Change of operation.

Insufficient review of design changes.
