ALLOY 690 STEAM GENERATOR TUBES

Originally published in: 6th CNS International Steam generator conference, November 2009

3.1 CRACK PRODUCTION IN INCONEL 690 STEAM GENERATOR TUBES

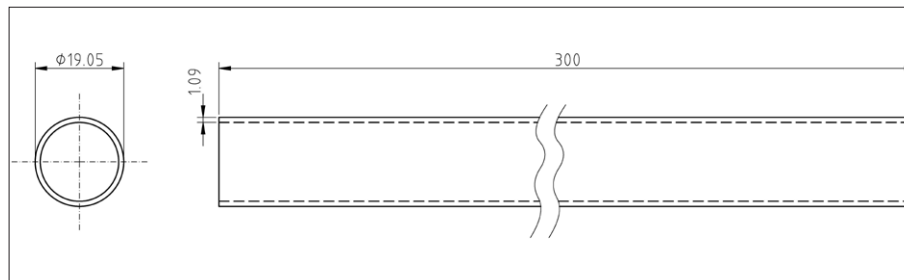
Figure 1 Tube sample drawing. The material is Inconel 690.

The qualification done for OL-3 was the first to be completed on Inconel 690 tubes with real cracks. Consequently, no cracked specimens were available nor had such specimens ever had been manufactured. Areva NP approached Trueflaw to manufacture the cracked samples. Figure 1. shows drawing of the tube sample used in qualification.

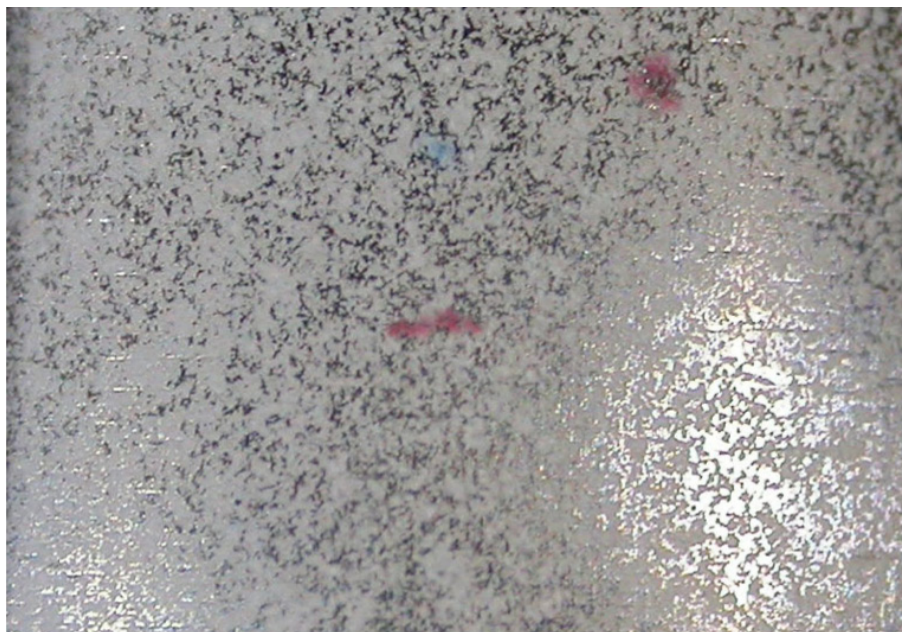
Figure 2 Small crack initiation in Alloy 690 steam generator tube; a dye penetrant indication.

Hence, the first target was to obtain successful small crack initiation to this new material with the thin wall section. After several trials, successful circumferential cracking was obtained (Figure 2). However, rather unexpected difficulties were met when developing technique for axial cracking. As it turned out, the material was highly anisotropic with respect to cracking. Presumably this is caused by the microstructural texture resulting from tube manufacturing. It was noticed, that the samples strongly

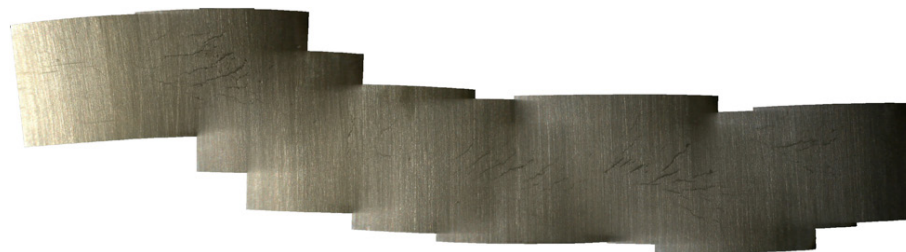
Figure 3 Circumferential cracking in steam generator tube samples.

The specified cracking included long and shallow cracks, i.e. the cracking extended up to several millimeters around the circumference but only a fraction of a millimeter in depth direction. Consequently, the production was met with a problem of through wall cracking. That is, successful crack initiation was obtained, but as soon as the surface length of the crack was extended, cracks rapidly grew through-wall. To overcome this problem, it was decided to produce the desired dimensions with non-contiguous cracking. Figure 3 shows such a non-contiguous crack pattern produced.

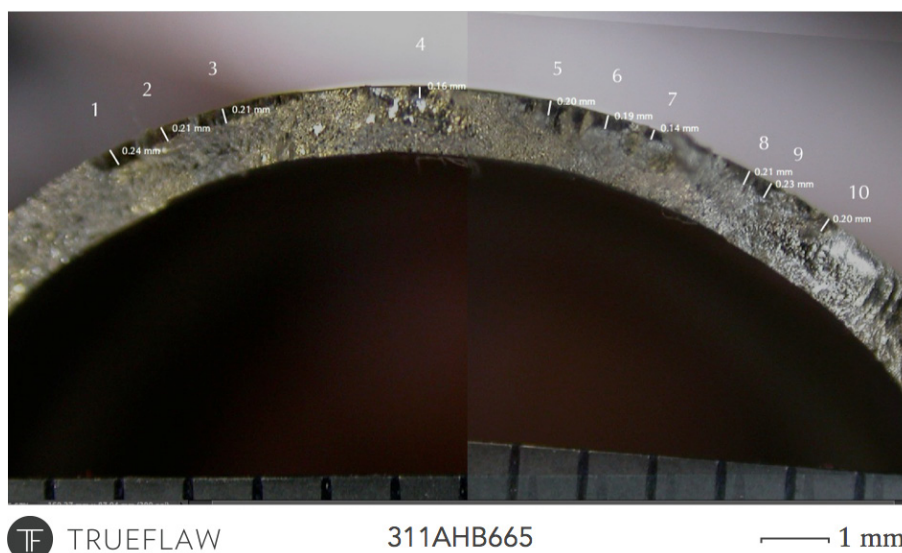
Figure 4 shows an image of destructive examination of a validation sample.

The validation samples were then sent to Intercontrole for inspection (see paragraph 3.1.2). The purpose of these inspections was to confirm that the produced samples are suitable for the intended use and to give the inspectors early experience on the cracked samples. Finally, the validation samples were destructively examined by Trueflaw in order to confirm the depth of the cracks.

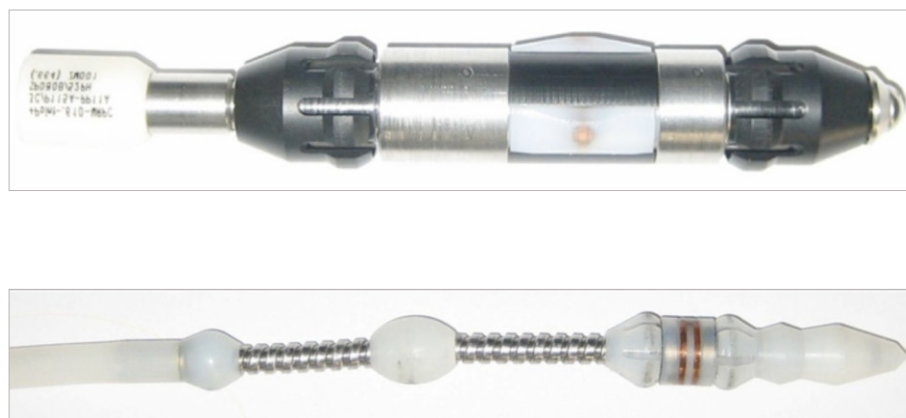
Figure 5 The probes used in the inspection were ET Bobbin probe, Zetec 610UL (upper image) and ET rotating probe, Zetec 3 coil 610PP with 1 +point coil PP11A, 1 pancake coil 115MR Ø 3 mm (medium range) and 1 pancake coil 080 HF Ø 2 mm (High frequency) (lower image).

Three samples were inspected with eddy current inspection by Intercontrole. The samples are detailed in Table 1. Inspection was carried out with two different probes: bobbin probe and rotating probe (Figure 5).

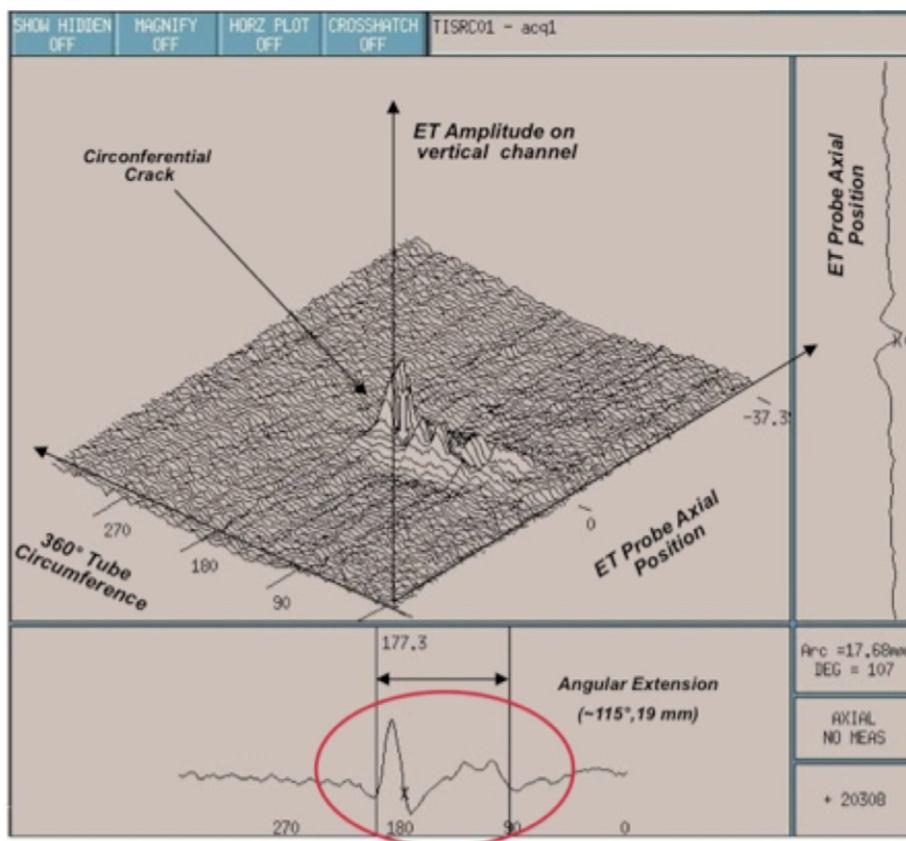
Figure 8 ET probe results for sample 1 for the rotating probe.

The EC response of cracks in each sample with two different probes can be seen in Figures 6-14. Three different pictures are shown for each sample: first the result of bobbin probe then results of rotating probe signals and finally topographic picture of the rotating probe response. The crack signal is marked to each image. The ET bobbin probe clearly detects single indication for all the inspected samples. For samples 1 and 2 the indication is correctly interpreted as OD defect and for sample 3 the indication is correctly interpreted as through-wall defect.

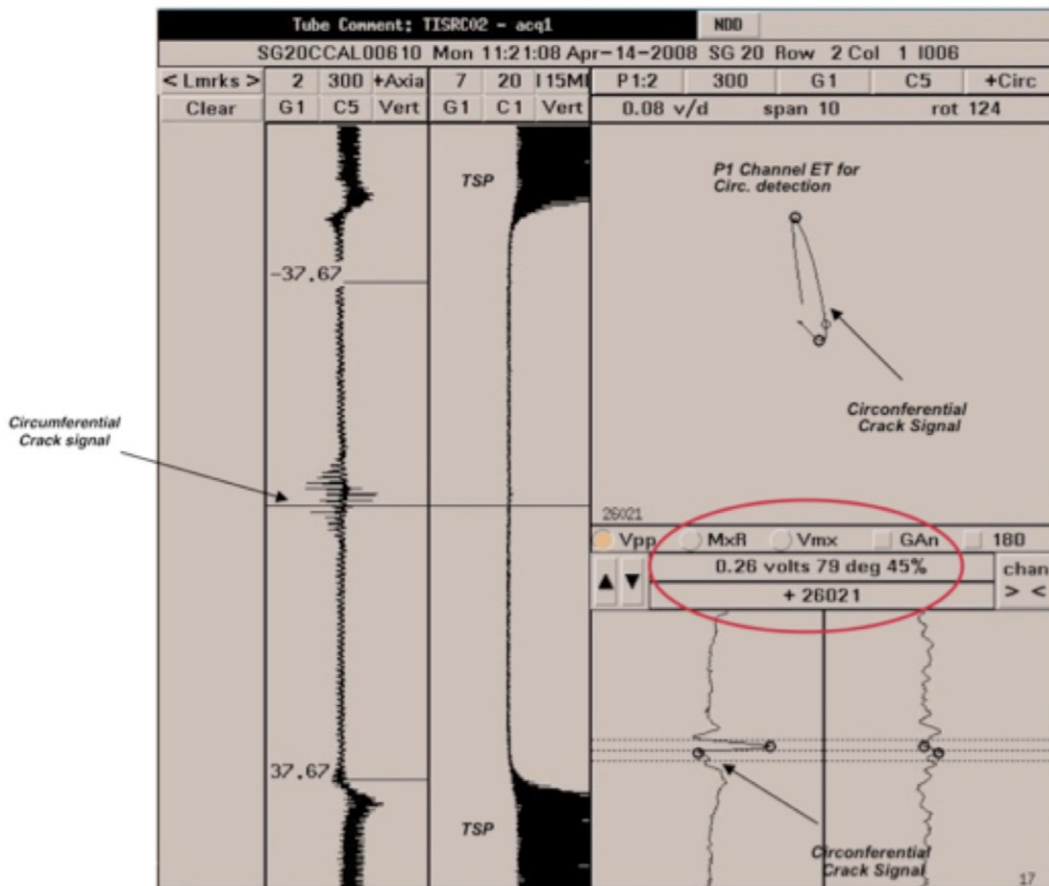
Figure 10 ET probe results for sample 2 for the rotating probe.

The results for the rotating probe are summarized in Table 2. The sizing results from the rotating probe agree very well with the true crack sizes. For the sample 1, where direct destructive results are available, the depth sizing is within 5%-units of the true depth, which corresponds to about 0.05 mm. For the sample 2, which was produced similarly to sample 1, the inspection results are within expected crack depth variance ± 0.3 mm. Furthermore, the EC inspection indicated that the thermal loading had caused slight local denting of the tube. However, this did not disturb the inspection.

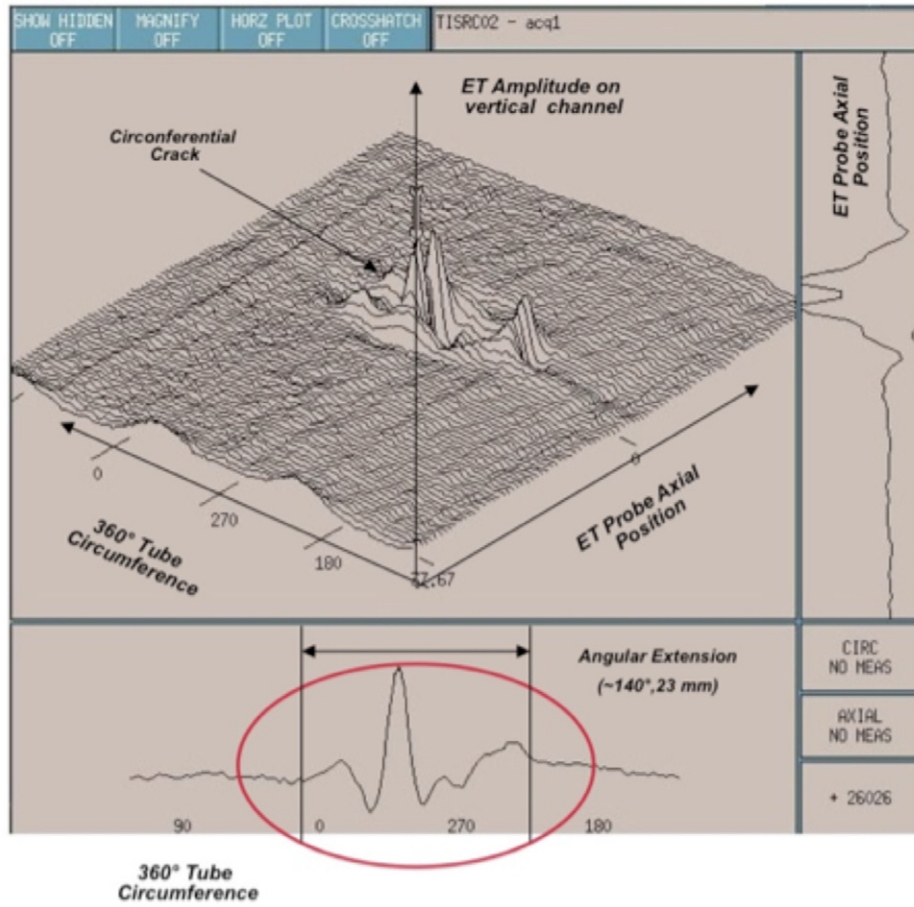
Figure 11 ET probe results for sample 2 for the rotating probe.

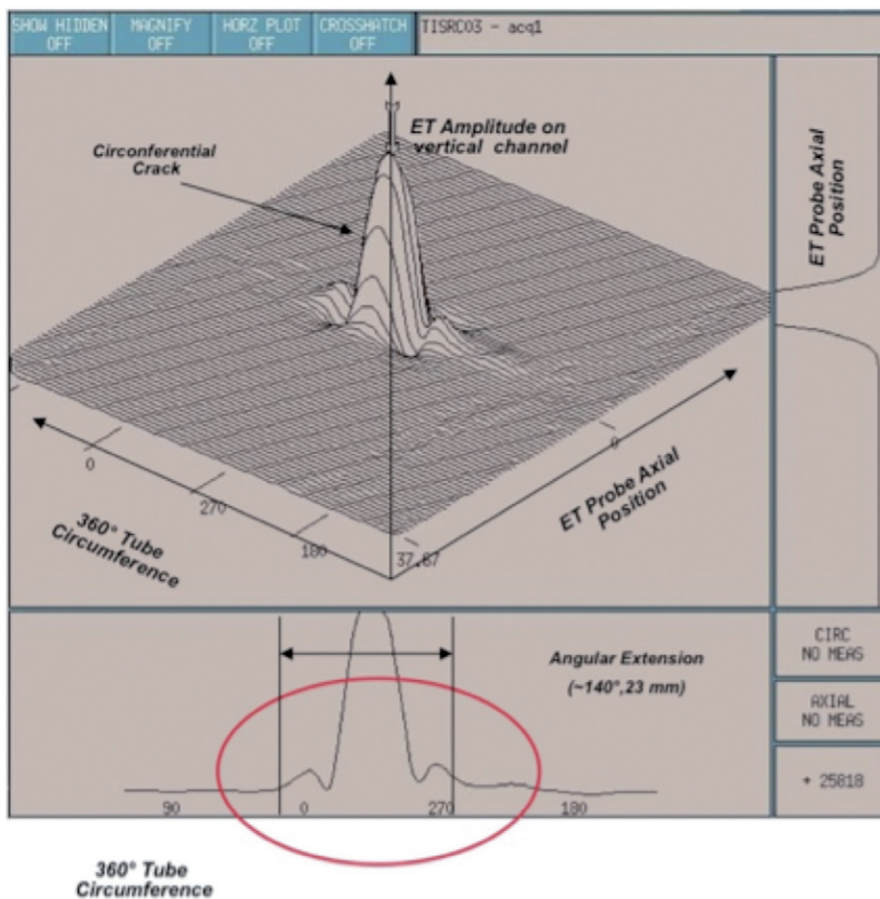
Figure 14 ET probe results for sample 3 for the rotating probe.
