## The 2011 off the Pacific coast of Tohoku Pacific Earthquake and the seismic damage to the NPPs

**Kazuo SAKAI** (National Institute of Radiological Sciences)  
And

**CRPPH-69 (17<sup>th</sup> – 19<sup>th</sup> May, 2011)**

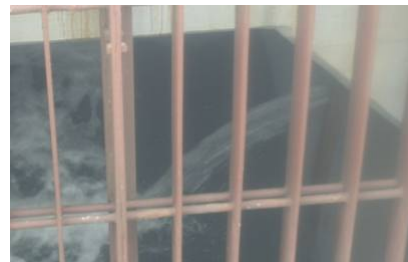
#### 4B-3. Leakage of highly radioactive water from Unit2

On April 2<sup>nd</sup>, **the outflow from the crack** with a length of around 20 cm in the concrete portion of the lateral surface of the pit into the sea was confirmed.

TEPCO's estimation;

Amount of spilled water: 520 tons

Quantity of radioactivity : 4700 TBq

#### Countermeasures

- Drilled a hole into the pit and **injected water glass (sodium silicate) into the pit.**
- On April 6, **the outflow was confirmed to stop.**
