## **TEPCO Releases Photos of Reactor Building Interiors, Confirming High Radiation Levels**

In order to further determine conditions at its Fukushima Daiichi NPS, the Tokyo Electric Power Co., Inc. (TEPCO) recently deployed radio-controlled robots for the first time to inspect the reactor buildings of the plant's Units 1, 2 and 3, each of which contains high levels of radiation.

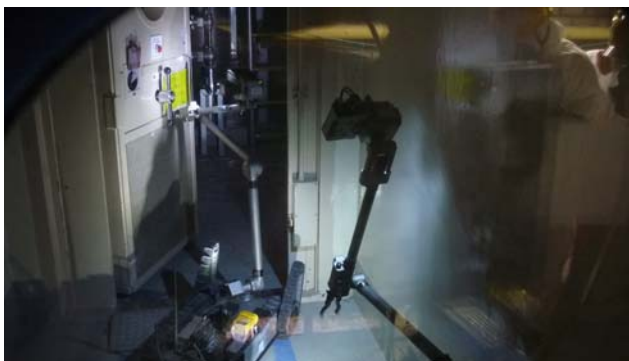
Radio-controlled robot opening the second door of the Unit 3 reactor building at the Fukushima Daiichi NPS (April 17, photo provided by TEPCO)

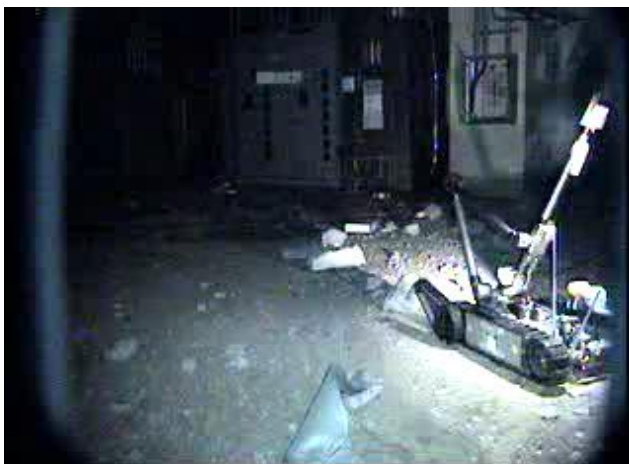
Robot advancing on the first floor of the Unit 1 reactor building (April 17, photo provided by TEPCO)
