Fukushima Spent Fuel Pond Explosions

by W.Christoph Müller

Revised version No 2, 15.Aug.2011

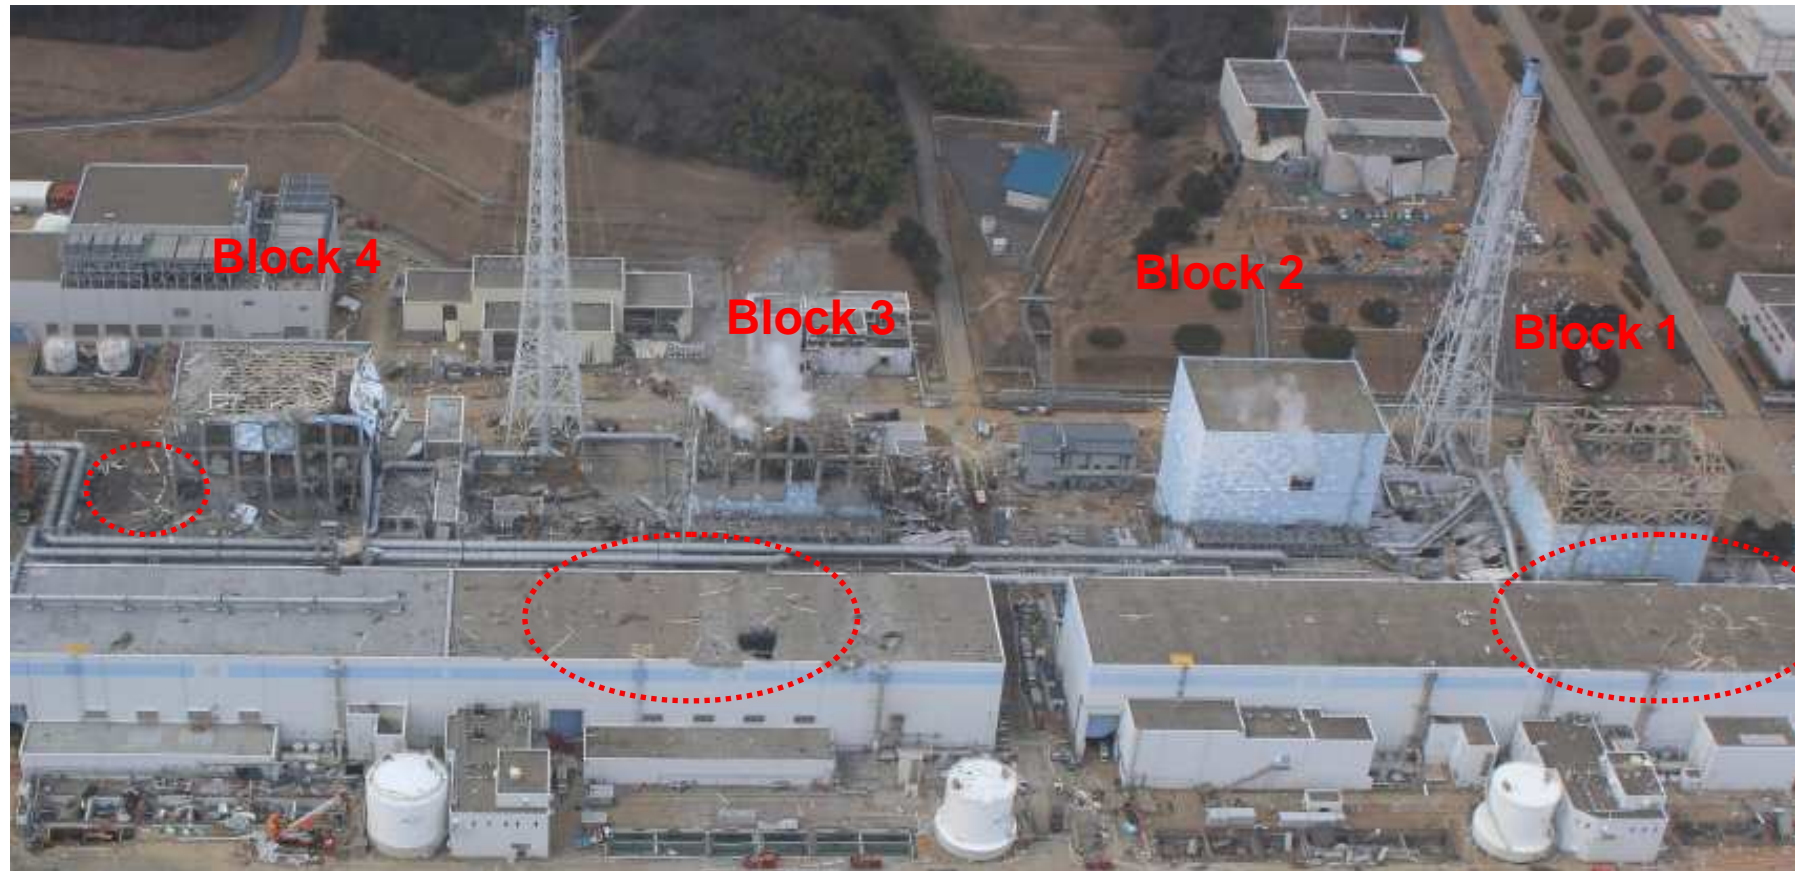
The visual destruction is limited to the upper part of the reactor building which consists of a light weight beam and plate reinforced concrete construction.

From the picture it can be concluded that block 1 and 3 have experienced a detonation which caused a substantial destruction of the upper structure. Parts of the building structure were scattered over a large area and debris can be found on the roof tops of the adjacent buildings (dotted circles).

Block 4 experienced a minor explosion with most of the structure deformed but still in place. Debris just fell down at the sides of the building (small dotted circle).

Block 2 shows only minor damage: Just one plate of the upper structure has been relocated. Looks like it opened like a rupture disk.

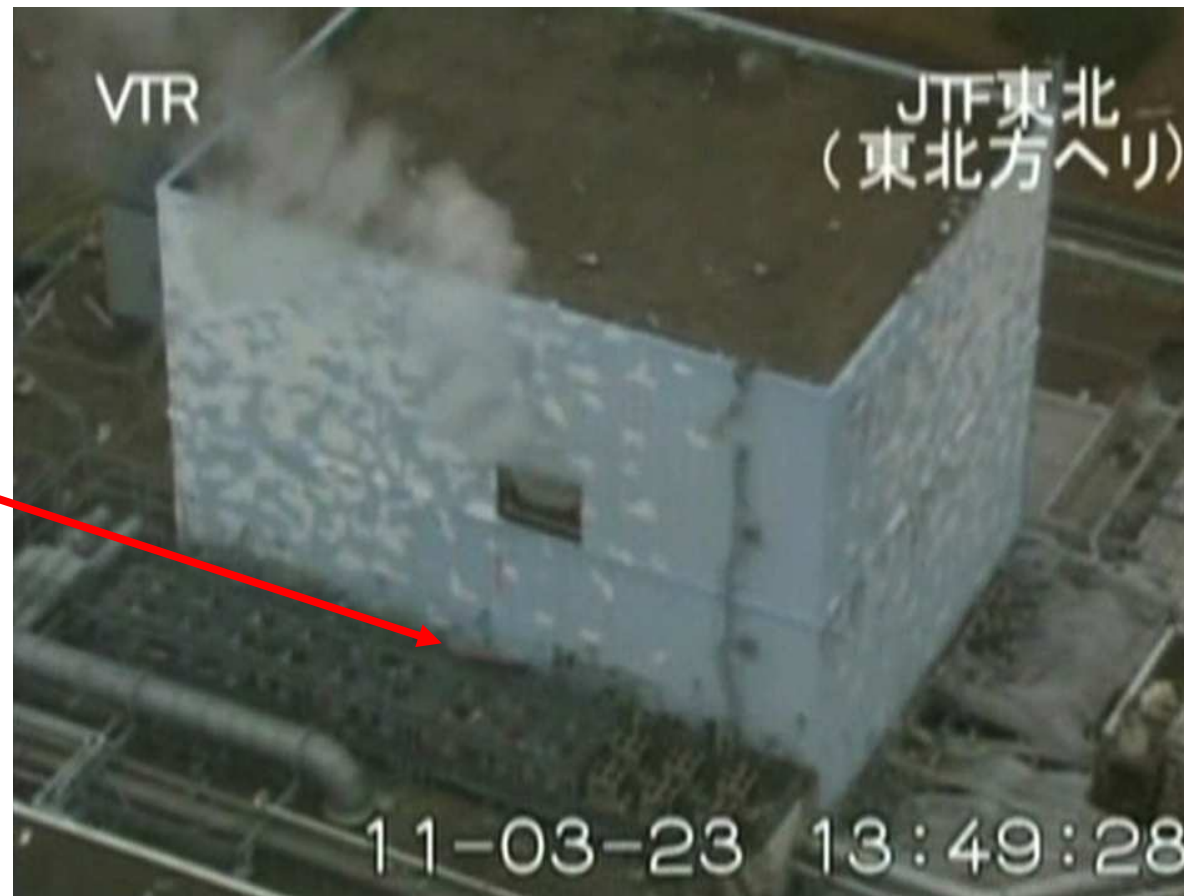
Block 2 shows only little damage.

Only one plate was blown out and is lying below the hole (red arrow). The formation of the hole in block 2 was not observed and no explosion noise was heard that was directly connected to the hole.

Basically it looks like it has been designed to fail in case of overpressure in the reactor building in order to avoid the complete failure of the building. It looks it was designed as a “rupture disk”.

This kind of destruction can only occur when the pressure build up is slow. So hydrogen deflagration is the best guess.

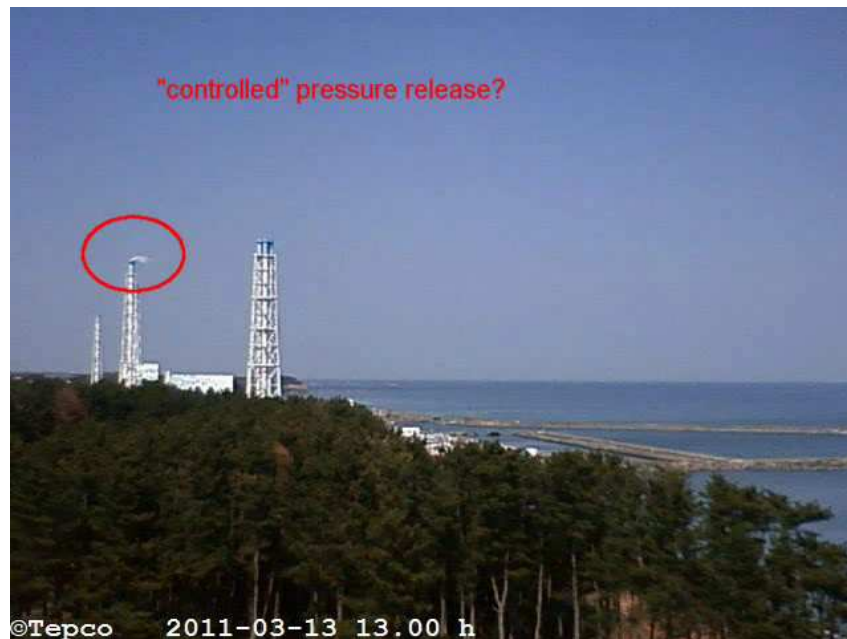
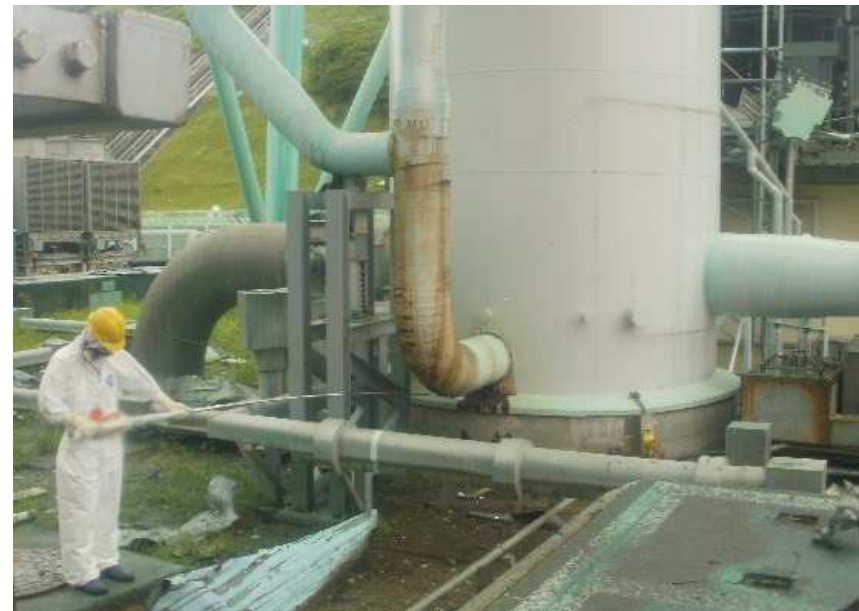
1. Webcam footages show a white discharge cloud during the venting of unit 1 and 2. Unit 3 was vented during the night, so there is no webcam footage.
2. High radiation levels were measured in the filter room of unit 1 and in the lower elbow of the SGTD pipe at the foot of the stack, which proves that venting through the stack took place.

As the flow path through the stack was open and worked well, it is hard to imagine that also a backward flow of the hydrogen into the SGTS occurred leading to the arrival of hundreds of kilograms of hydrogen at the fifth floor.
