Results of the Second Soundness Inspection of Unit 4 Reactor Building at Fukushima Daiichi Nuclear Power Station

August 30, 2012

Tokyo Electric Power Company

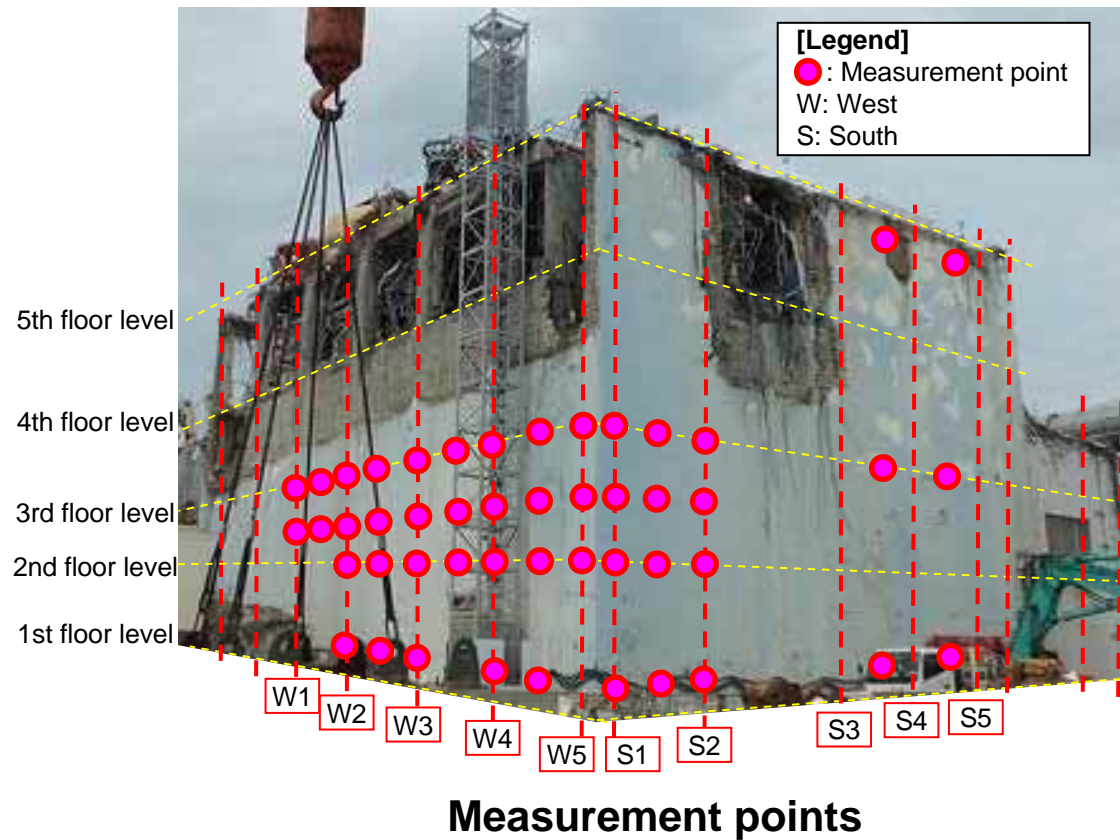
The horizontal differences*1 of the exterior walls were measured by an optical equipment (with fixed points set on the upper and lower sides of the walls) and the deformation characteristics of the exterior walls were evaluated.

Though partial bulge was found on the exterior walls, it has been confirmed that the building itself is not tilted based on the results of the first inspection (May 2012) and the detailed inspection of exterior walls (June 2012).

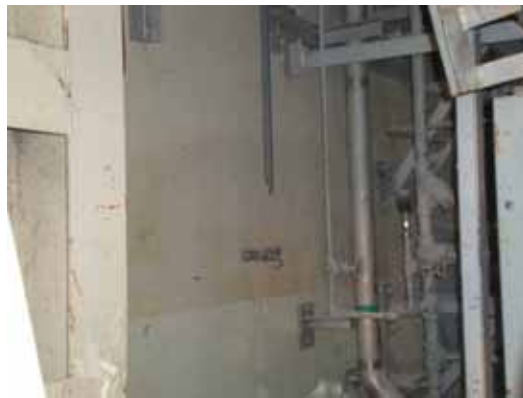
① West wall

As a result of visual inspection, no cracks with the width of 1mm or more or with possible rebar corrosion were found (similarly to the results obtained at the first inspection (May 2012) and the detailed inspection of the exterior walls (June 2012)).
