# DATA REPORT

## QUICK LOOK INSPECTION RESULTS

Prepared by:  
TMI-2 Technical Planning Department  
GPU Nuclear, Inc. - Bechtel National, Inc.

TPO/TMI-026

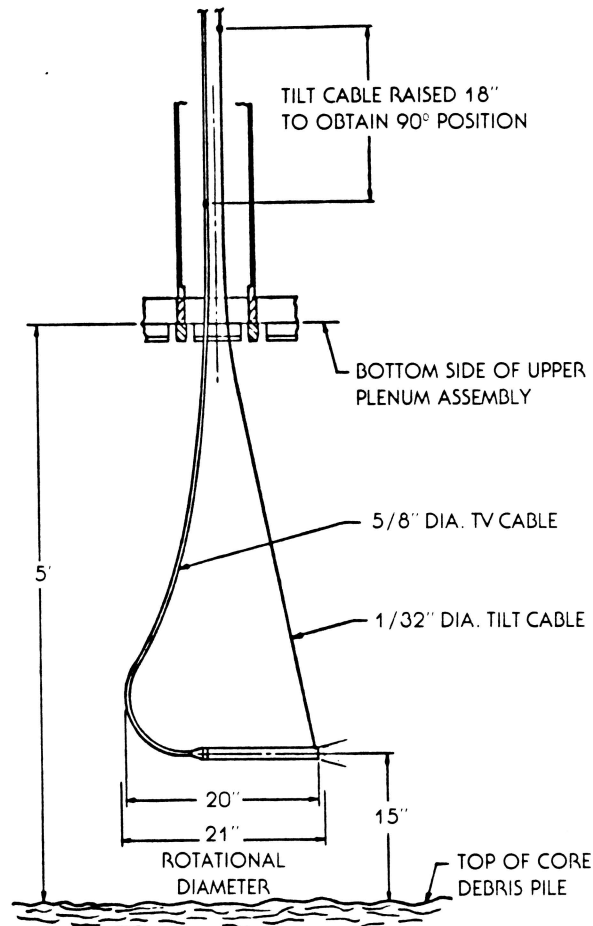
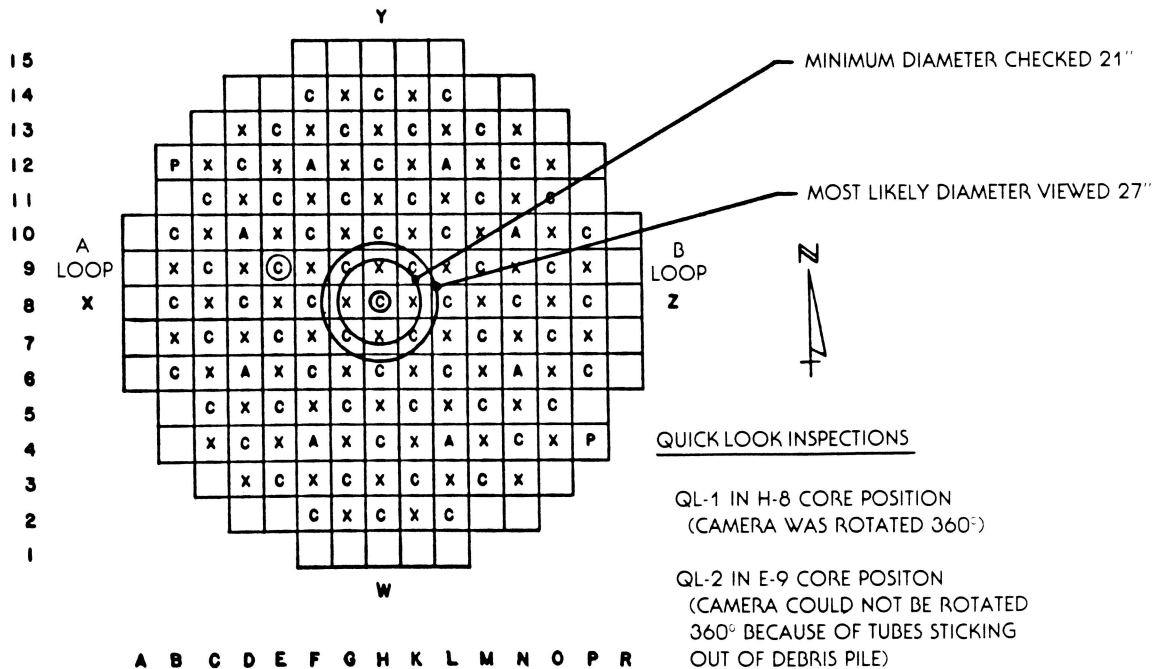
FIGURE 9  
LOOKING UP AT UNDERSIDE OF UPPER PLENUM ASSEMBLY  
AT H-8 CORE POSITION DURING QUICK LOOK 1

There is a void in the upper central portion of the core. At the very center, at H-8, the void extends downward from the bottom of the plenum to a debris bed whose top surface is 5 feet 3 inches below the plenum lower surface. This void includes at least the central 9 fuel element locations, and possibly as many as 21, as shown in Figure 8. This was concluded based on the ability to rotate the camera 360 degrees while it was pointed horizontally, without encountering any obstruction.

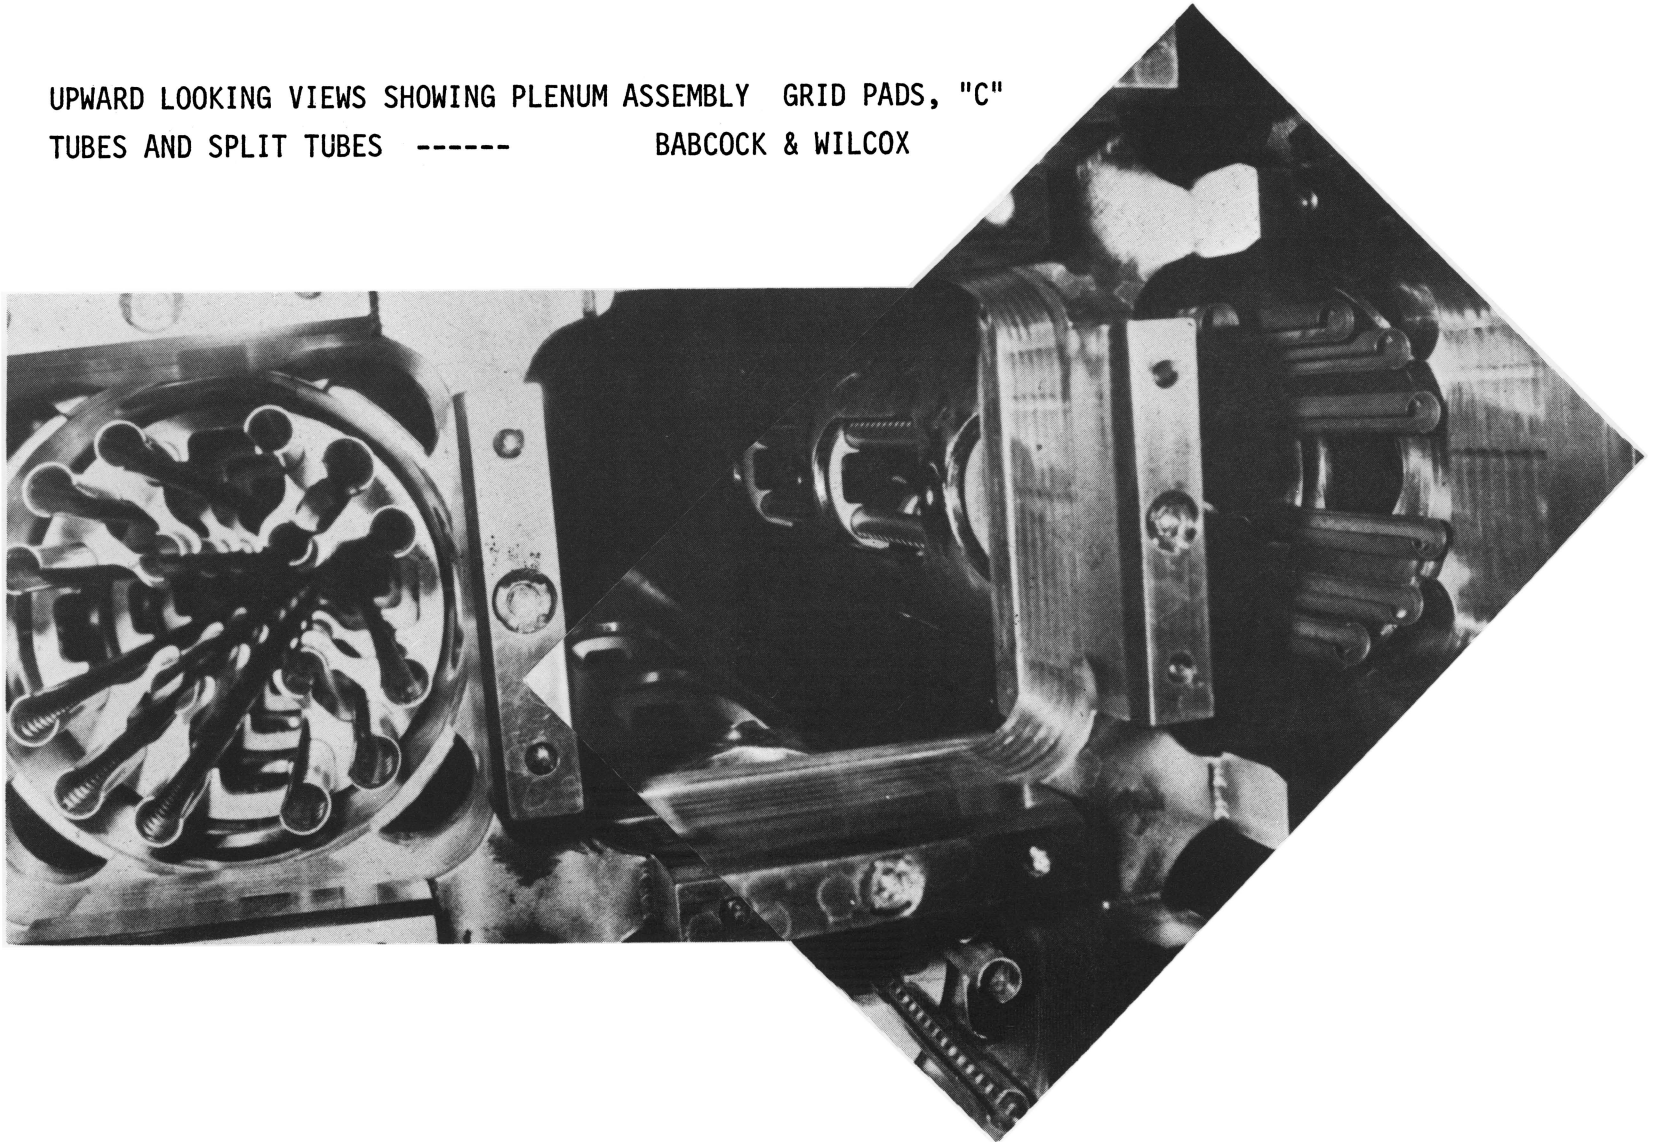
FIGURE 11  
 LOOKING VERTICALLY UPWARD AT UNDERSIDE  
 OF THE UPPER PLENUM ASSEMBLY GRID PLATE  
 (LIKE LOOKING INTO THE H-8 POSITION  
 OF QUICK LOOK 1 OF JULY 21, 1982)

At the H-8 location, the underside of the plenum assembly appeared to be in the normal configuration, which resembles the view shown in Figures 10 and 11. However, the field of view was not as large as that in the photograph. Two of the grid pads were seen and appeared to be in normal condition, except for linear surface patterns. These patterns could have been either cracks in a surface coating of fine debris, or fracture marks associated with spalling of the pad surface. It was not possible to determine which by looking at the video image. Gas bubbles appeared to collect on the underside of the grid pads.

The entire fuel element upper end was gone from the H-8 location. No upper end fittings were suspended at H-8 or at the adjacent locations visible (see Figure 11). Because of uncertainty as to the way the camera was pointed, it was not possible to determine which locations adjacent to H-8 were observed.

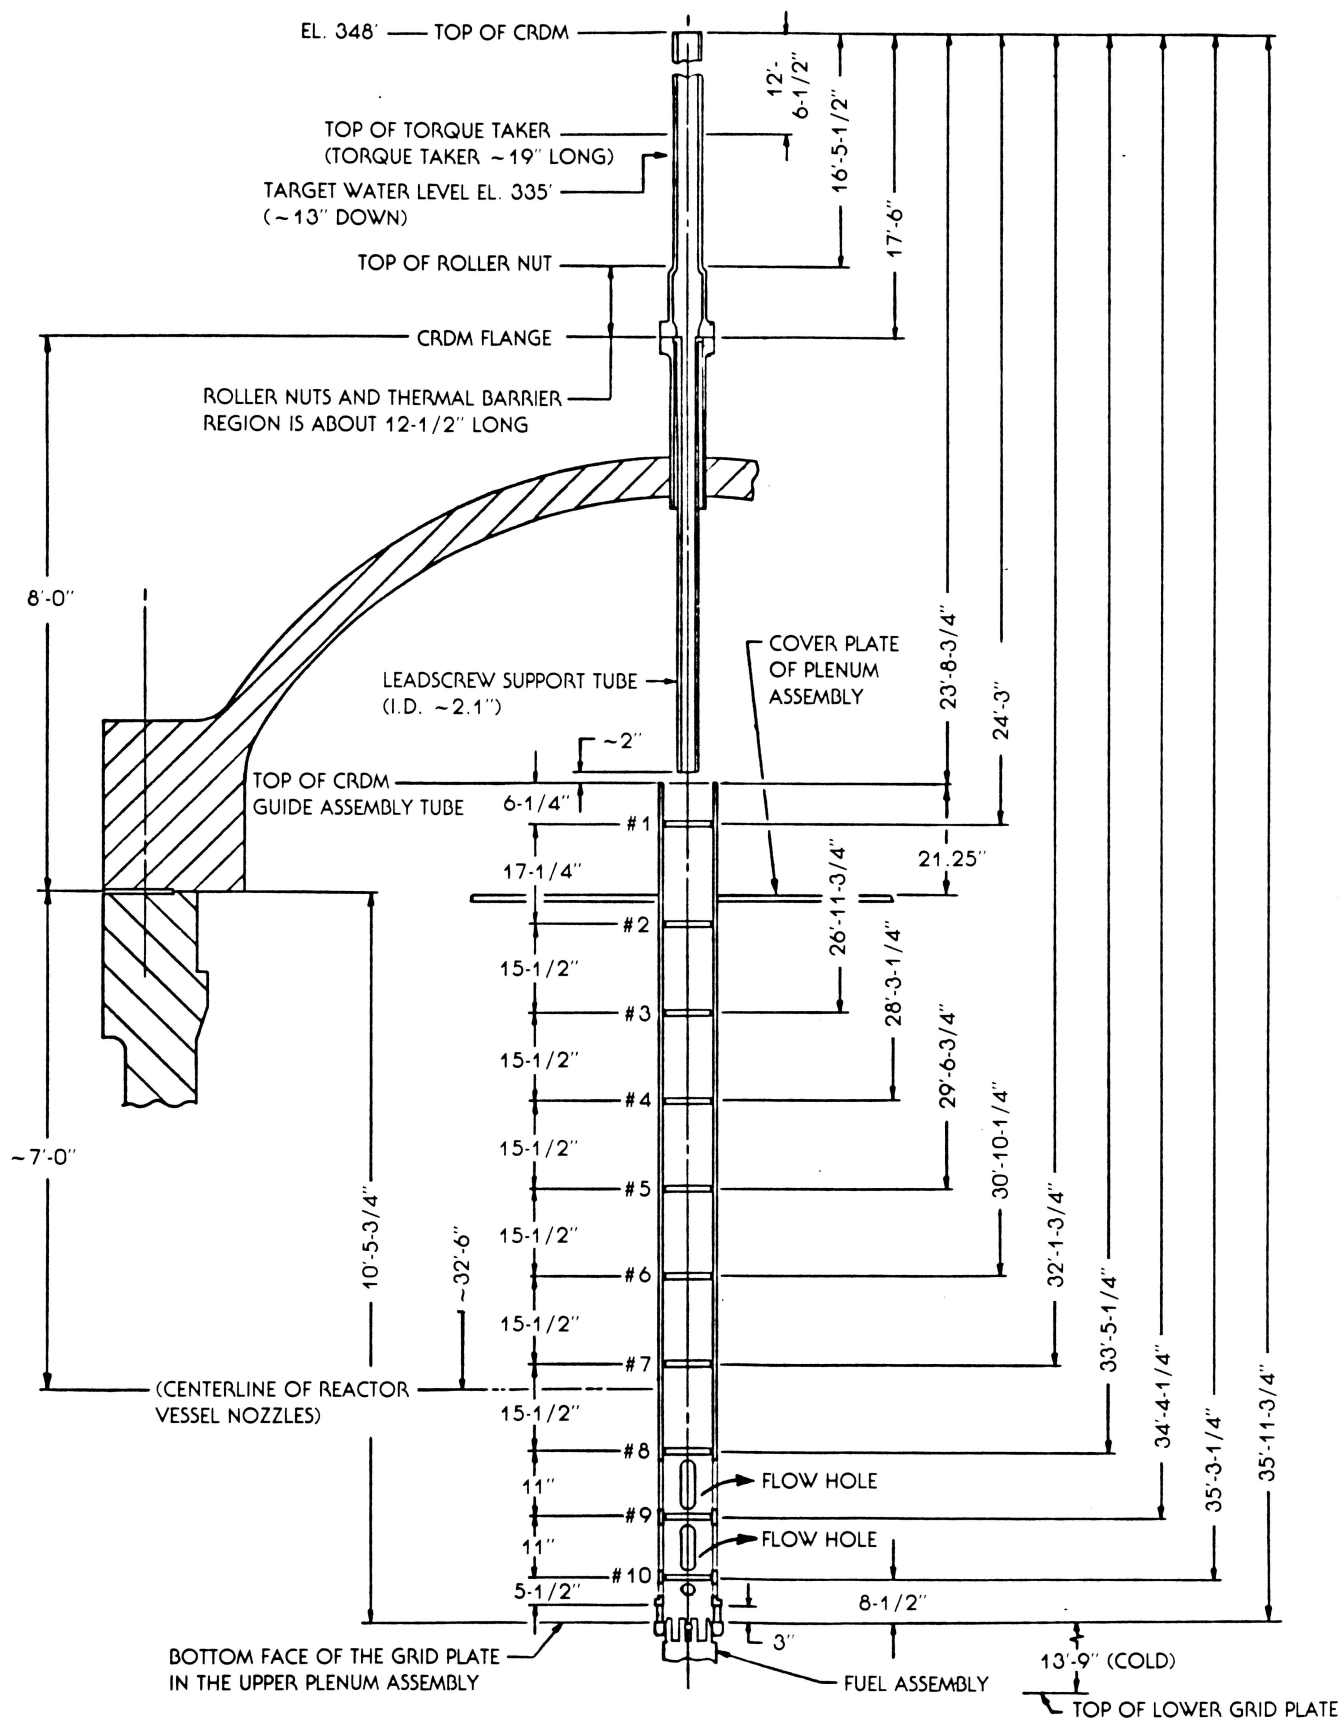
FIGURE 16  
RIGHT ANGLE VIEWING CAMERA  
INSIDE CONTROL ROD GUIDE ASSEMBLY

At nearly every brazement support plate observed, the 3/8-inch diameter setscrews that fasten the support plate to the column weldment were found (see Figures 16 and 17). All screws appeared to be in good condition, with intact threads clearly visible. The screws had varying amounts of fine surface deposits, and several had small, flaky debris resting on their top surfaces.

Top and bottom sides of horizontal surfaces on the 1st, 2nd, 3rd, 4th, 5th, 6th, and 10th support plates (see Figure 15) of the E-9 guide tube were inspected with the right-angle lens (see Figures 16 and 17). The top surface of the first and second support plates appeared to have a light corrosion film typical of that found in normal plants. Starting with the third support plate, the top surface had some debris with thickness (e.g., probably less than 1/64 inch). The thickness and amount of the debris on the horizontal surfaces increased the closer the support plate was to the top of the core. Down through the six support plate, the thickest layer of debris flakes appeared to be no more than about 1/16 inch in depth. On the top side of the 10th support plate, the amount and size of debris were more extensive. For example, a piece of what appeared to be a pellet was observed lying on top of the 10th support plate.

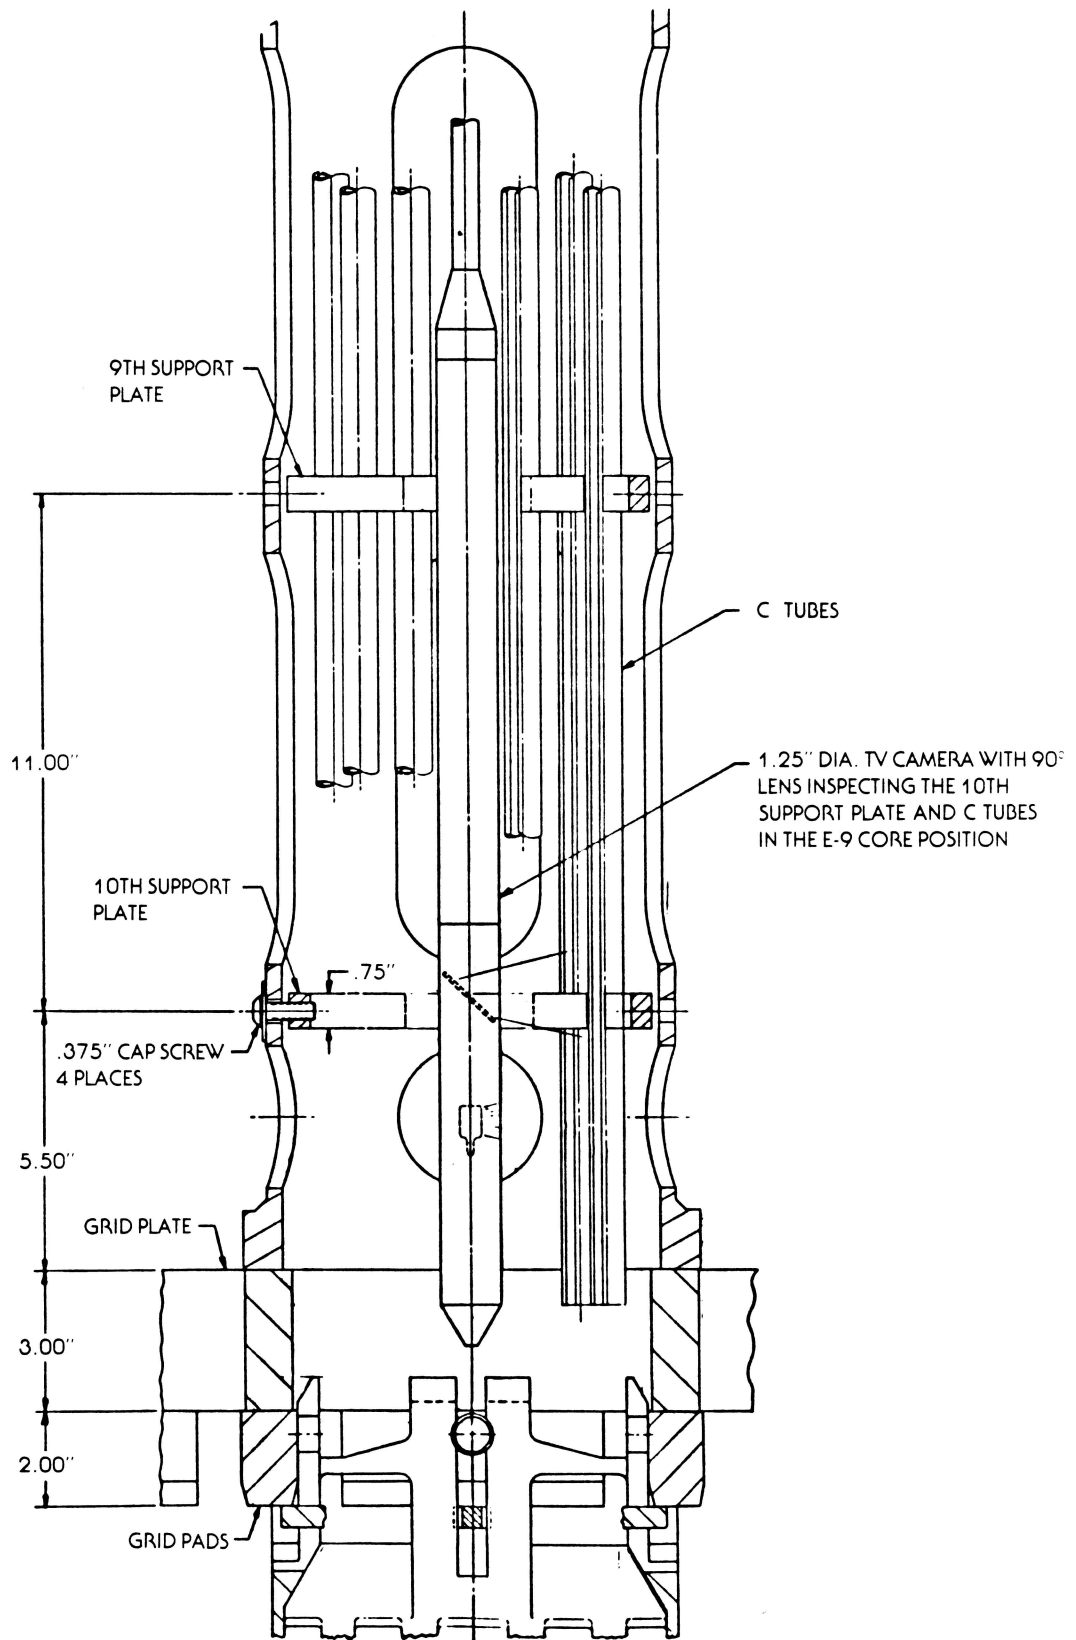
FIGURE 17  
INSPECTION OF C TUBES AND SUPPORT PLATES  
USING 1.25-INCH DIAMETER CAMERA WITH 90-DEGREE LENS

The underside of horizontal surfaces of the 1st through the 6th support plates and the 10th support plate of E-9 guide were inspected by the 90-degree lens and were clean and free of material buildup. The undersides of the two grid pads inspected in the H-8 position were clean and free of material buildup (Figure 11). On the underside of almost all horizontal surfaces there were gas bubbles, which is normal for reactor internals.

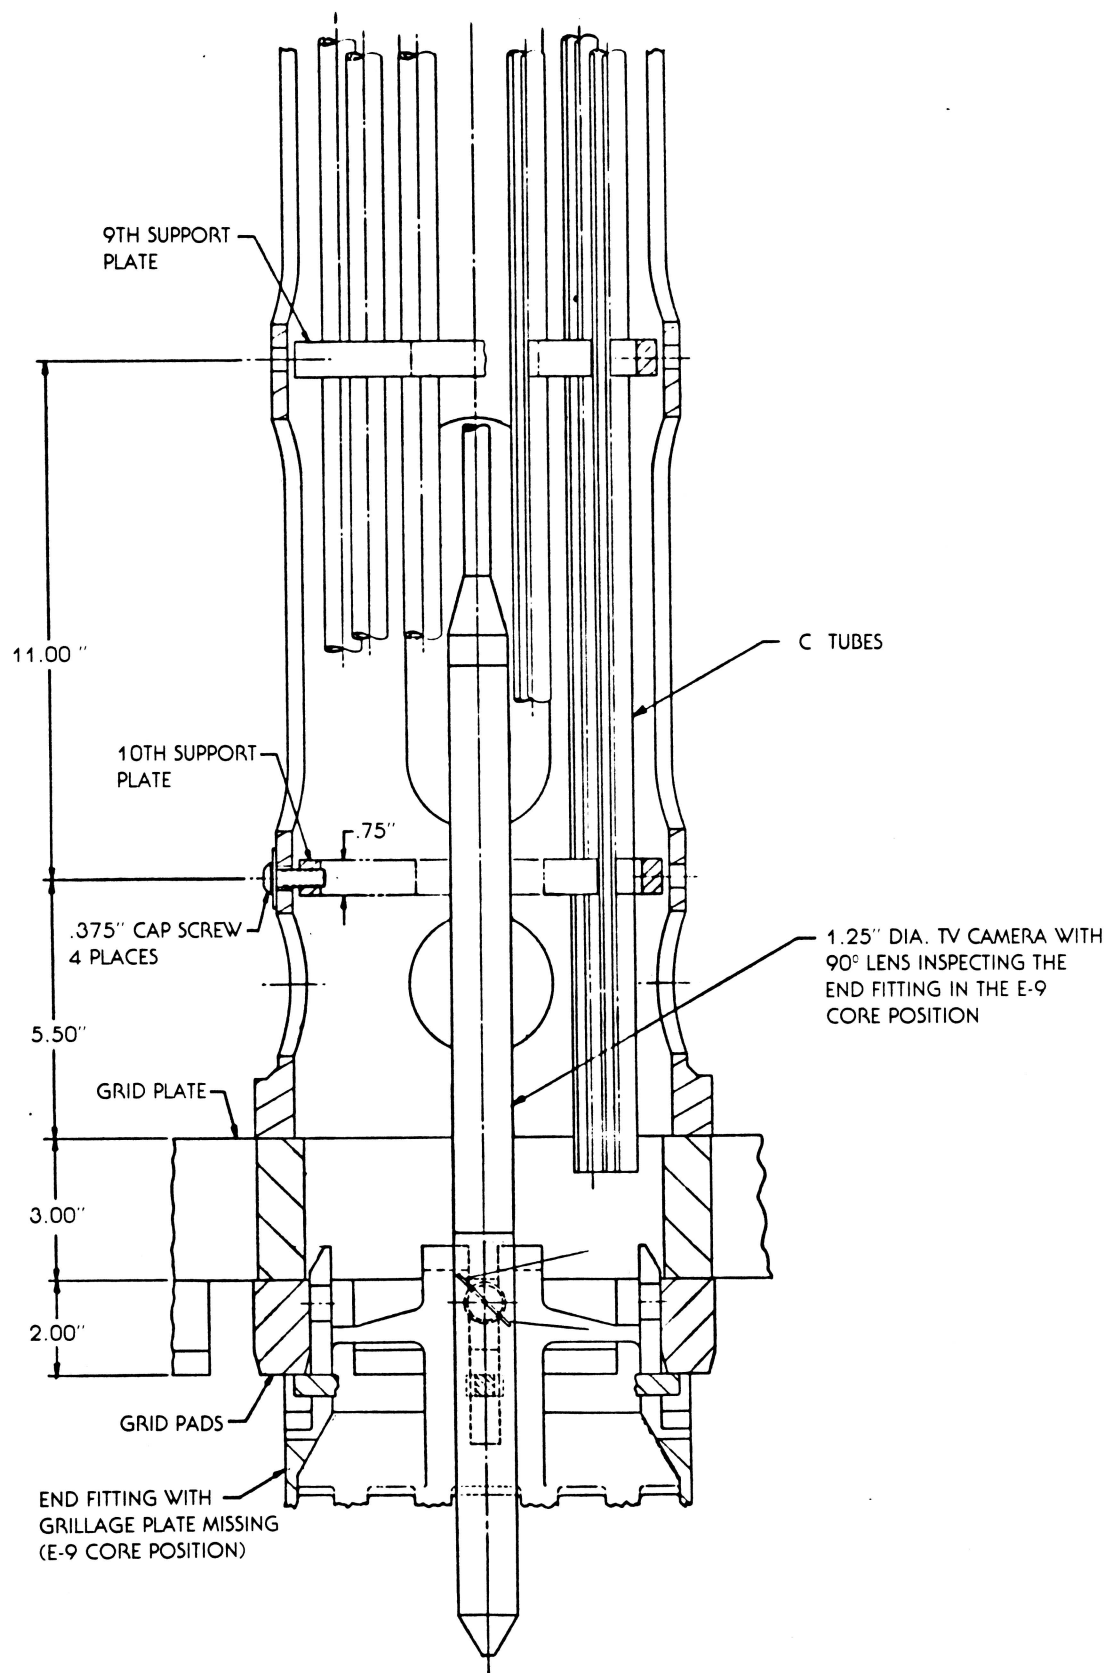
FIGURE 19  
EXPANDED VIEW OF THE E-9 END FITTING  
(GRILLAGE PLATE MISSING)  
(AS SEEN BY THE 90-DEGREE TV LENS ON AUGUST 12, 1982)

The E-9 end fitting had debris of a larger characteristic size that was packed into the tight space between the upper end fitting centering tabs and the plenum grid plate (see Figure 19). This debris looked like metal chips or fragments, rather than tiny flakes. One piece of debris appeared to be a fragment of a pellet.
