Report of Japanese Government  
to the IAEA Ministerial Conference on Nuclear Safety  
- The Accident at TEPCO's Fukushima Nuclear Power Stations -

June 2011

Nuclear Emergency Response Headquarters  
Government of Japan

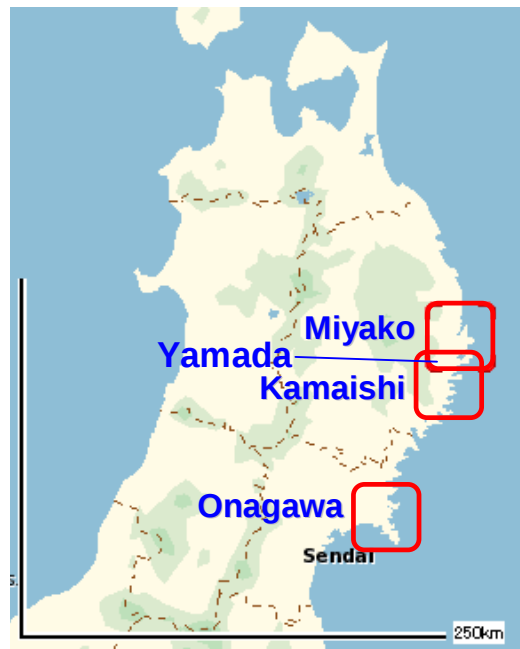
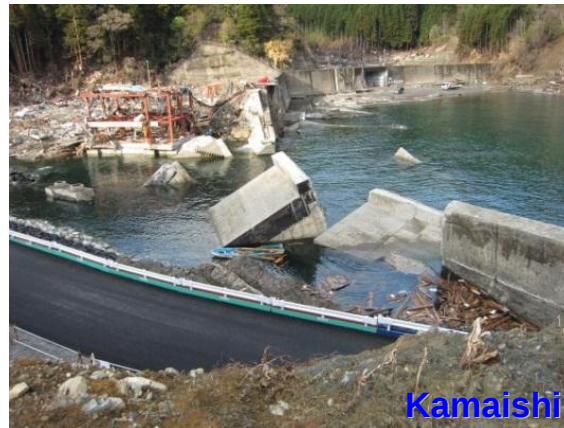
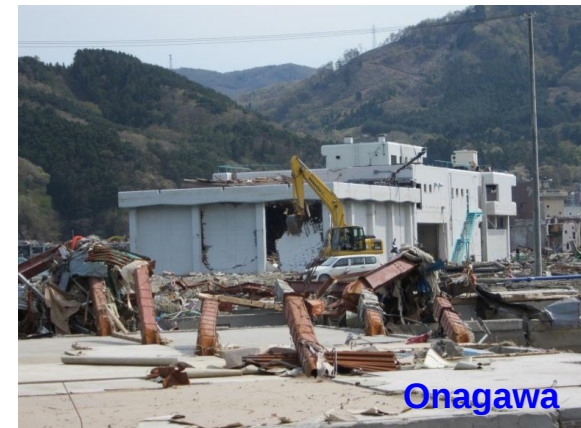
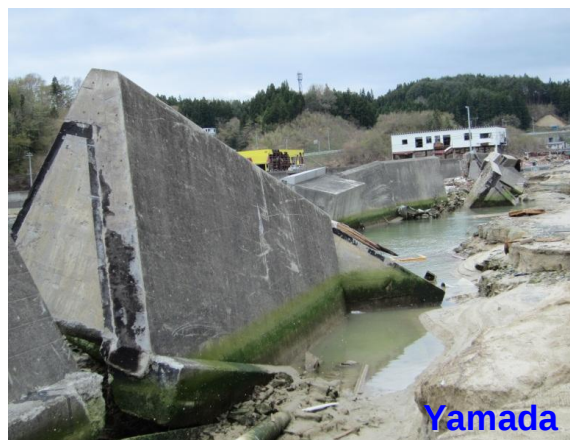
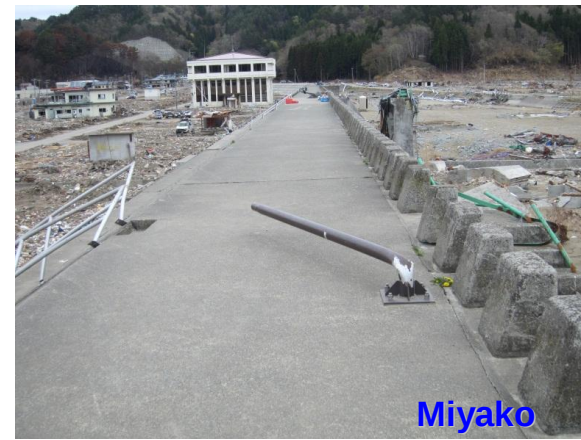
Destruction by tsunami scouring

Destruction by wave pressure

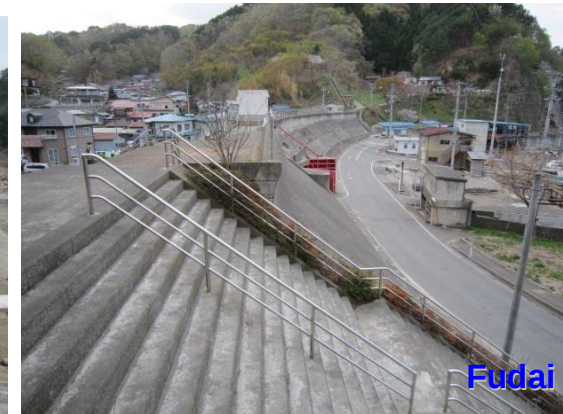
The 15.5m-high seawall was undestroyed in Otabe district, Fudai village, Iwate Pref.

Fig. III-1-16 Difference of seawall heights resulting in different consequence.

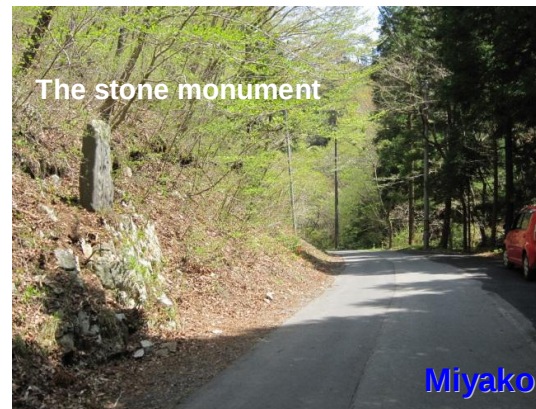
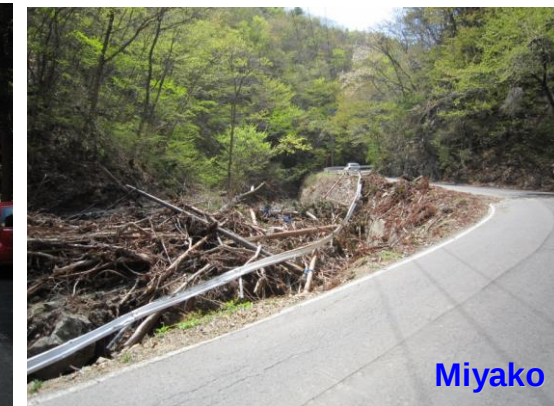
In the Aneyoshi area, Miyako City in Iwate Prefecture, there is a stone monument with the warning not to build houses in the area lower than that point as shown in Fig. III-1-17 (left picture) at the entrance (height 60 m) of the village, showing lessons learned from runups of the two historical tsunamis mentioned above.

By observing this lesson, the area was able to avoid casualties this time even though the tsunami ran up (the actual runup height was 38.9 m) near the village as shown in the figure (right picture).

Fig. III-1-17 Photos of a stone monument and tsunami invading area below the stone monument.

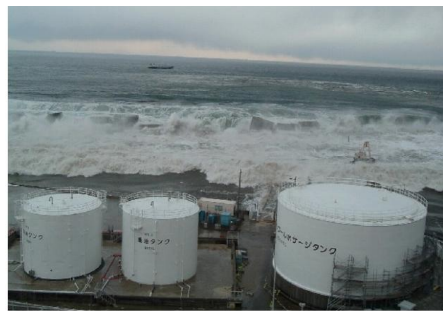
【福島第1原発 津波来襲状況 2011年3月11日 固体廃棄物貯蔵庫東側のり面(6号機の近傍(南側)から東側を撮影)＝東京電力提供】

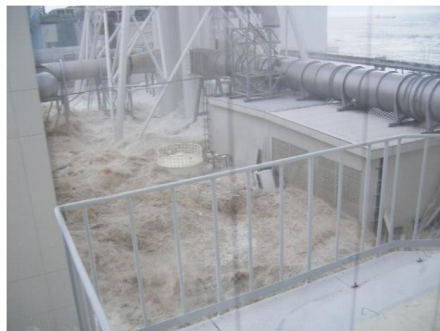
【福島第1原発への津波来襲状況 2011年3月11日 廃棄物処理建屋4階から北側を撮影】午後3時43分ごろ(2)＝東京電力提供】

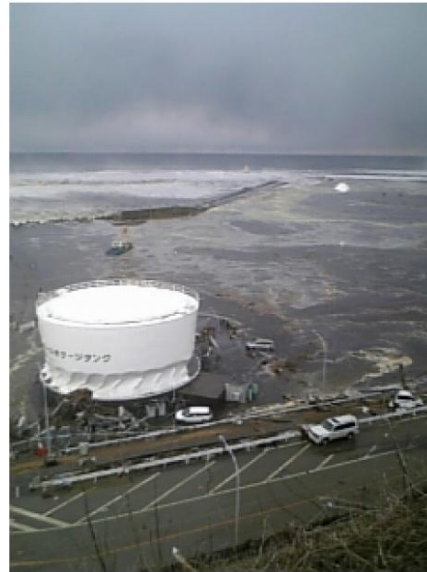
Fig. III-2-4(b) Photos showing plant damages at the Fukushima Dai-ichi NPS.

【福島第1原発 津波来襲状況 2011年3月11日 固体廃棄物貯蔵庫東側のり面(6号機の近傍(南側)から東側を撮影)＝東京電力提供】

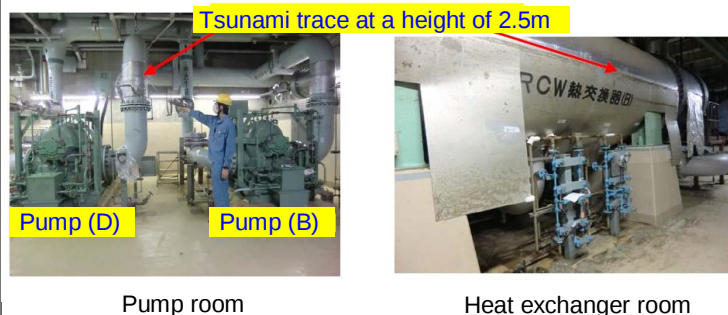
Fig. III-3-5(a) Inundation in the heat exchanger room for a component cooling system (1) at Onagawa NPS.

The observed tsunami height was 13 m, and despite the land sinking, the tsunami did not cause the seawater pump room (on the site as high as 13.8 m, adjusted to sinking by about 1 m) to be directly submerged. However, as the water level rose due to the tsunami, the water level in the underground intake pit also rose as shown in Figure III-3-5, caused by the siphon phenomenon. This resulted in seawater overflowing through the opening of the tide gauge into the seawater pump room. Then the seawater flowed from the pump room, via the trench, into the basement floors of the reactor buildings, causing the heat exchanger room of the component cooling water system in the second basement to be submerged. In addition, the component cooling water pump of Unit 2 was also submerged, which thereby caused the cooling function of emergency diesel generators to be lost, with two units stopped out of those three generators.

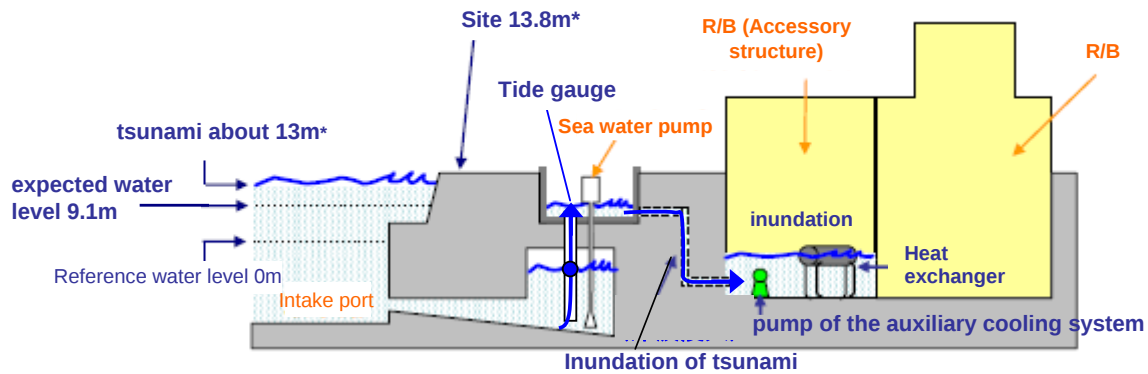
[ Inundation pathway to Heat exchanger (B) room for component cooling system ]

\*Subsidence of 1m at Onagawa site is considered

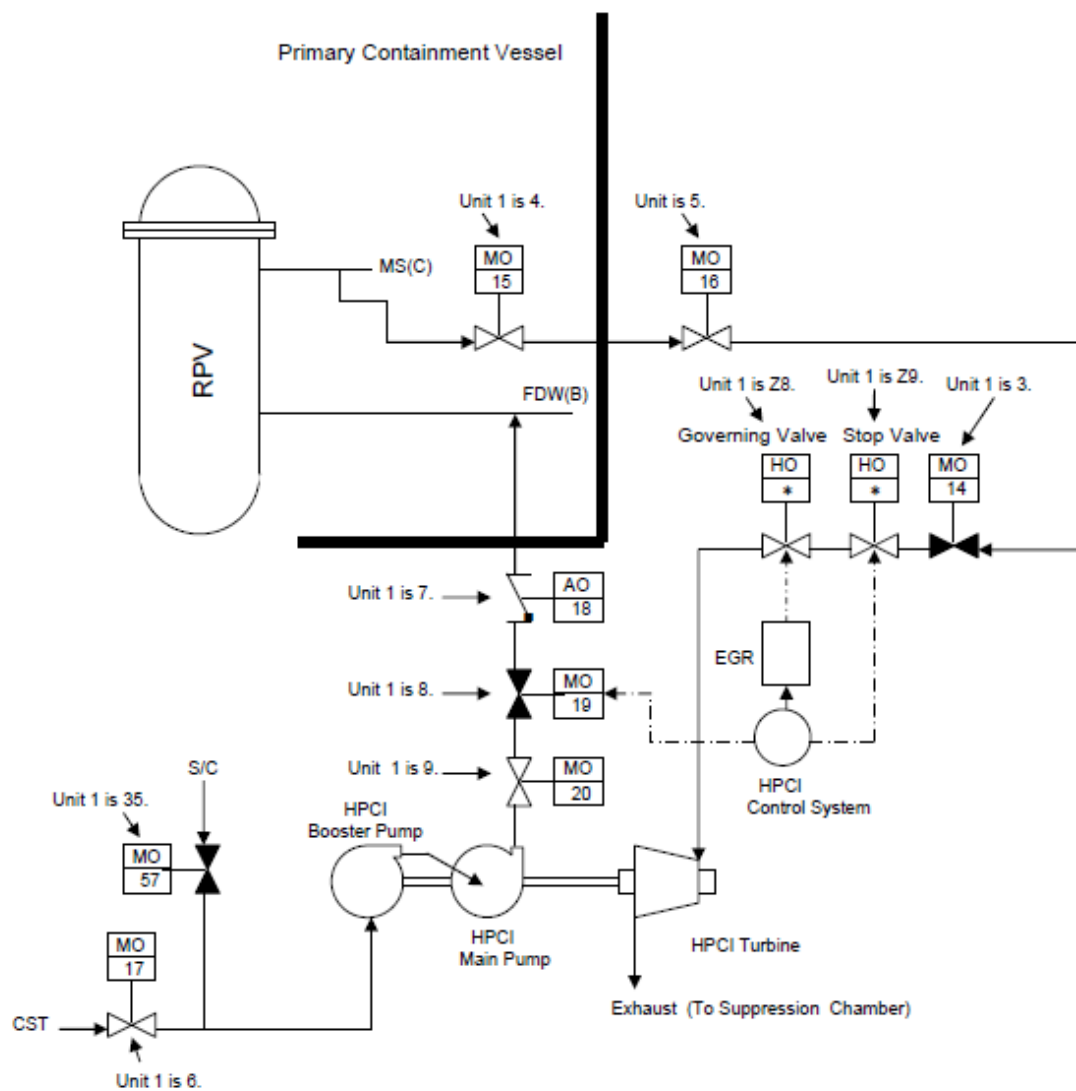
Fig. IV-2-3 System Structure Diagram of High Pressure Coolant Injection System  
(Units 1 to 3)

- \*1: During normal operation, MO-15, 16, 17, 20 and HO valves are "open" and MO-14 and 19 valves are "close".  
At startup, 14 and 19 valves are "open".
- \*2: MO-15 valve is inoperative due to AC power loss. (as-is)
- \*3: MO-14, 16, 17, 19 and 20 valves are inoperative due to DC power loss (the separate power source from isolation logic circuits). (as-is)
- \*4: During DC power loss, isolation (close) logic circuits are operative.  
At that time, if the drive power of each valve (written in \*2 and \*3) is activated, each valve is closed. If the drive power of each valve is already lost, the circuits are inoperative. (as-is)

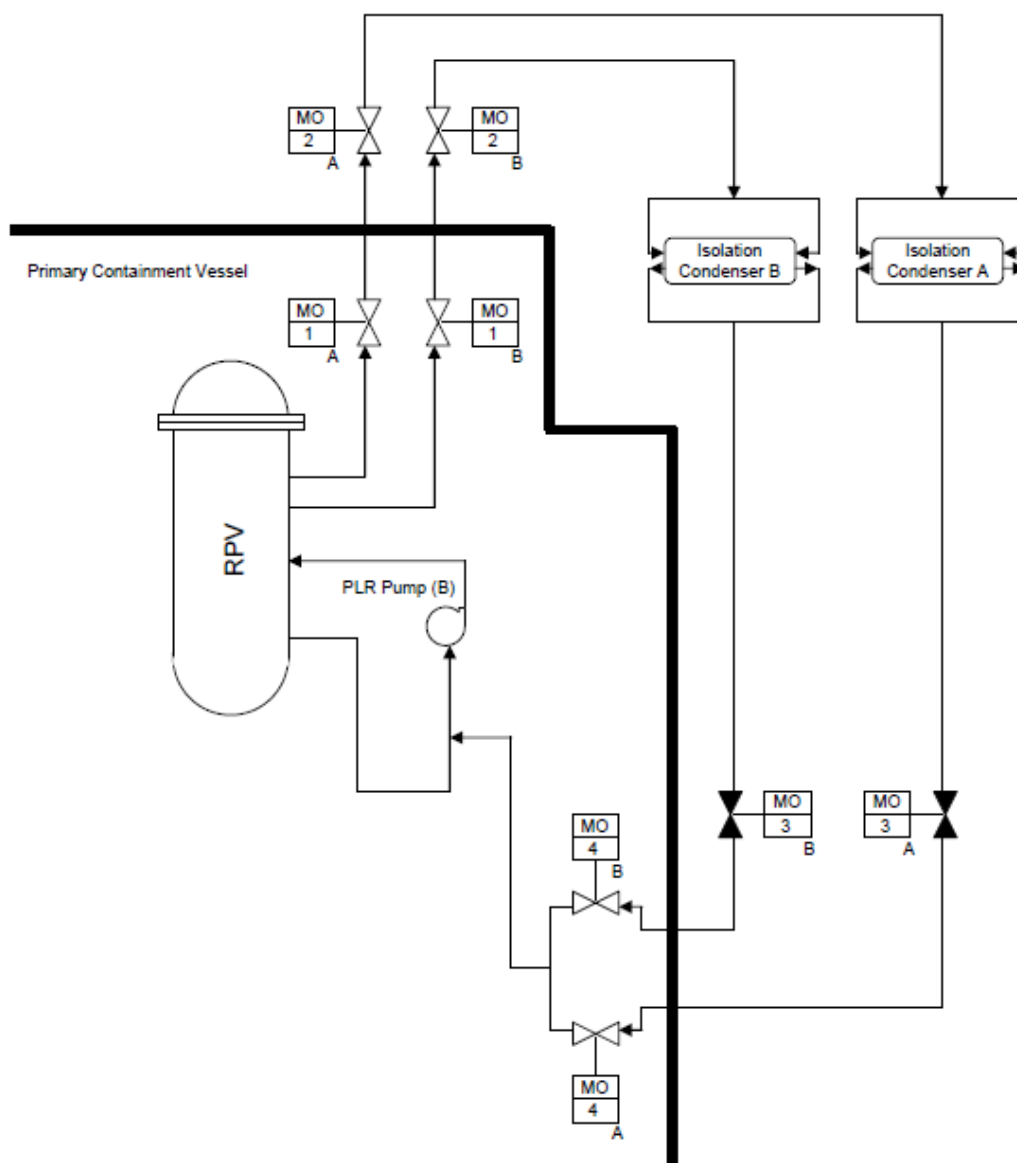
Fig. IV-2-4 System Structure Diagram of Isolation Condenser (Unit 1)

- \*1: During normal operation (in a standby condition), MO-1, 2 and 4 valves are "open" and MO-3 valve is "close". At startup, MO-3 valve is "open".
- \*2: MO-1 and 4 valves are inoperative due to AC power loss. (as-is)
- \*3: MO-2 and 3 valves are inoperative due to DC power loss (the same power source as isolation logic circuits). (as-is)
- \*4: During DC power loss, isolation (close) logic circuits are operative.  
At that time, if the drive power of each valve (written in \*2 and \*3) is activated, each valve is closed. If the drive power of each valve is lost, the valves are inoperative. (as-is)

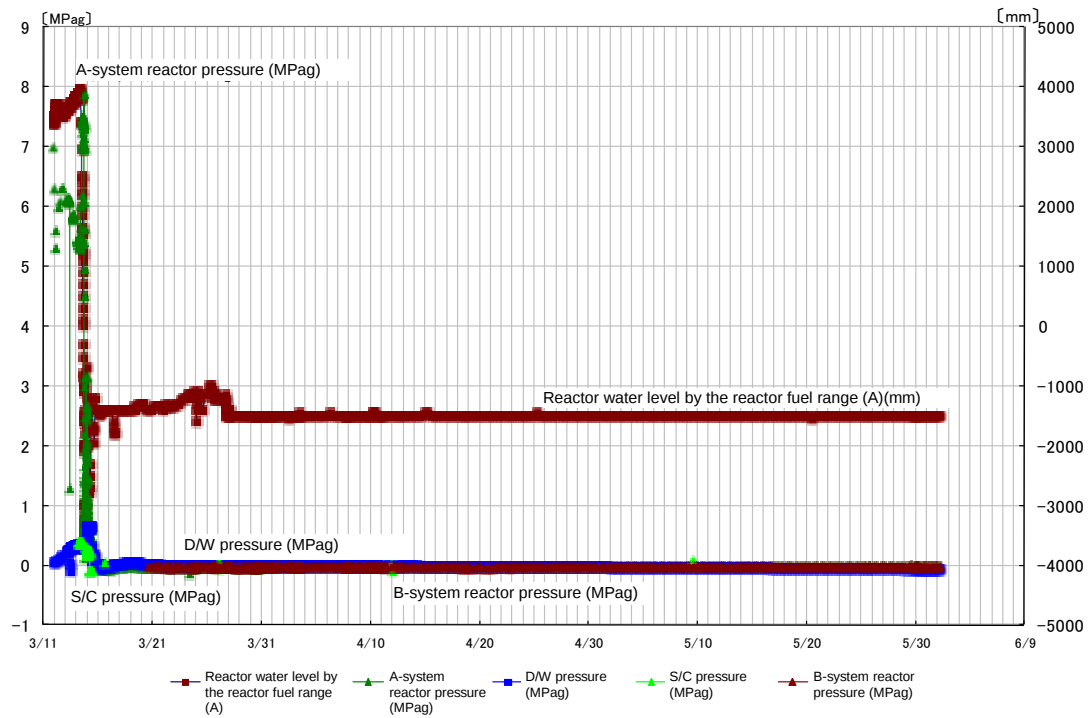
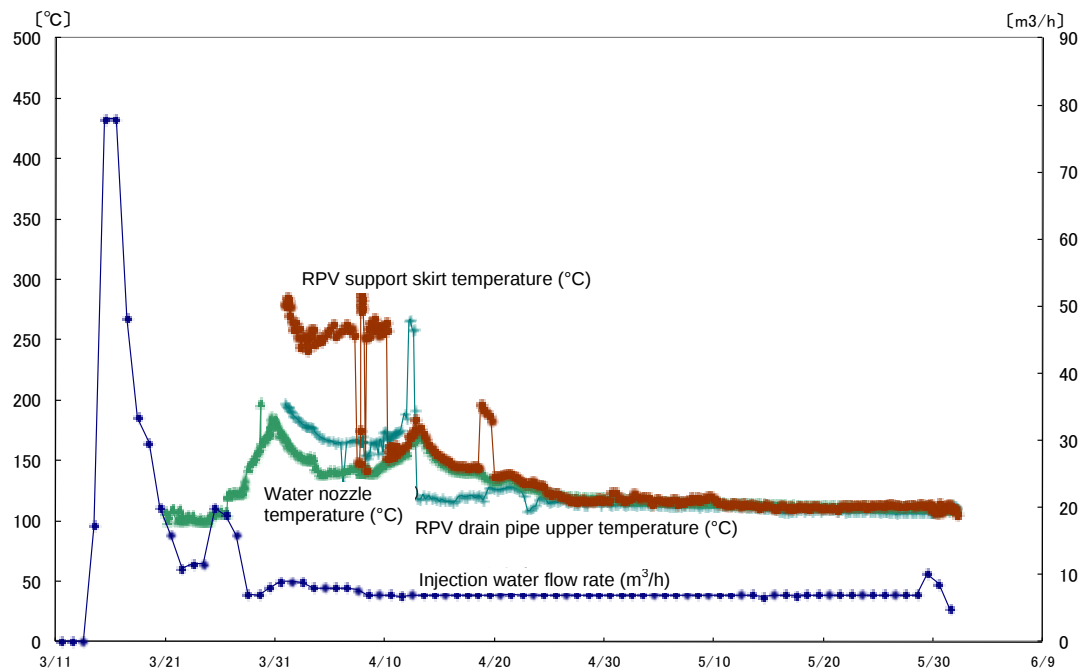
Fig. IV-5-4 Changes in key parameters [1F-2] (From March 11 to May 31)

TEPCO judged that during this time, although RCIC operation was continued, water leakage from RPV was presumed to have occurred, based on PCV pressure behavior, that this leakage caused the RCIC to shut down. TEPCO supposed that the fuel was

uncovered for five hours from 13:25 on March 14 (75 hours after the Earthquake began) and that the core damage started two hours later. After that, assuming there was an outflow of alternate injection water due to insufficient maintenance of the reactor water level in the fuel region, the core likely melted, and the melted fuel moved to the lower plenum so that the RPV was damaged 109 hours after the Earthquake began.

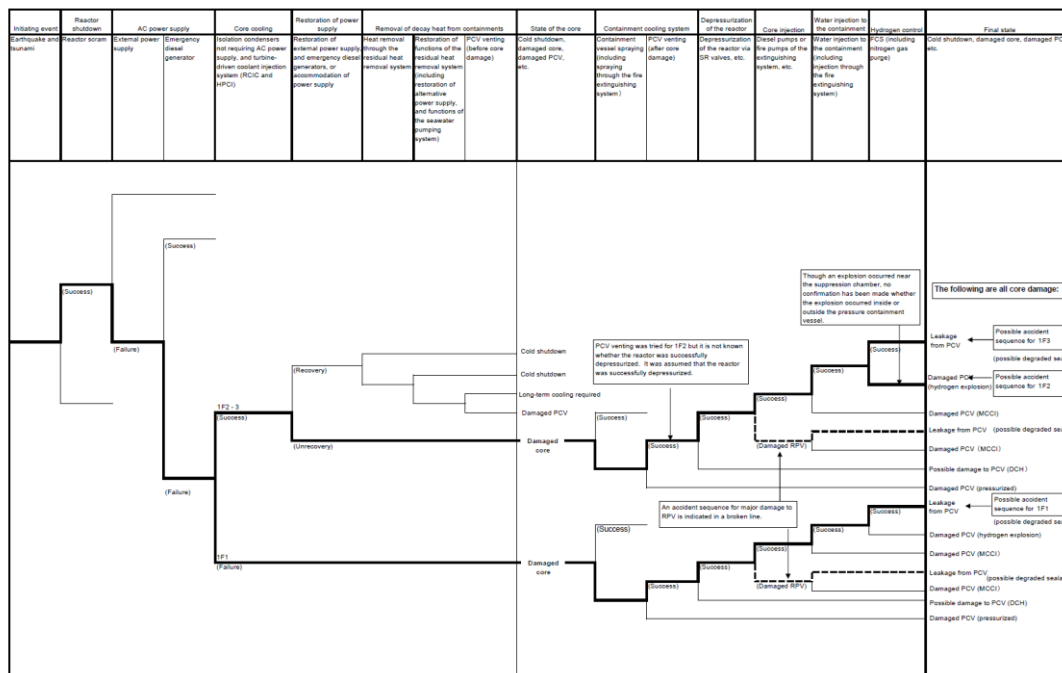
Figure IV-7-1: Function event tree for units 1, 2 and 3 of Fukushima-Daiichi Nuclear Power Station

The PCV pressure increased in Unit 3 during this time. For depressurization, spray to the S/C was used, and it was confirmed that the accident management system functioned properly. In units 1 and 2, the PCV vent was superseded, and thus the PCV spray (D/W and S/C) was not performed.
