## **8. DEBRIS RELOCATION SCENARIO**

J. R. Wolf and D. W. Akers, Idaho National Engineering Laboratory  
L. A. Neimark, Argonne National Laboratory

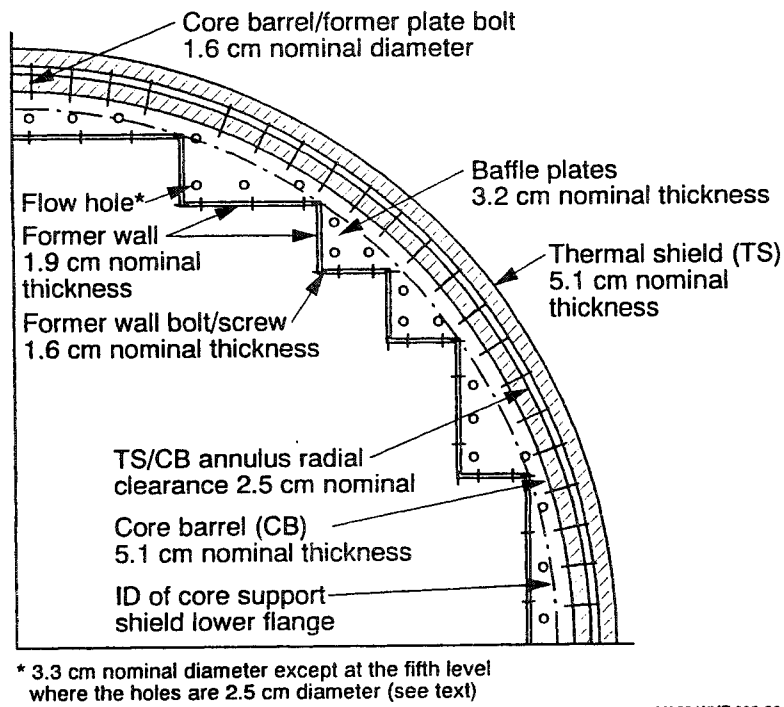
**Figure 8-1.** Reactor vessel internal structures.

At the bottom of the vertical core former plates, the molten material melted back into the lower core support assembly (CSA). Visual observations indicate a massive hole and damage in the bottom on the vertical core former wall located at core grid locations R-6, R-7, P-4, and P-5.

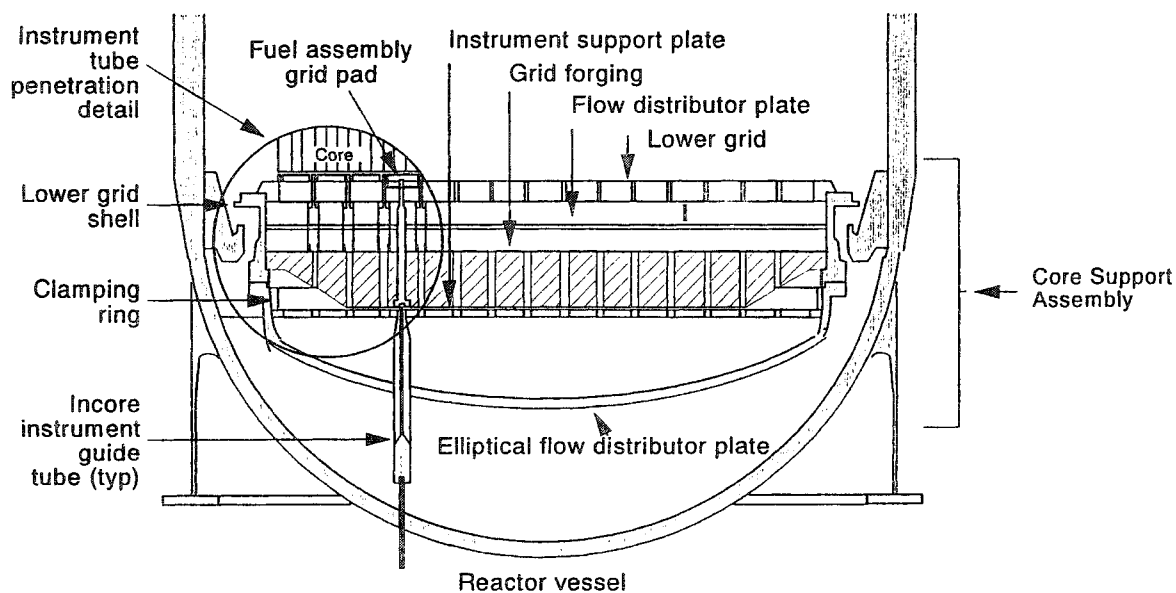
**Figure 8-3.** TMI-2 core support assembly.

The CSA geometry consists of a number of plates and forging and as shown in Figure 8-3. Once in the CSA, the majority of the molten material continued to flow down through the structures on the eastern periphery in the R-6/7 and P-4/5 area. However, visual examinations indicated that some of the molten material was found to have flowed around the perimeter of the CSA structures as it penetrated downward towards the lower head. Figure 8-4 shows the location of solidified material at several locations in the flow holes of the lower grid, the area between the lower grid and the flow distributor plate, and between the flow distributor plate and the grid forging. The presence of solidified material is assumed to indicate that molten material flowed through or adjacent to these locations.
