II. Further developments of the nuclear accident since that time

1. The Tohoku District-Off the Pacific Ocean Earthquake and the resulting tsunamis

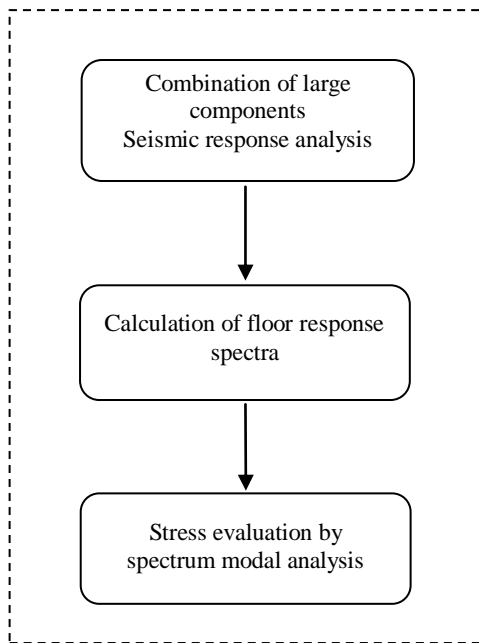
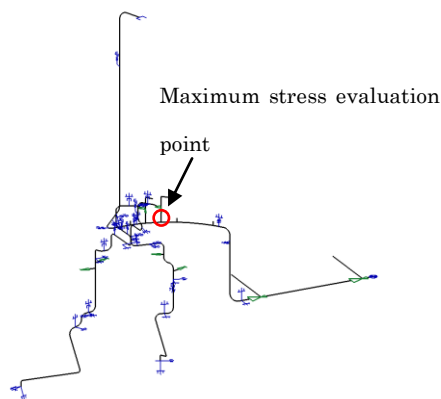
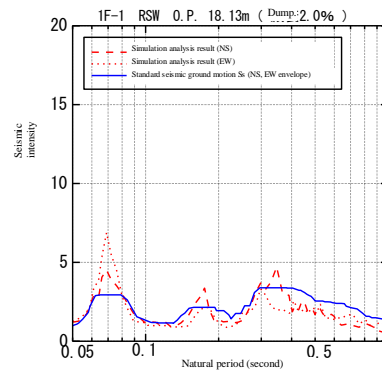
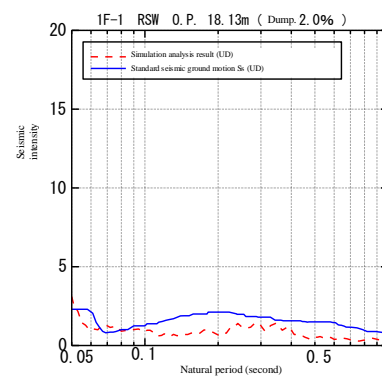
Table II-2-8 Outline of Seismic Evaluation (Example of Main Steam System Piping)  
(Fukushima Dai-ichi NPS, Unit 1)

\*: The horizontal floor response spectra of this earthquake is greater than that of standard seismic ground motion Ss in part of the periodic band, whereas the vertical floor response spectra of this earthquake is generally less than that of standard seismic ground motion Ss. Accordingly, it is thought that the calculated values for this earthquake were less than those of standard seismic ground

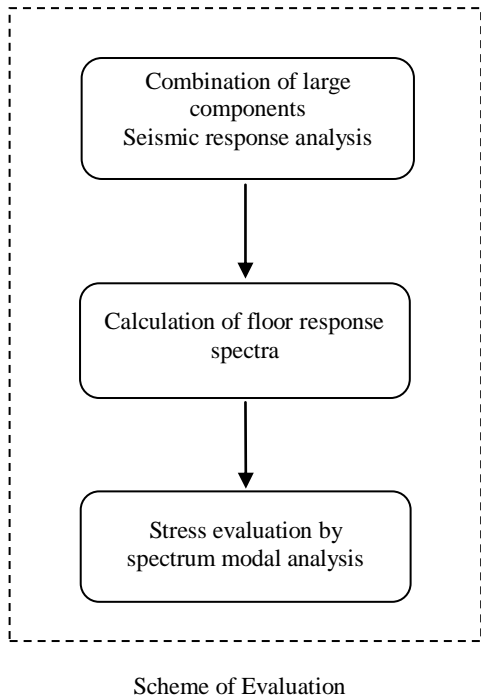
The floor response spectra of this earthquake are generally less than those of standard seismic ground motion Ss. It is in part of the periodic band that the floor response spectra of this earthquake are greater than those of standard seismic ground motion Ss.

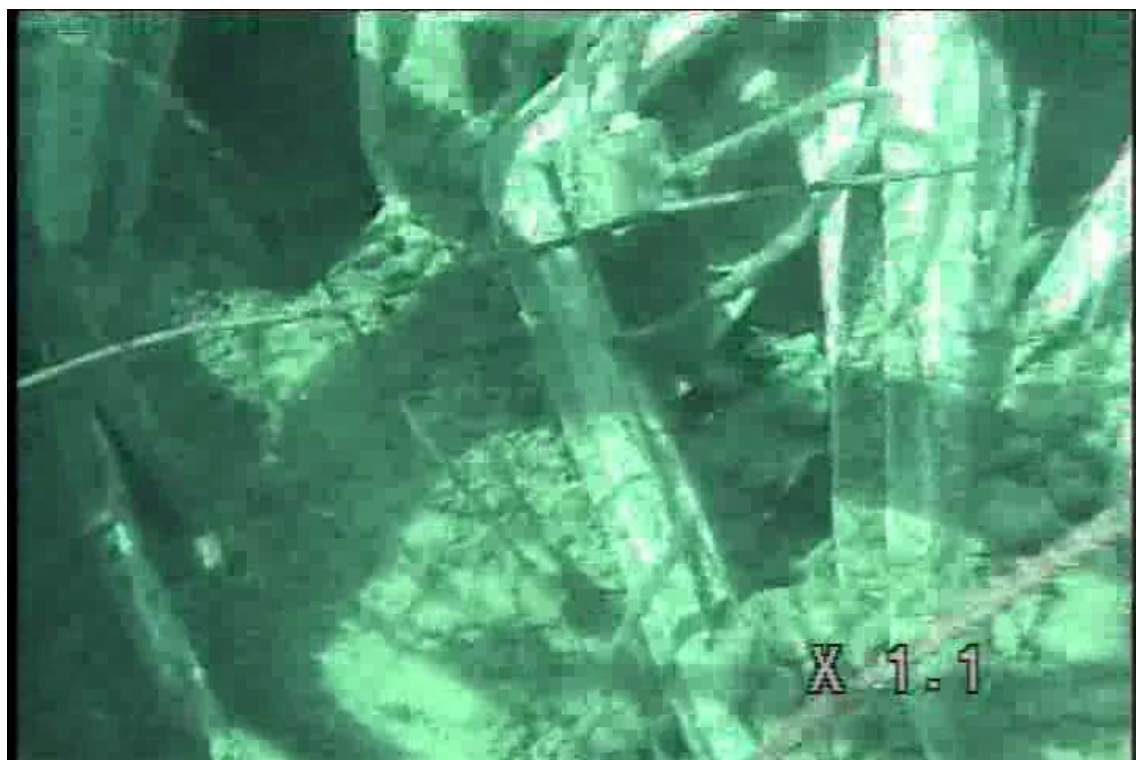
When pool water sampling was conducted on May 8, filming by video camera was done at the same time. Picture is shown in Figure II-2-41. Because a large amount of rubbles fell inside of pool water, conditions of fuel etc. stored in pool couldn't be confirmed.

Figure II-2-41 Unit 3 Spent Fuel Pool Viewed from Underwater

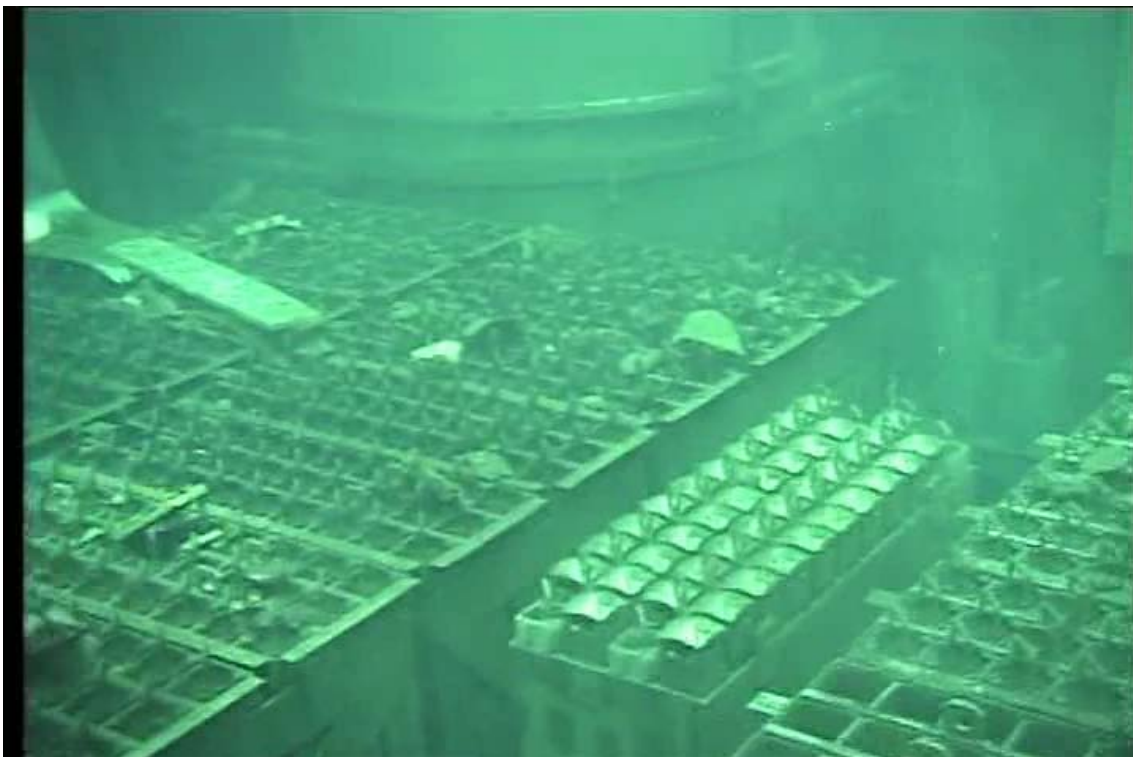
Figure II-2-46 Unit 4 Pool Viewed from Underwater (No. 1)

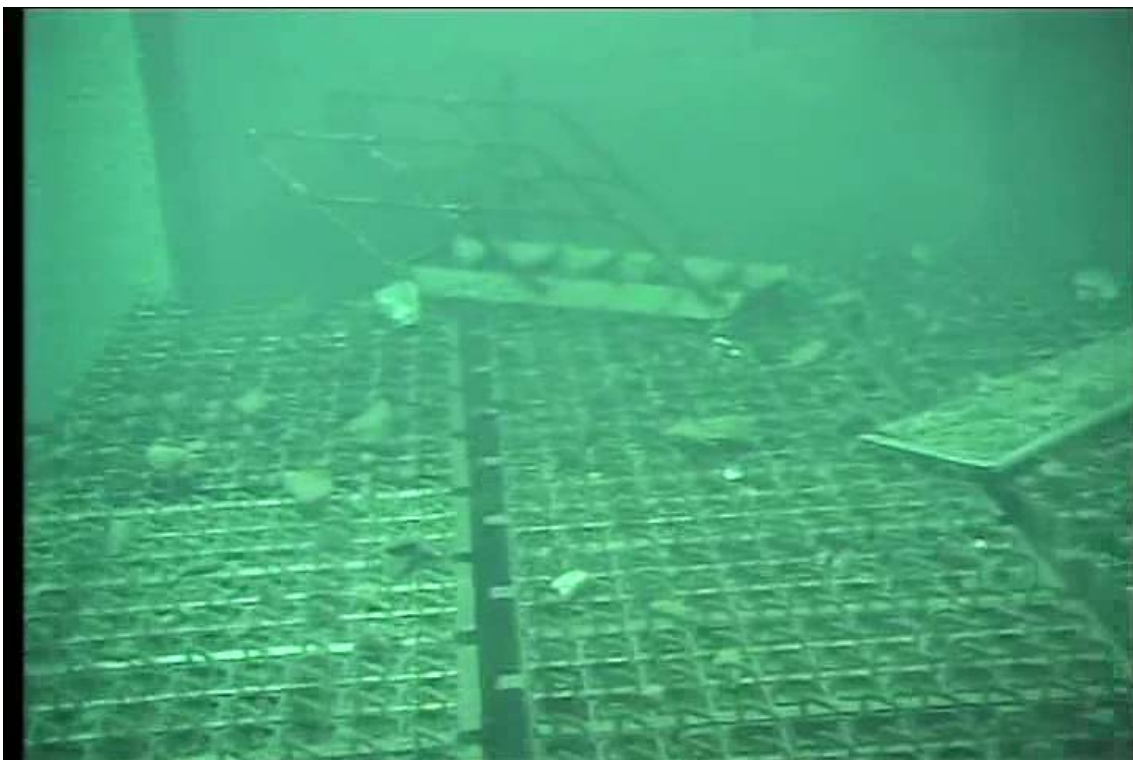
Figure II-2-47 Unit 4 Pool Viewed from Underwater (No. 2)

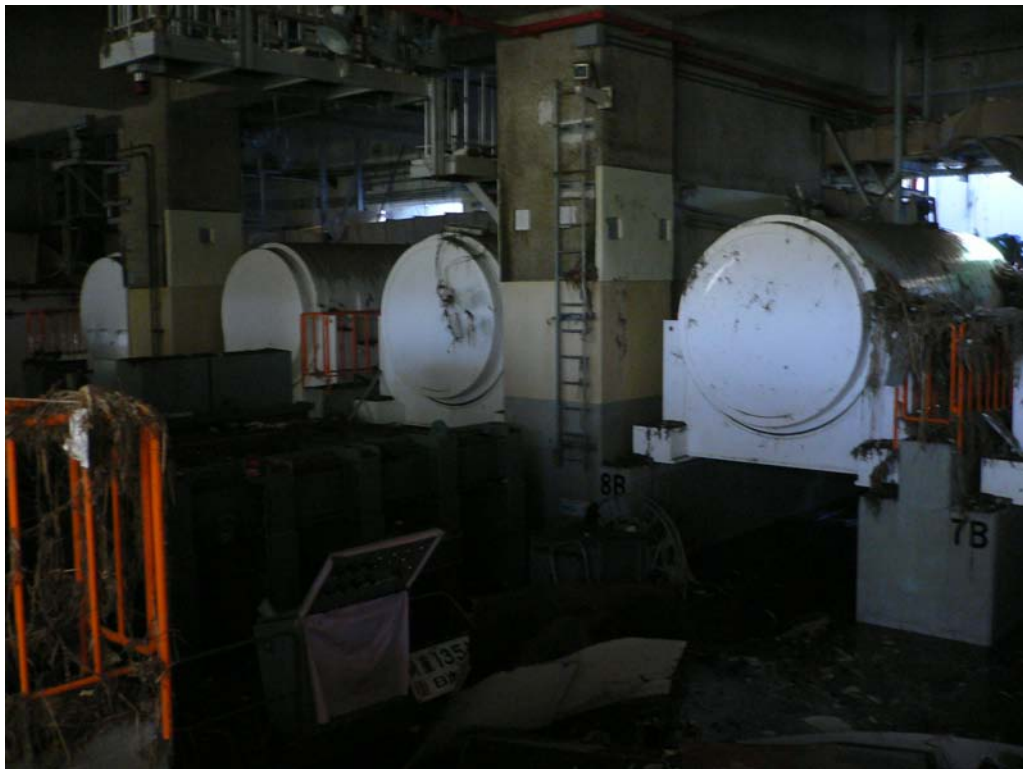
Tokyo Electric Power Company has carried out multiple investigations inside the cask building since March 17. In the cask building, the cask storage area was inundated up to floor-level, with louvers and doors also destroyed. However, the airflow expected from the natural convection of air was not hampered, and it was confirmed that no problems occurred regarding cooling.

Except that they are covered with the rubbles that was washed into the building by the tsunami, the casks remained bolted in their original positions, and so far, no issues on their integrity have been identified from appearance. The dose level within the cask building (up to few tens of  $\mu\text{Sv/h}$ ) is not abnormally high compared to background radiation. Dry storage casks have high seal performance ensured by a double sealing structure through primary and secondary covers, but at the moment, the integrity of their sealing performance has not yet been verified directly through leakage tests. Figure II-2-56 is a photo showing the conditions inside the cask building.

Figure II-2-56 Situation in Dry Storage Cask Facility

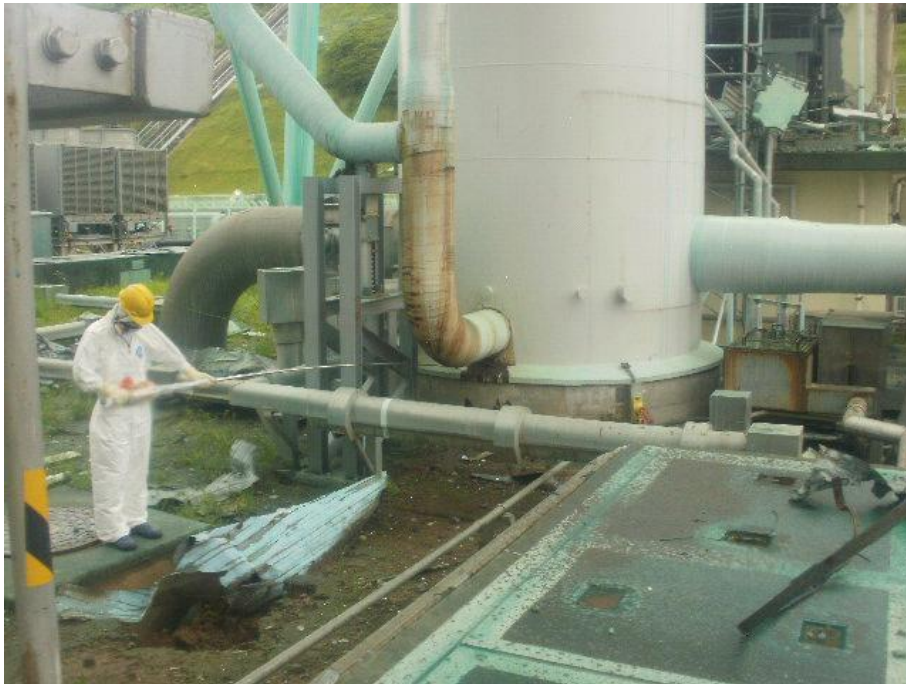
Location: Near the standby gas treatment system pipe joint at the bottom of the main exhaust stack of Units 1 and 2  
Time: August 1, 2011, around 14:30  
Photographed by: TEPCO

Figure II-2-60 Near the Main Exhaust Stack of Units 1 and 2 in Fukushima Dai-ichi  
NPS

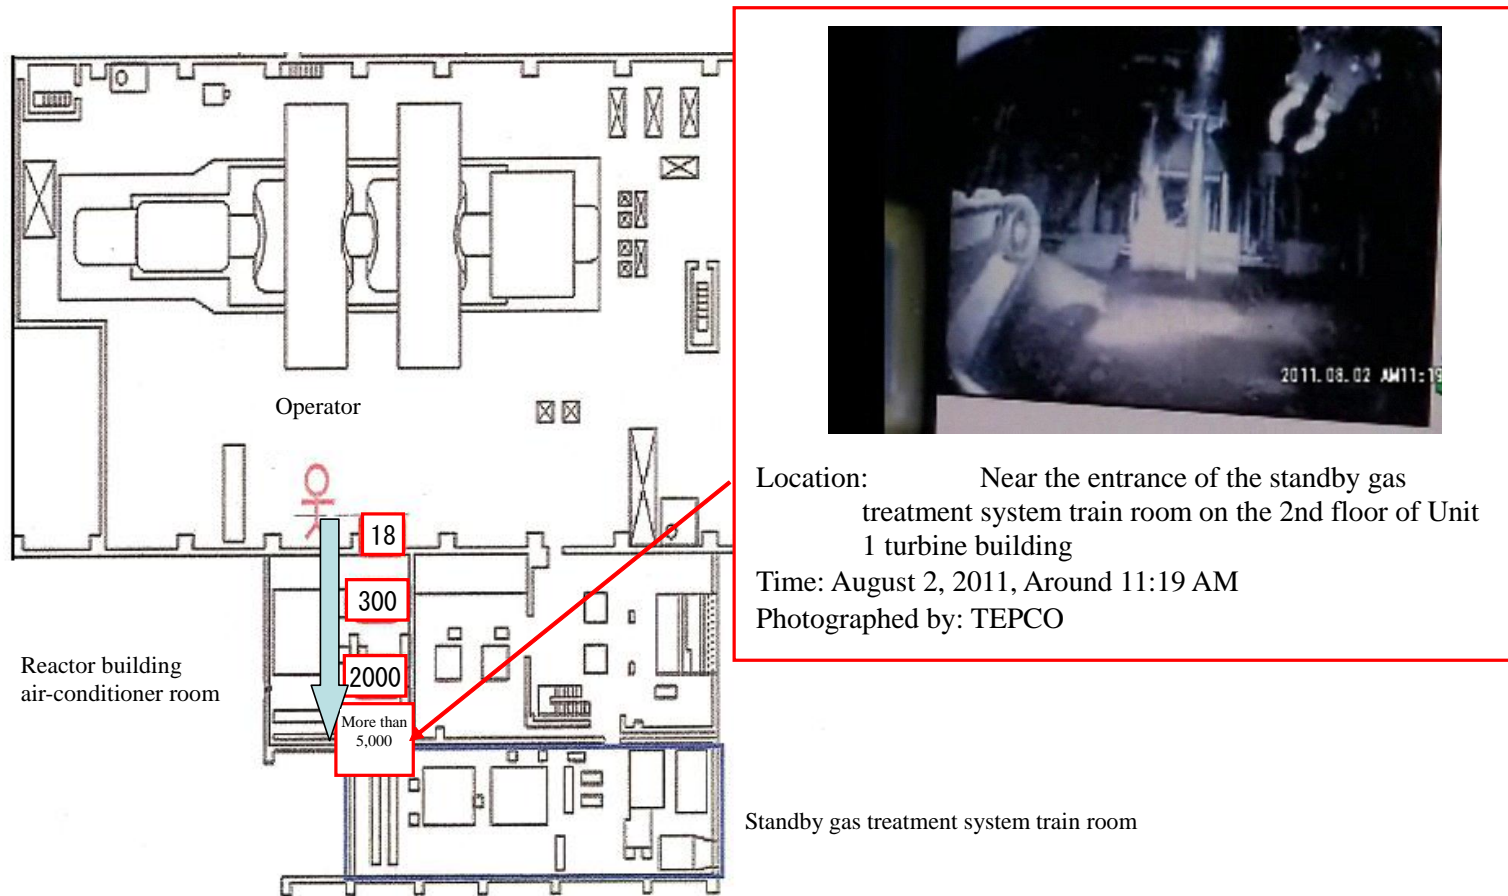
Figure II-2-61 High-dose Detected Area on the 2nd Floor of Unit 1 Turbine Building in Fukushima Dai-ichi NPS

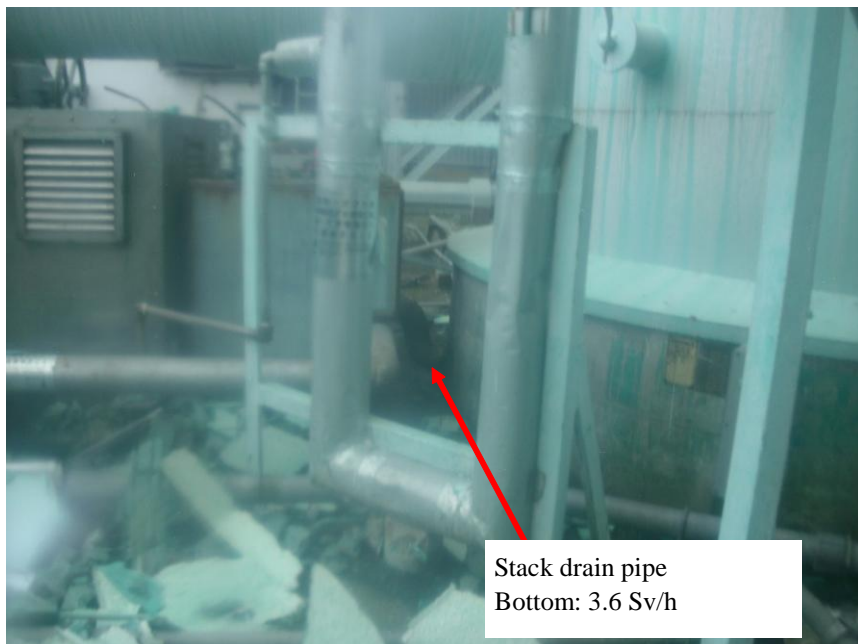
Figure II-2-62 Stack Drain Pipe of the Main Exhaust Stack of Units 1 and 2 in Fukushima Dai-ichi NPS

Location: Stack drain pipe at the main exhaust stack of Units 1 and 2 (view from the west side)

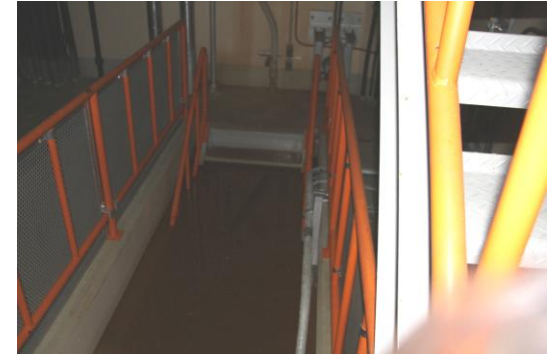
Figure II-2-63 Result of Investigation inside Unit 2 Reactor Building in Fukushima Dai-ichi NPS (No. 1)

Northwest stairs (half basement)

Southeast stairs (half basement)

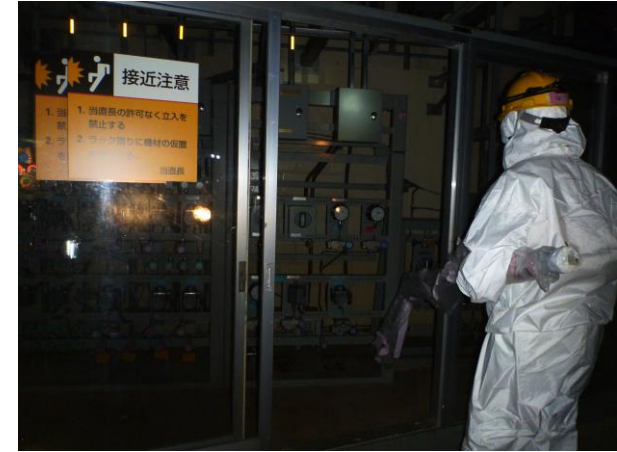
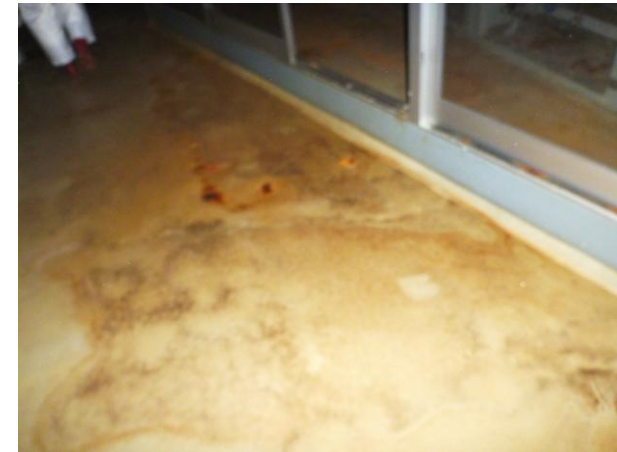
Figure II-2-64 Result of Investigation inside Unit 2 Reactor Building in Fukushima Dai-ichi NPS (No. 2)

Reactor instrumentation rack

Floor in front of reactor instrumentation rack

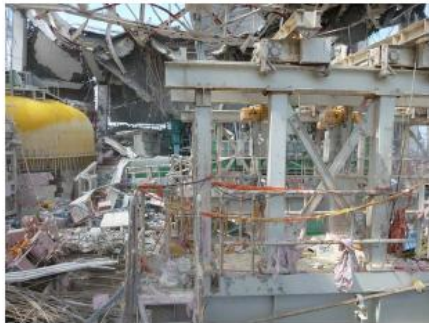
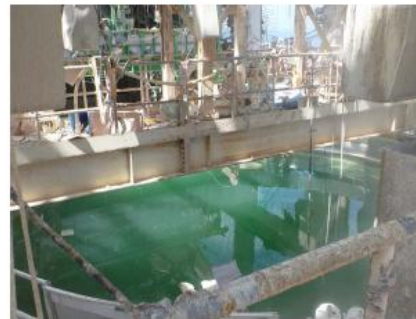
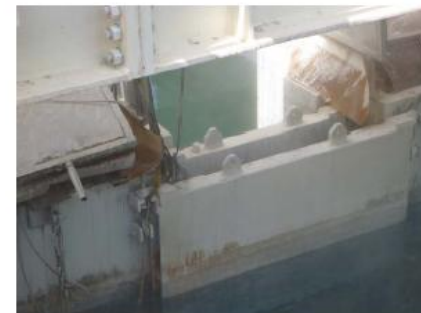
Figure II-2-69 Result of On-the-spot Investigation of the 5th Floor of Unit 4 Reactor Building in Fukushima Dai-ichi NPS

Equipment storage pool viewed from refueling carriage

Reactor well

Spent fuel pool gate

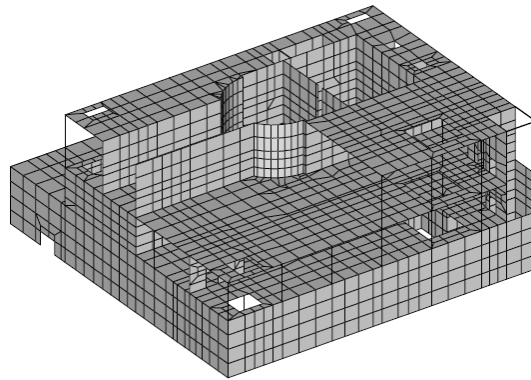
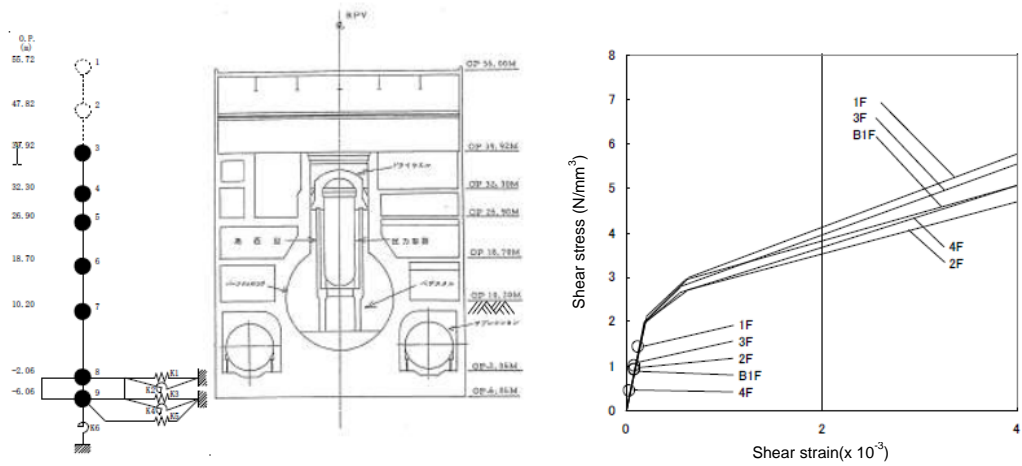
Fig. II-2-79 Lumped Mass Model and Maximum Shear Strain in the Seismic Wall for Unit 3 (TEPCO Report, July 13)

As for the Unit 3 reactor building, the structures above the operating floor (the fifth floor level) were damaged by an incident which is believed to be a hydrogen explosion on March 14. According to available sources such as photographs and video films, a majority of the structures above the fifth floor level are in the state of a stack of iron frame and concrete structures which collapsed after the explosion. The floor at the fifth level at the northwestern corner has been damaged, causing some of the collapsed iron frame and concrete structures to pile up on the fourth floor, and many parts of the walls on the fourth level are damaged.

In consideration of the above information, modifications were made to a model (II2-6) that had been prepared for the seismic design back-check; the frame structures that remained above the operating floor and the damaged seismic walls below the operating floor were no more counted as structural components. In other words, the structures above the operating floor were removed from the model for the back-check, and modifications were made to the assumed structural performance of the structures below the operating floor by decreasing the shearing cross-sectional area and the cross-sectional secondary moment from their integrity states. In addition, the model was modified to properly represent how the weight of the structures above the operating floor is distributed on the operating floor. The model was further modified to properly represent how the weight of the collapsed northwestern corner of the operating floor, and the weights of the collapsed walls and frame structures on the fourth level, are distributed on the fourth floor.

Since no part of the building was identified to have any danger of failure in ensuring the seismic safety, TEPCO, at this moment, does not plan any urgent implementation of seismic reinforcement works, etc.

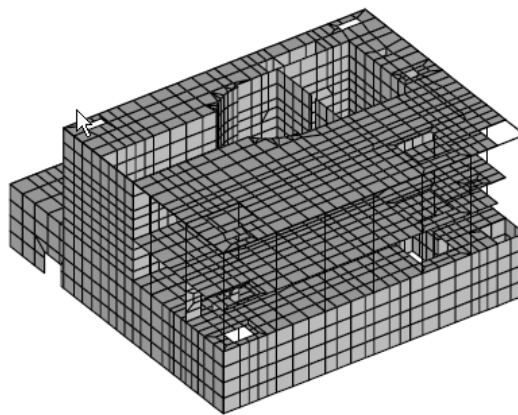
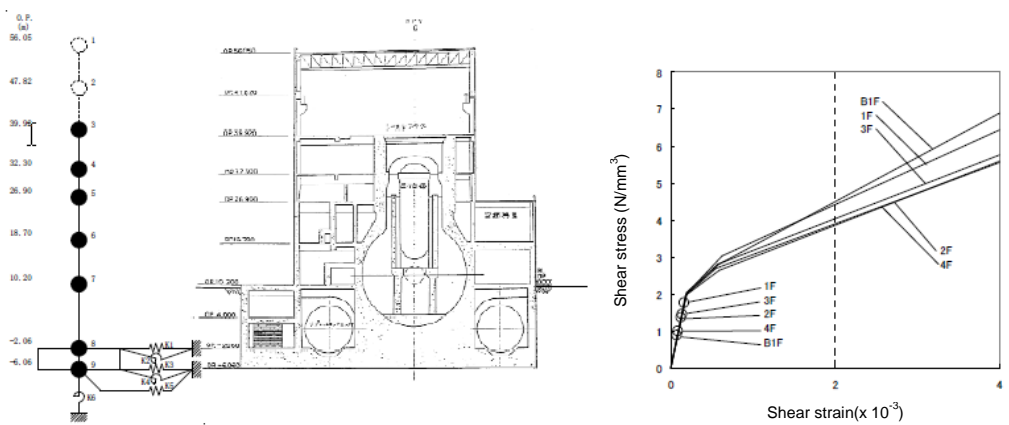
Fig. II-2-80 Lumped Mass Model and Maximum Shear Strain in the Seismic Wall for Unit 4 (TEPCO Report, May 28)

As for the Unit 4 reactor building, the building lost a majority of its roof slabs and walls above the fifth floor level due to unidentified cause on March 15, leaving only the frame structures of columns and beams, and furthermore, the available sources such as photographs and video films indicate that a majority of walls on the fourth level and some walls on the third level have also been damaged.

In consideration of the above information and also of the fact that Unit 4 was not loaded with fuel because of a scheduled outage underway on the day of the earthquake, modifications were made to a model (II2-7) for the seismic design back-check, referring to data concerning the load conditions during scheduled outages. The frame structures that remained above the operating floor and the damaged seismic walls below the operating floor were no more counted as structural components. In other words, the structures above the operating floor were removed from the model for the back-check, and modifications were made to the assumed structural performance of the structures below the operating floor. In addition, the model for the back-check was modified to properly represent how the weight of the structures above the operating floor is distributed on the operating floor.

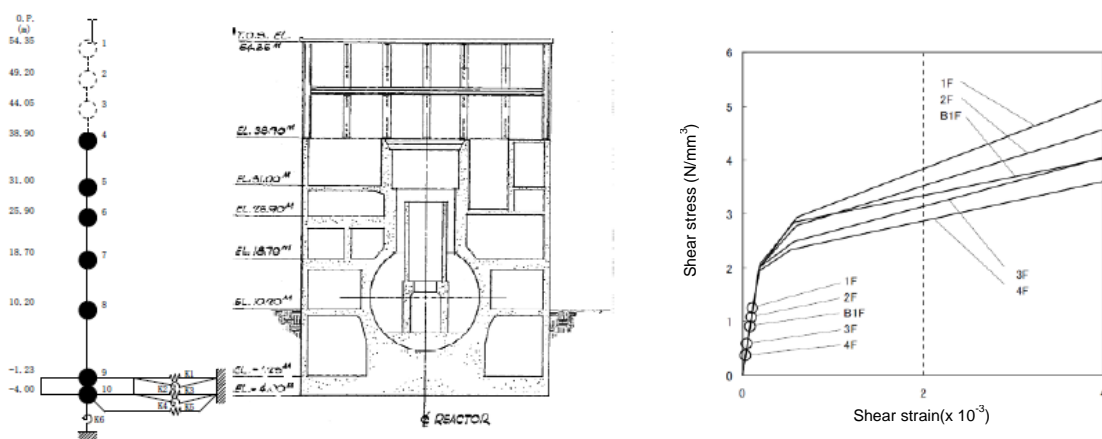
Fig.II-2-77 Lumped Mass Model and Maximum Shear Strain in the Seismic Wall for Unit 1 (TEPCO Report, May 28)

At the Unit 1 reactor building, the structures above the operating floor (the fifth floor level) were damaged by an event, which is believed to be a hydrogen explosion, occurring on March 12, the day after the Tohoku District - off the Pacific Ocean Earthquake.

Studying damages from the available sources of information such as photographs and video films, modifications were made to a model (II2-6) that had been prepared for the reassessment of seismic safety using the updated guide for seismic design (hereinafter referred to as “seismic design back-check”); the steel frame structures that remained above the operating floor were no more counted as structural components. In other words, the structures above the operating floor were removed from the model that had been prepared for the seismic design back-check. In addition, the model that had been prepared for the back-check was modified to properly represent how the weight of the structures above the operating floor is distributed on the operating floor. Components such as seismic walls and floors below the operating floor were assumed as unaffected by the explosion, thus the structural performance of the back-check model was assumed to remain unchanged.

Since no part of the building was identified to have any danger of failure in ensuring the seismic safety, TEPCO, at this moment, does not plan any urgent implementation of seismic reinforcement works, etc.

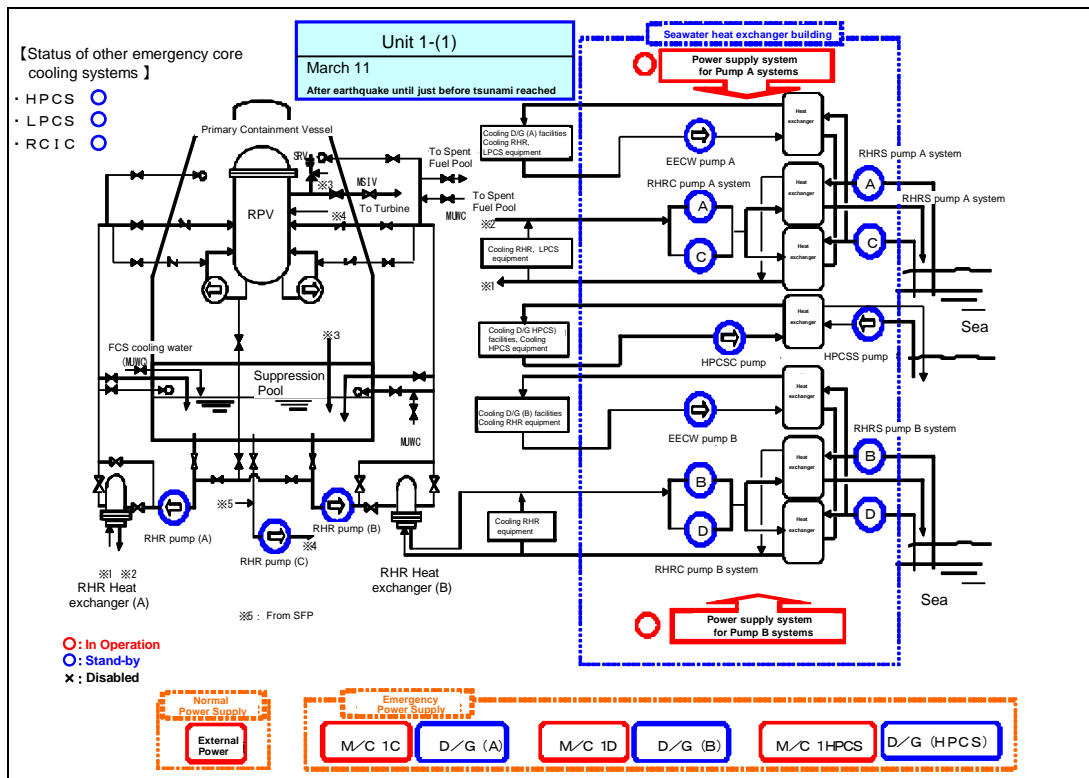
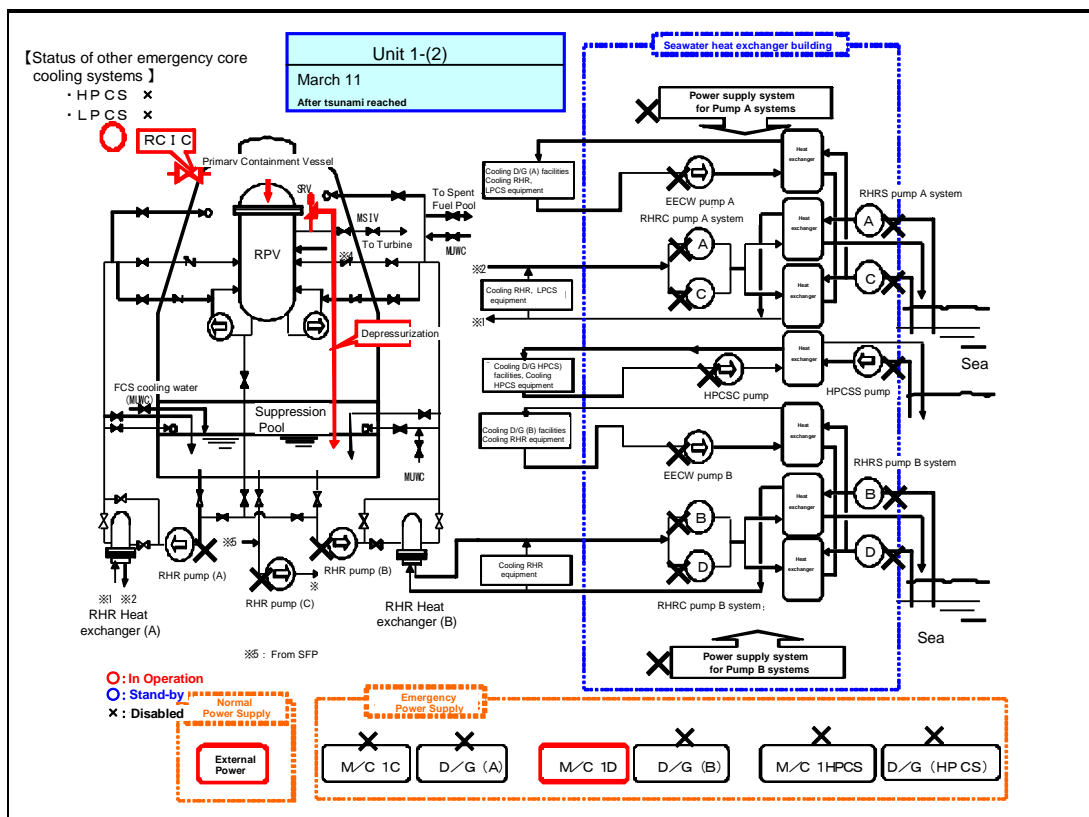
Figure II-2-107 Schematic Diagram of Station Status [2F-1] (Part 1)

SFP Cooling (RHR)		R/B 2 <sup>nd</sup> basement (o.p.0000)	A	○	○	○	×→◎	Unavailable because RHRS, RHRC and EECW was unoperable due to tsunami. Started operation after recovery of RHRS, RHRC and EECW on Mar. 16.	
Confinement Function	Cantainment Building		A	○	○	○	○	Maintain negative pressure and observed no sign of damage.	
	Primary Containment Vessel		As	○	○	○	○	Observe no sign of damage regarding PCV pressure

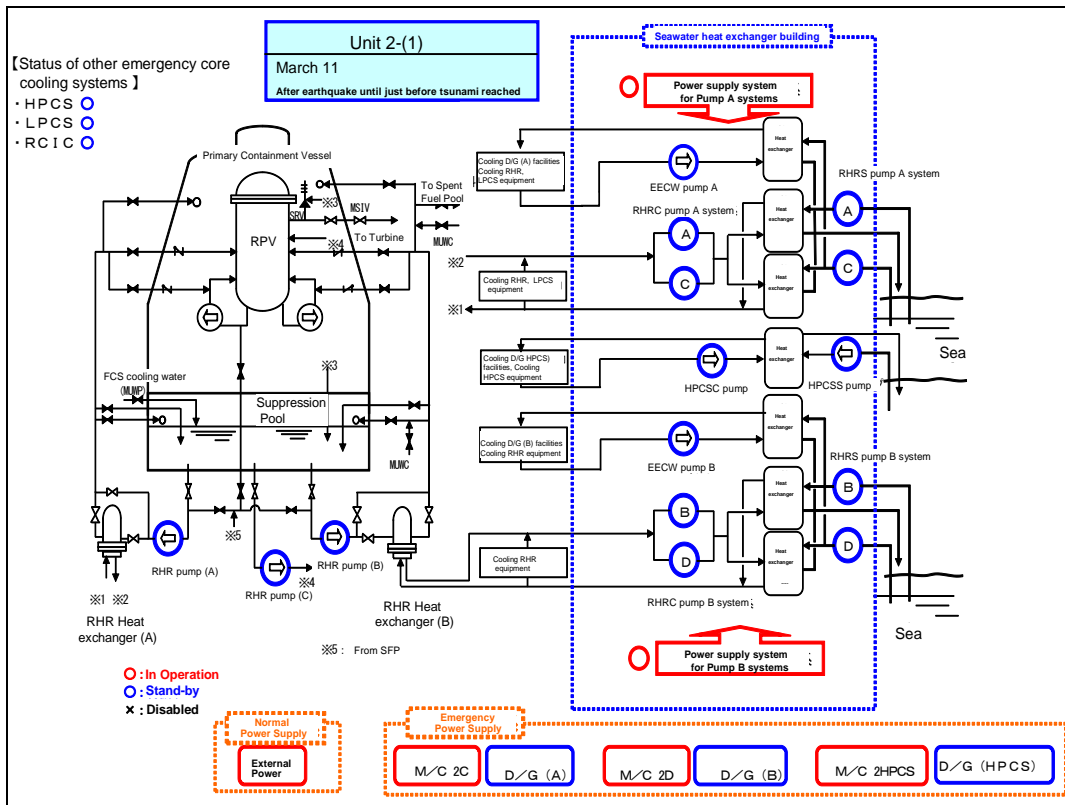
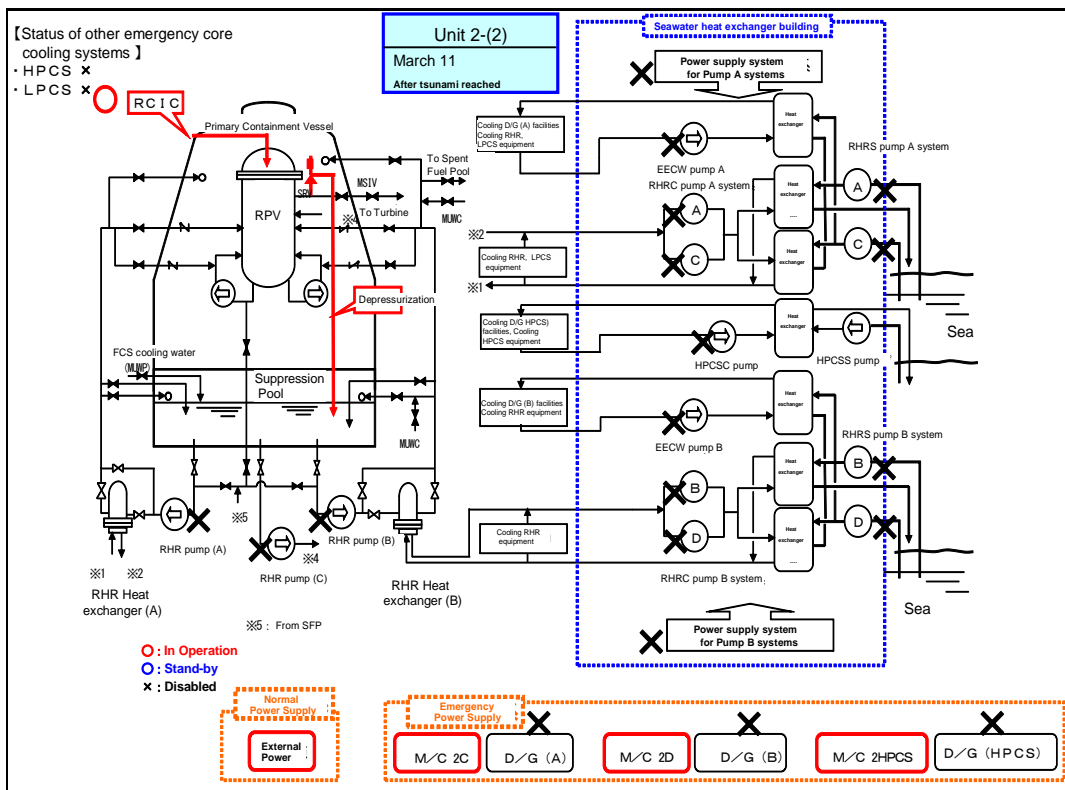
Figure II-2-112 Schematic Diagram of Station Status [2F-2] (Part 1)

Primary Containment Vessel	/	As	○	○	Observe no sign of damage regarding PCV pressure

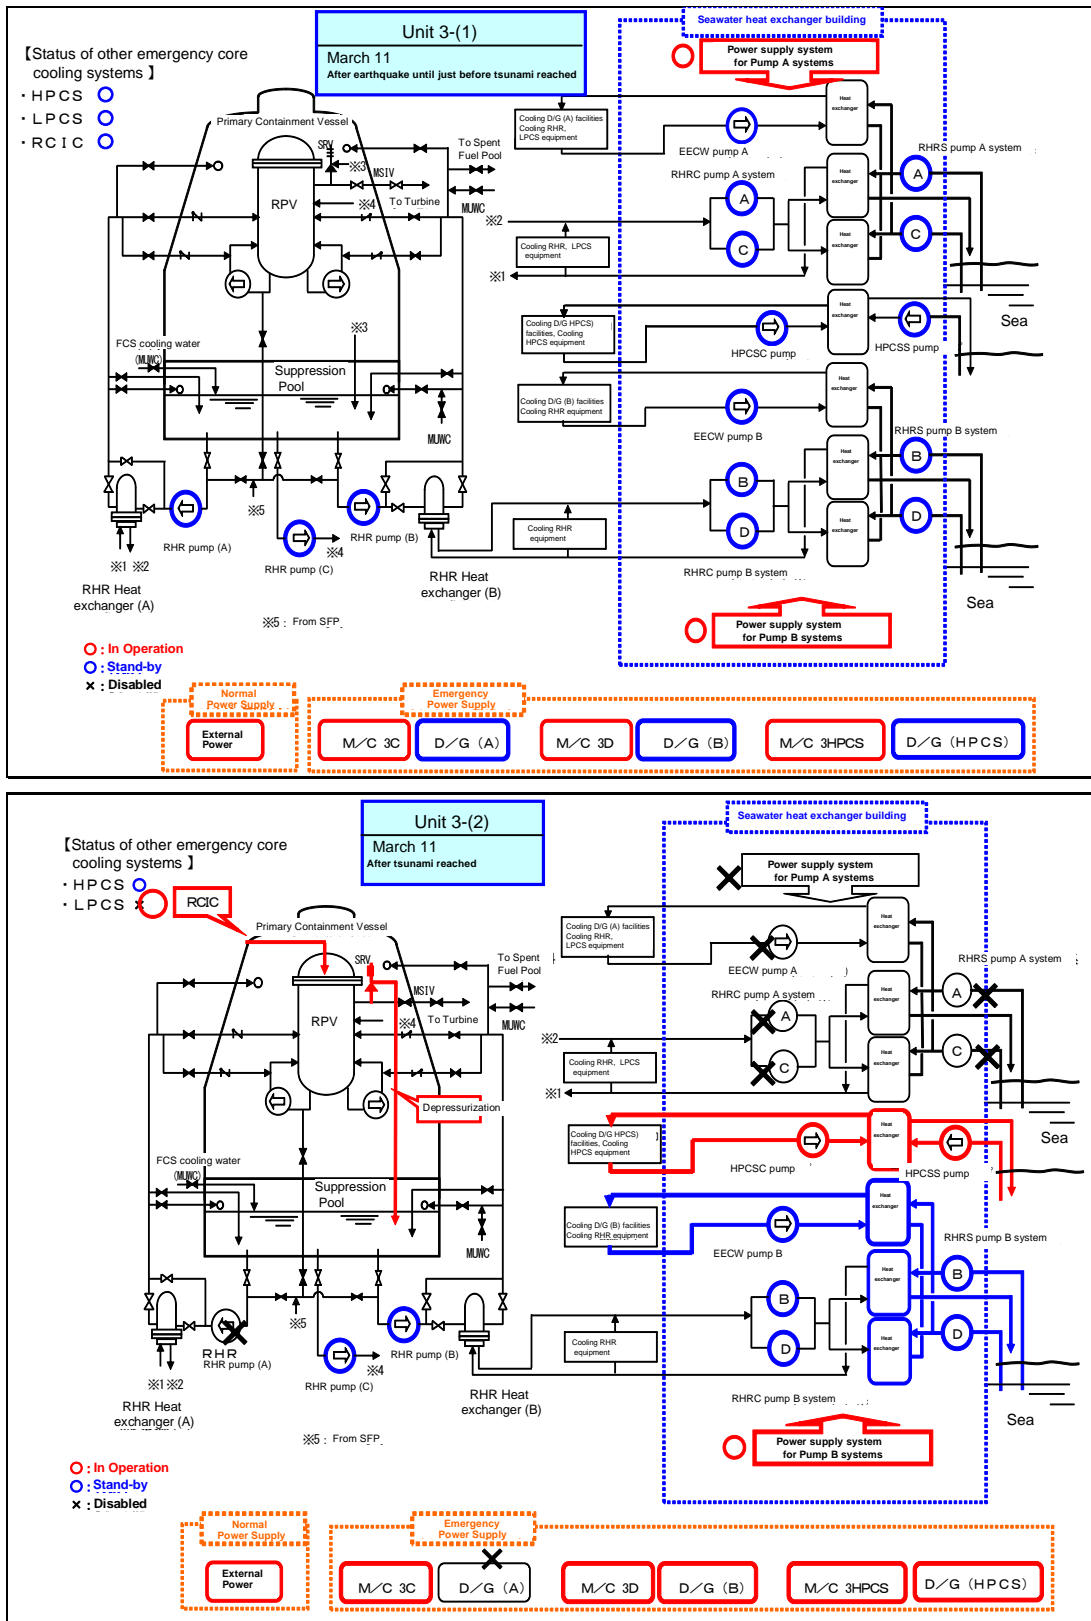
Figure II-2-117 Schematic Diagram of Station Status [2F-3] (Part 1)

Primary Containment Vessel	/	As	○	○	○	Observe no sign of damage regarding PCV pressure

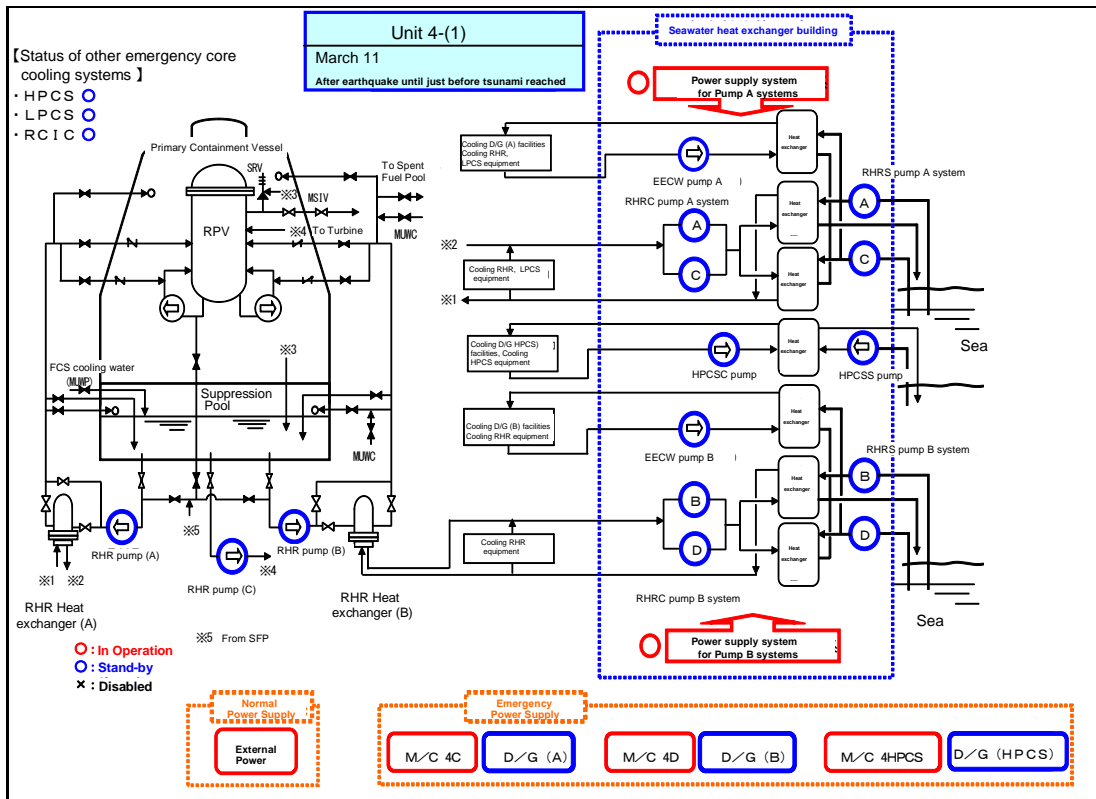
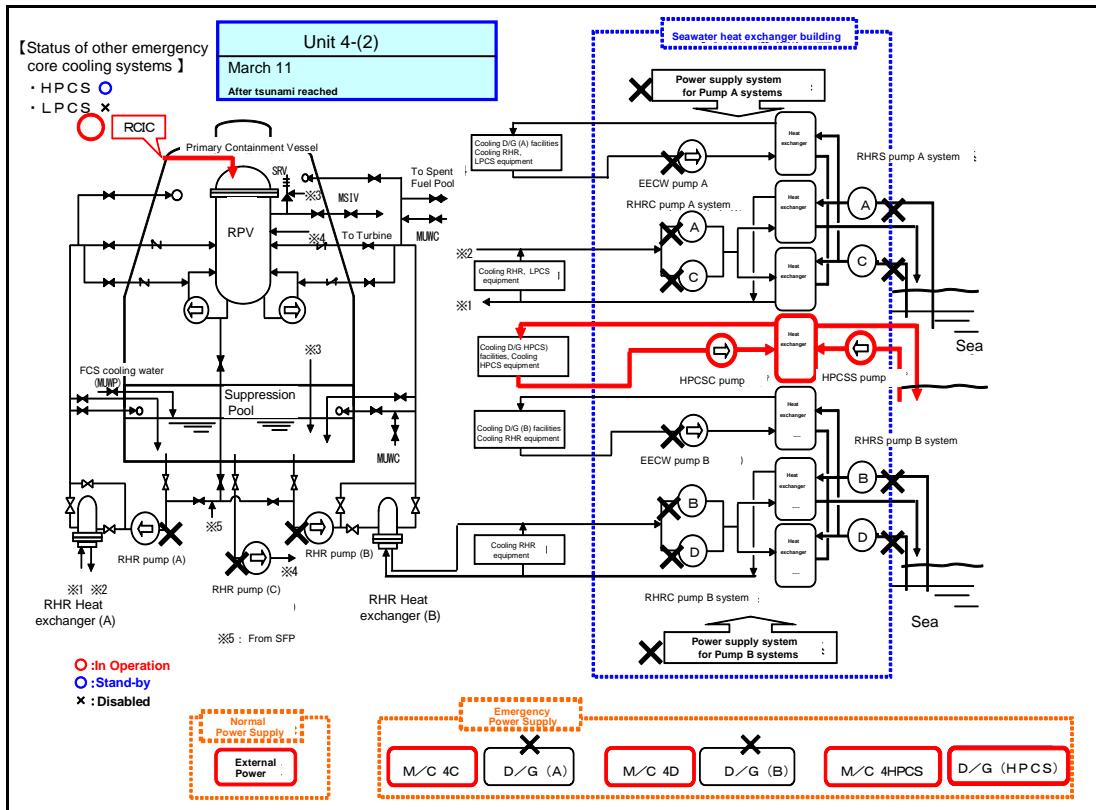
Figure II-2-122 Schematic Diagram of Station Status [2F-4] (Part 1)

Confinement Function	Containment Building	/	A	○	○	○	Maintain negative pressure and observe no sign of damage.	
	Primary Containment Vessel	/	As	○	○	○	Observe no sign of damage regarding PCV pressure

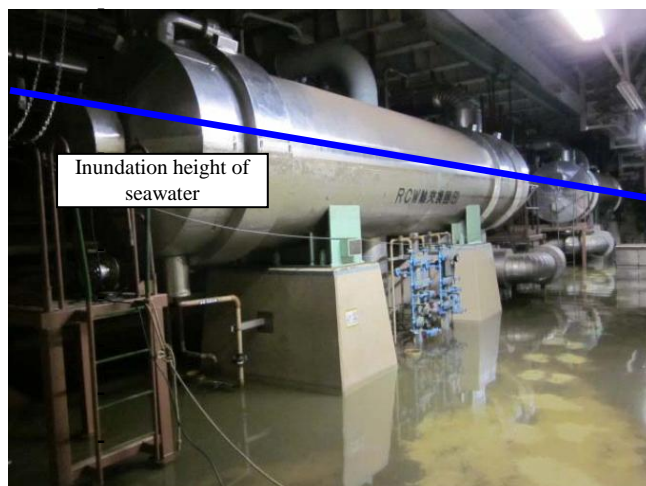
The depth of water was confirmed to have been 2.5m, based on traces found in the relevant area.

Seawater flooding in the RCW heat exchanger chamber B

Submerged pump motors and MO valve drives were disassembled, examined, repaired, and recovered.

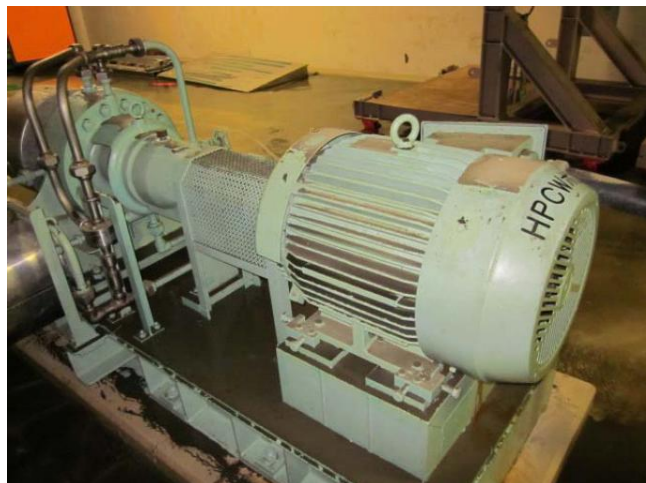
HPCW pump (after seawater was drained)

- (4) Seawater that had flown into RCW heat exchanger (B) room leaked through the watertight door to flow into HPCW heat exchanger room. (Water inflow to HPCW heat exchanger room; inundation of HPCW pump)

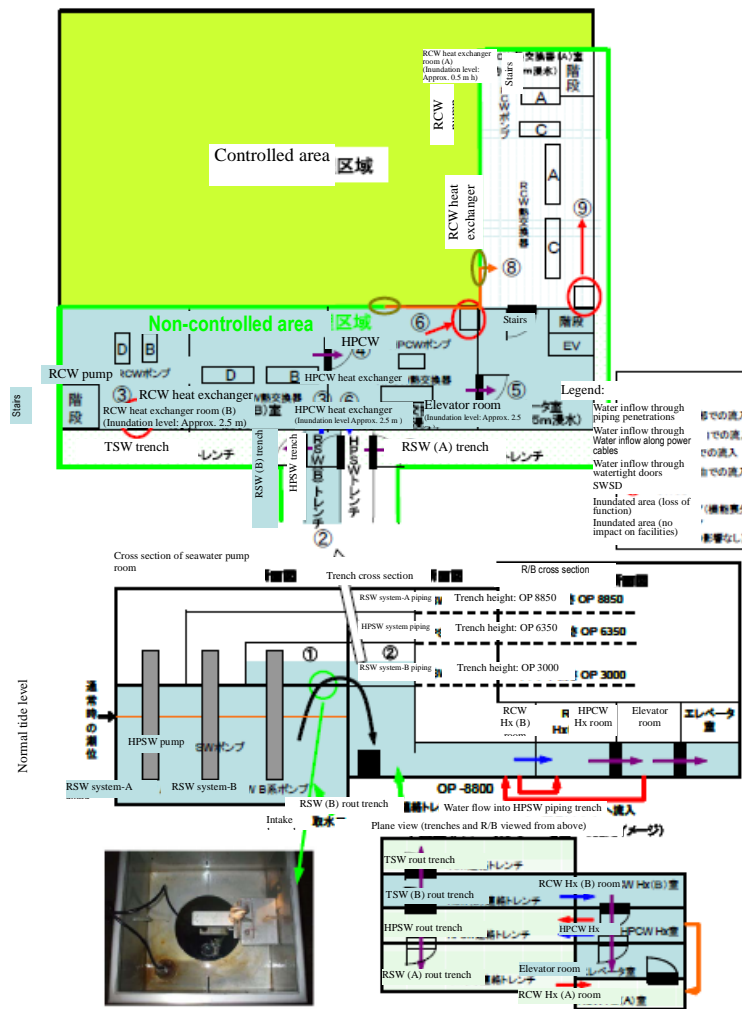
- Fig. II-2-144 Estimated mechanism of flooding

Inlet to the seawater pump room  
 - (Water gauge for automatic shutdown installed in circulation water pump room)

- (1) Due to tide rise caused by the tsunami that followed the earthquake, the container upper cover of the water gauge for automatic shutdown of the circulation water pump, which was installed on the floor of RSW pump (B) area in the seawater pump room, opened to allow seawater to overflow into RSW pump (B) area. (床面設置のメーターに流入)

- (5) Seawater that had flown into HPCW heat exchanger room leaked through the watertight door to flood the elevator area. (Inundation of the elevator area)

- (6) Seawater that had flown into HPCW heat exchanger room leaked through the watertight door to flow into HPSW piping trench through the seawater storm drain transfer-system sump. (Water inflow to HPSW piping trench)

- (7) Seawater that had flown into HPSW piping trench leaked through the watertight door to flow into RSW (A) piping trench. (Water inflow to RSW (A) piping trench)

- Repair work has been undertaken on penetrations for pipes and cable trays from the seawater pump room to the trench.
- In the future, the water-tightness of building doors will be improved and tide embankments/barriers will be constructed.
