II. Further developments of the nuclear accident since that time

1. The Tohoku District-Off the Pacific Ocean Earthquake and the resulting tsunamis

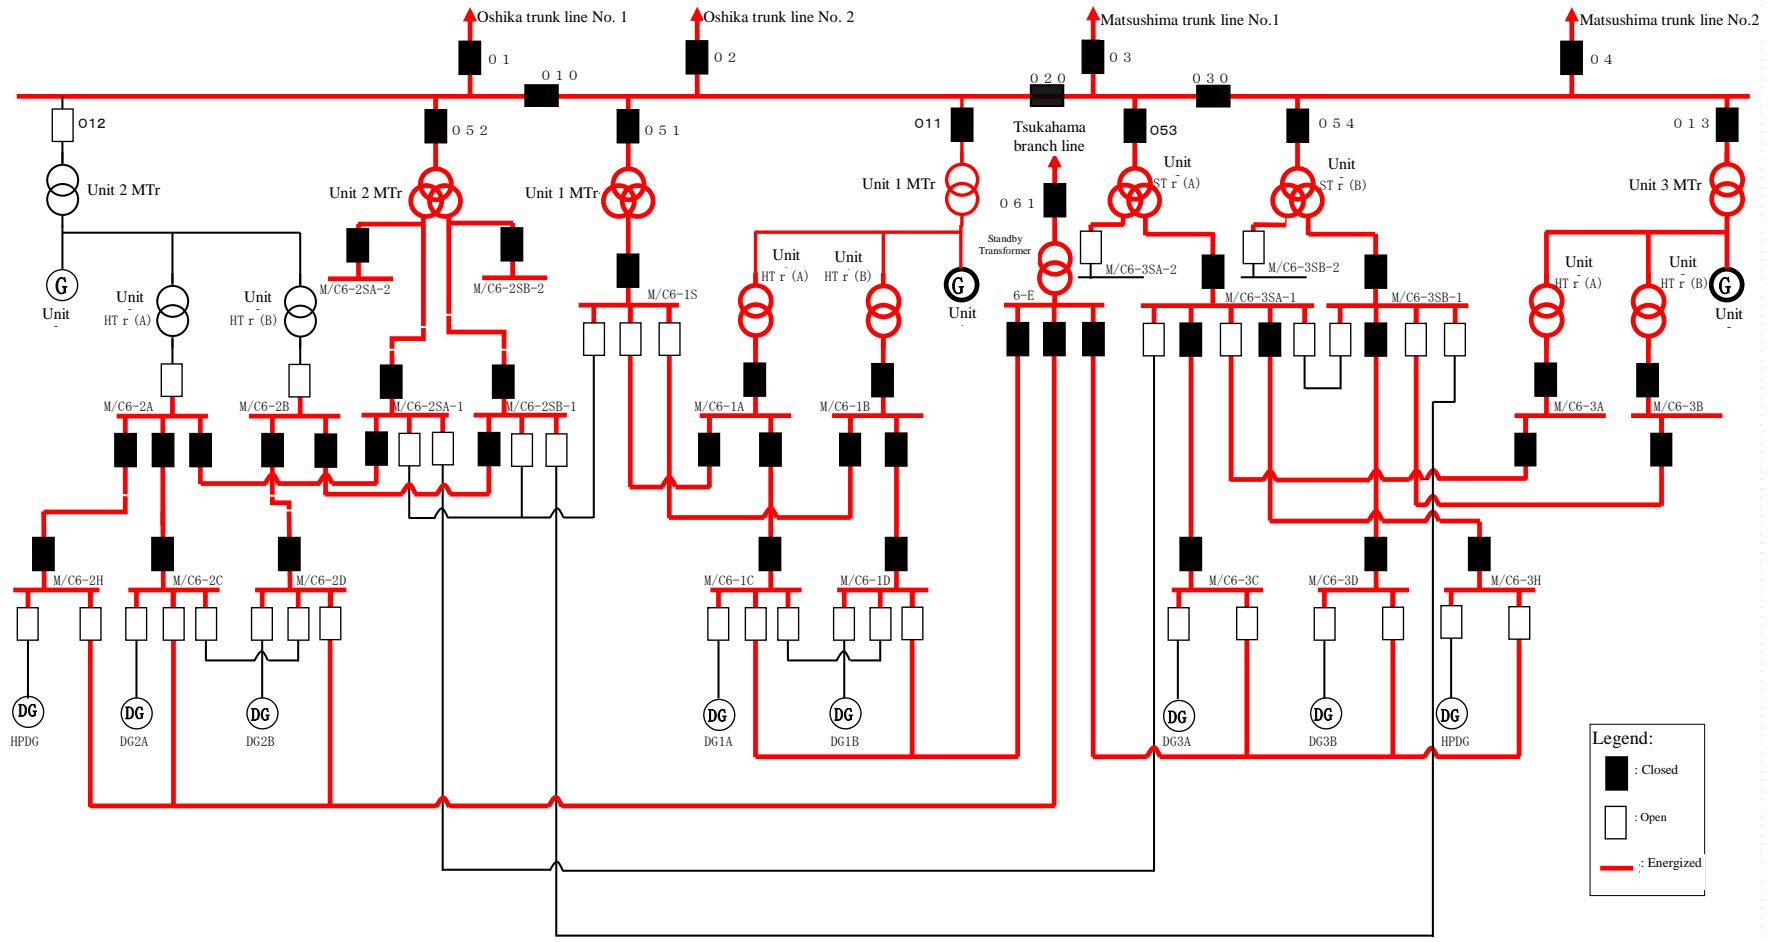
Fig. II-2-146 Power source system before and after the earthquake (before the quake)

After the earthquake, the external power supply was secured. After that, an earth fault/short-circuit in the regular high-voltage metal-clad switchgear (M/C) 6-1A occurred due to the earthquake, causing the start-up transformer to stop. Consequently, the power supply in the station failed instantaneously, but an emergency power supply was immediately secured by emergency DGs.

Due to the fire in the high-voltage power panel on normal system caused by the earthquake, the power supply to the emergency power unit from an external source became unavailable, and an emergency power supply was made via emergency DGs. Details of this incident are as described below.

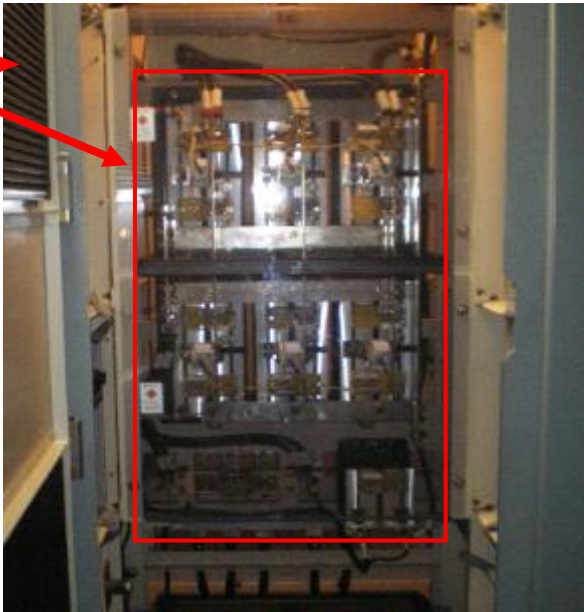
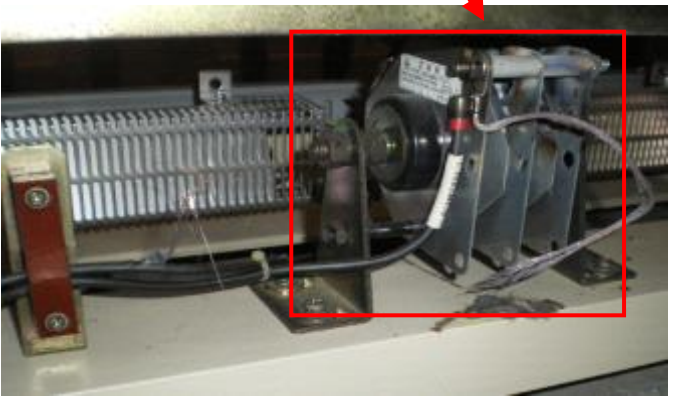
Fig. II-2-151 Onagawa Nuclear Power Station Unit 1 Damage to the DG (A) field circuit components

Figure II-2-151 shows damages of parts of the emergency DG (A) field circuit.

Rectifier

Varistor

\* 2 out of 12 diodes (6 pairs) short-circuited.

- i. In order to prevent fire, the high-voltage power panel 6-1A of the normal system in which fire broke out will be replaced with one using horizontal-type vacuum circuit breakers having a stronger anti-seismic structure.
- ii. The varistor and the rectifier with which abnormalities had been found were replaced on April 28. In addition, those emergency DG (A) and synchronoscope circuits with which ground faults had been found were isolated.

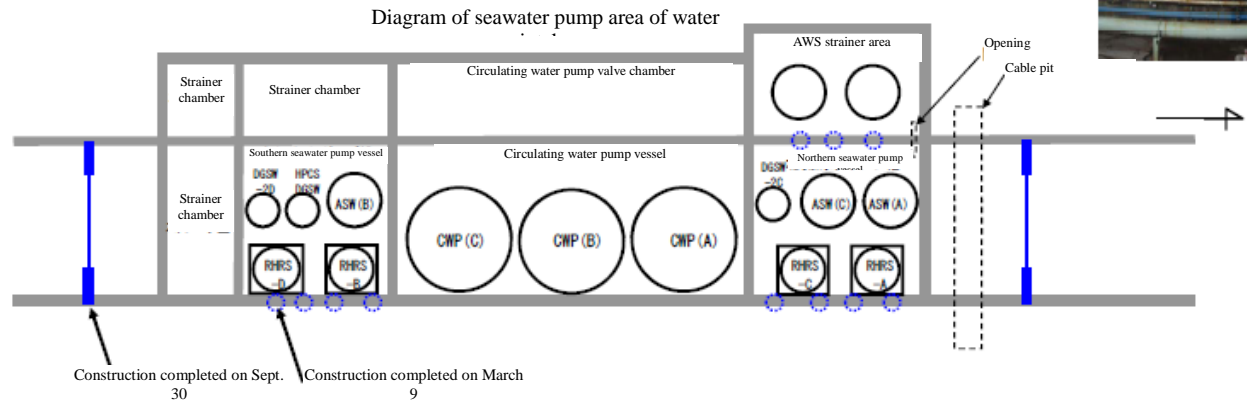
Fig. II-2-172 Status of Construction at Seawater Pump Area for Anti-tsunami Measures When Earthquake Occurred (March 11)

② Filling of piping penetration portions

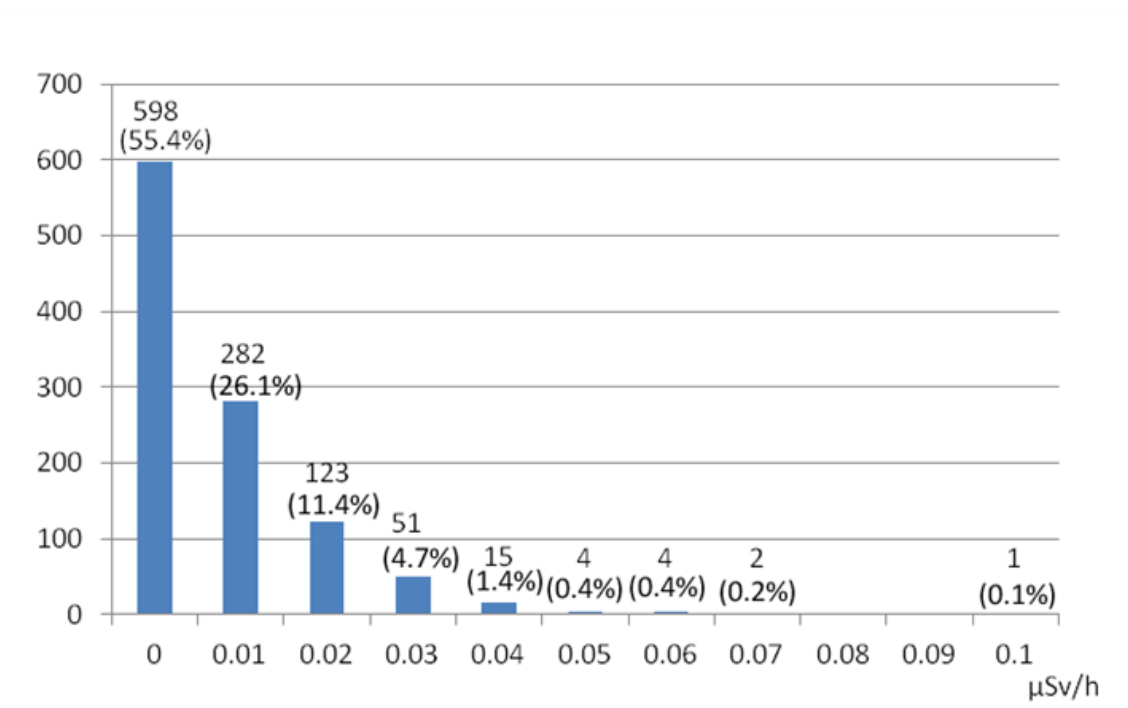
Figure 5-1 The result of Simplified survey for thyroid internal exposure of Fukushima children
