***Dominion  
North Anna Power Station  
Restart Readiness***

***October 21, 2011 Briefing***

# ***Dominion Assessment***

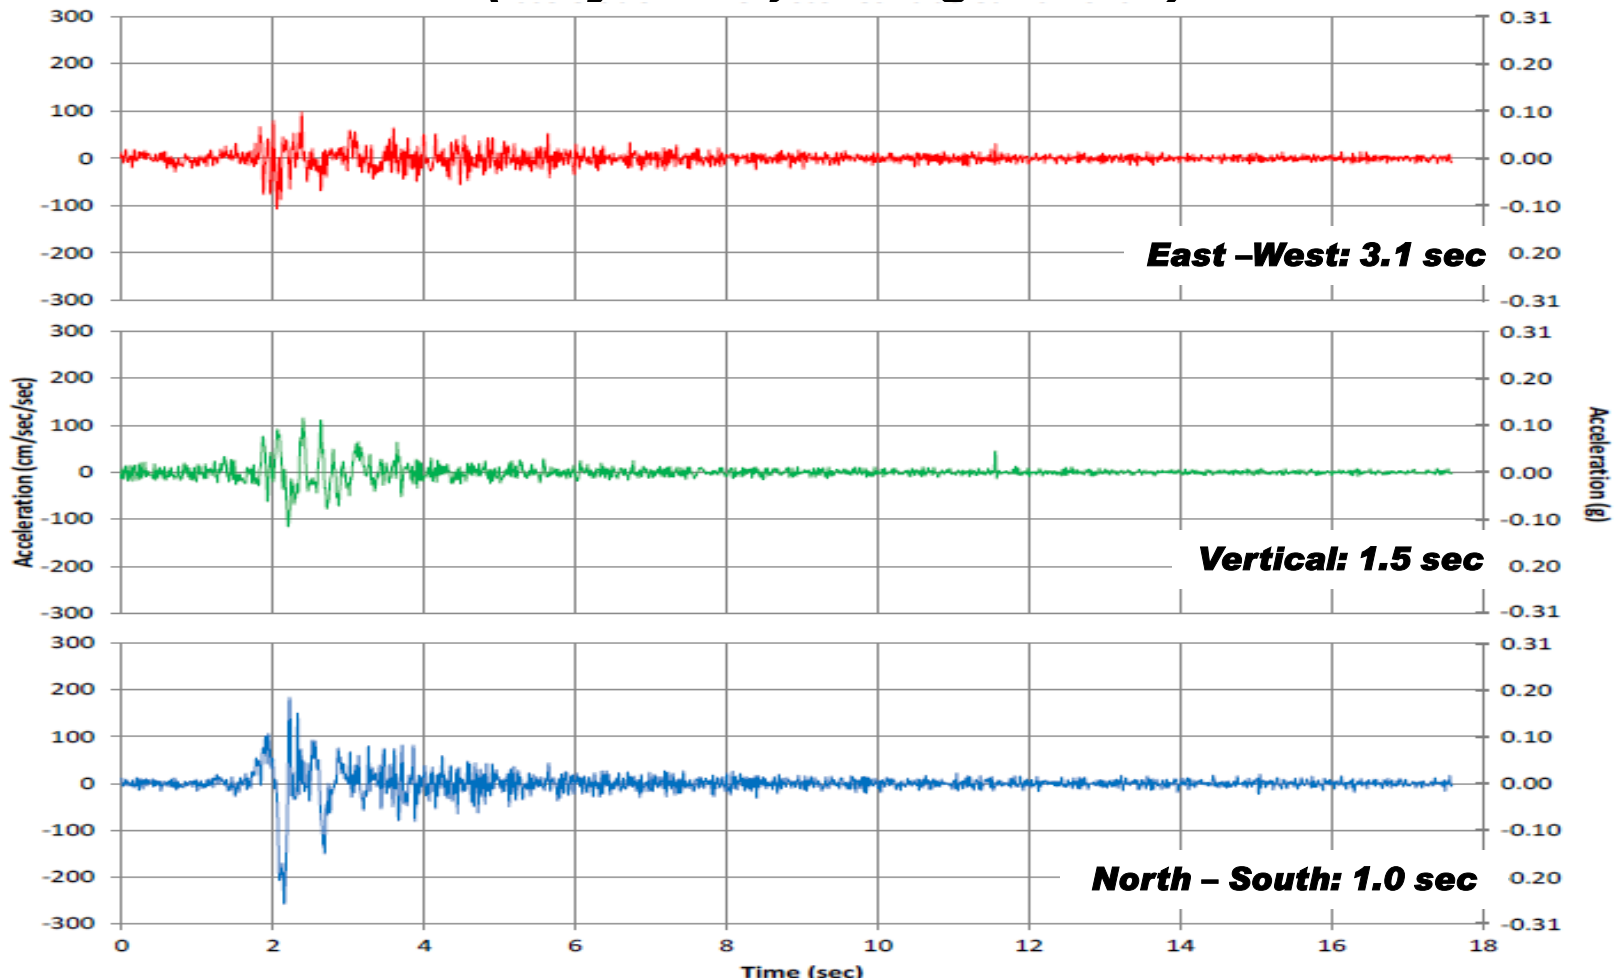
***Containment Basemat (elevation 216')***

***(very short, strong motion)***

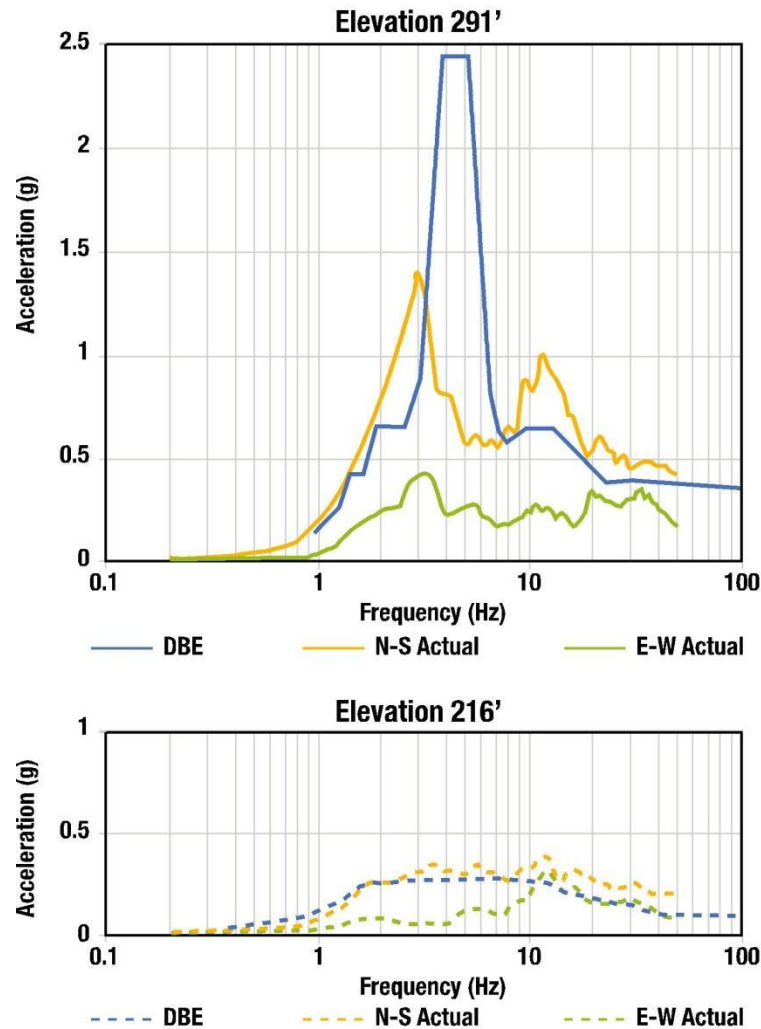
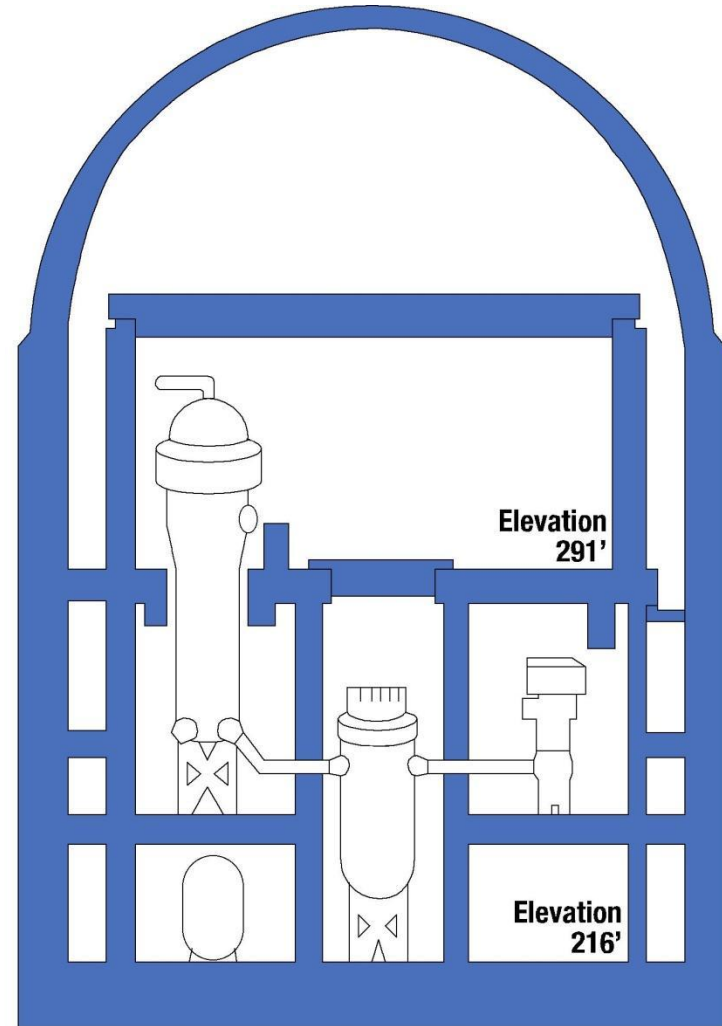
Horizontal Response Spectra vs. DBE @ Basemat & Elevation 291'

# Conservatism In Modeling Structures

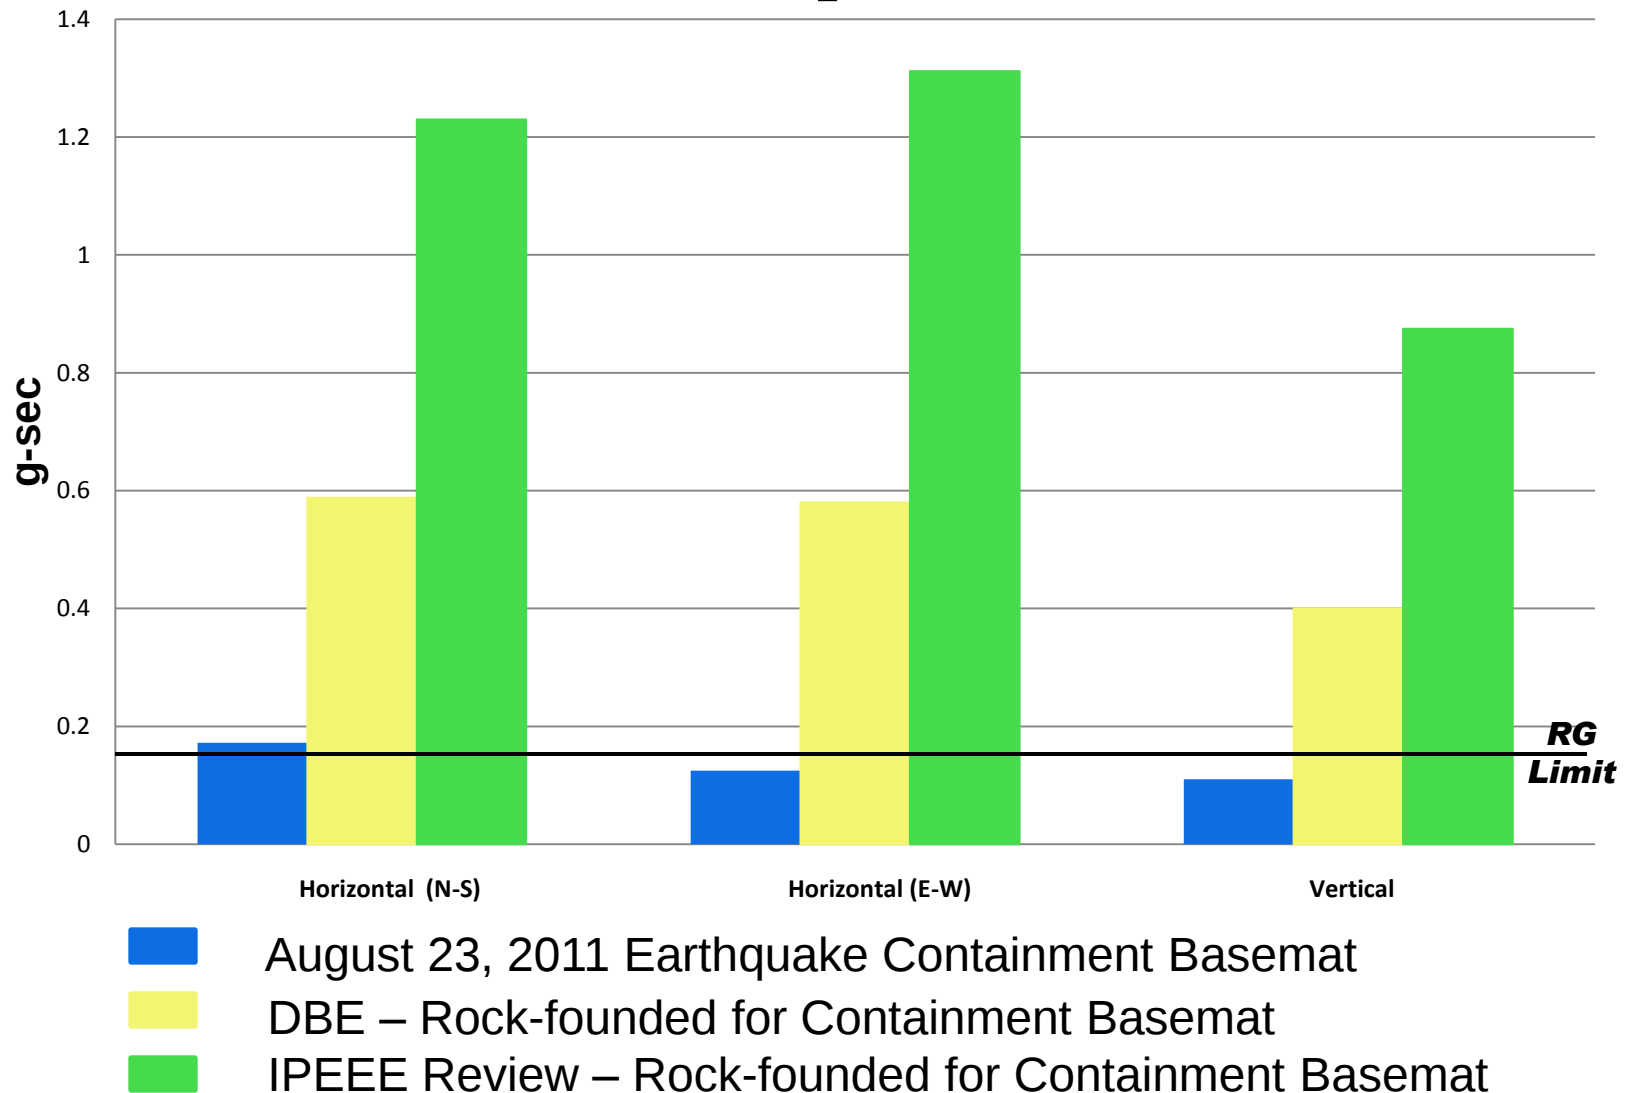
# CAV Comparisons

| <b>Seismic Case</b> | <b>CAV<br/>North – South Direction<br/>(g-sec)</b> | <b>CAV<br/>East – West Direction<br/>(g-sec)</b> | <b>CAV<br/>Vertical Direction<br/>(g-sec)</b> |
|---|---|---|---|
| <b>August 23, 2011 Seismic Event</b><br>(data from containment basemat) | <b>0.172</b> | <b>0.125</b> | <b>0.110</b> |
| <b>Design Base Earthquake</b><br>(rock-founded; synthetic time-history used for containment structure) | <b>0.588</b> | <b>0.580</b> | <b>0.400</b> |
| <b>IPEEE Review Earthquake</b><br>(rock-founded; synthetic time-history used for containment structure) | <b>1.230</b> | <b>1.312</b> | <b>0.875</b> |
| <b>OBE exceedance criterion is CAV &gt; 0.16 g-sec (EPRI TR – 100082 &amp; RG 1.166 )</b> | | | |

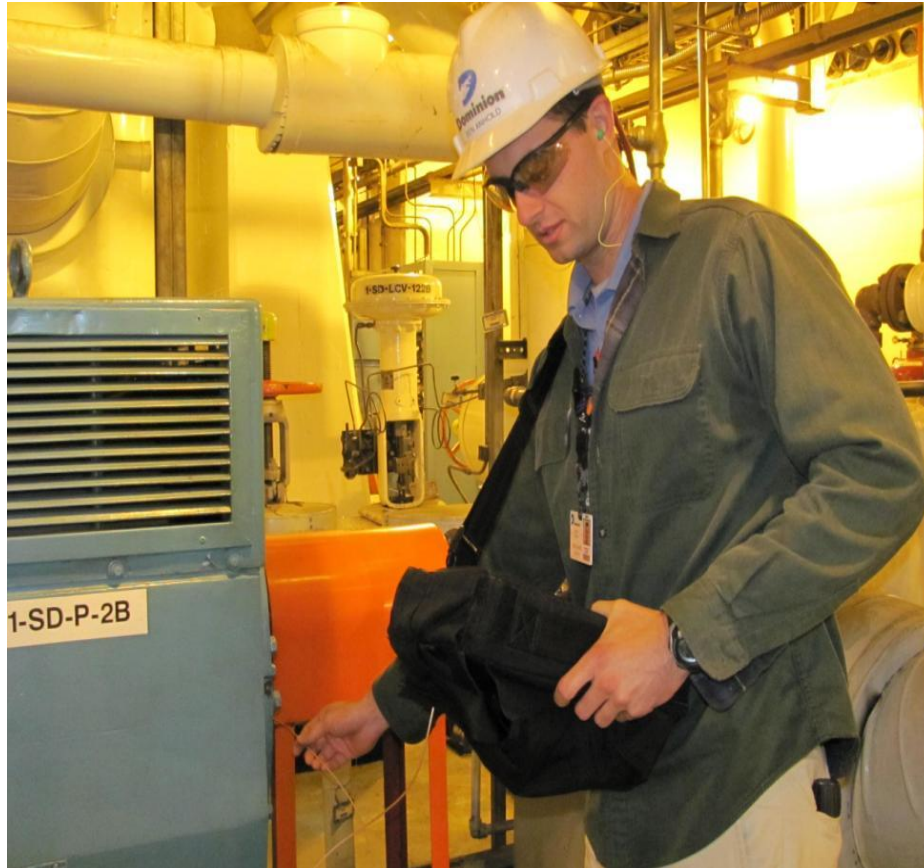
# ***Pump In-service Test & Verification***

Pump verification included assessing:

- Motor current
- Pump / motor vibration
- Pump flow
- Pump discharge pressure
- Oil analysis
- Bearing temps

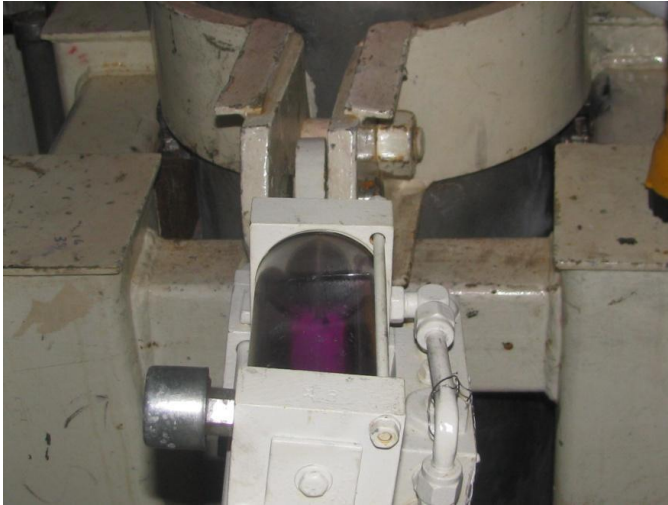
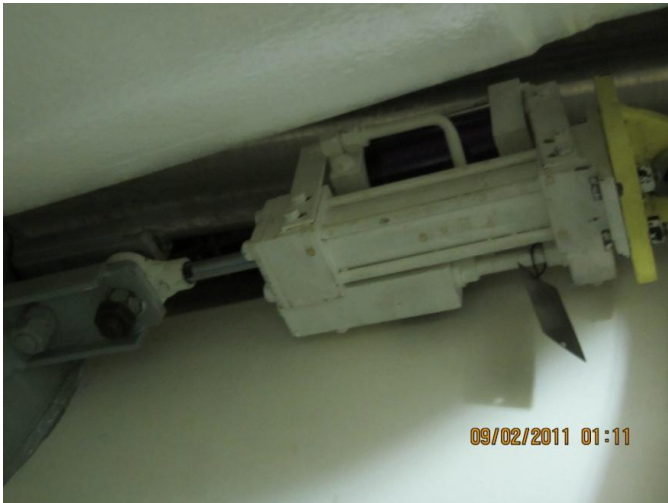
# ***Snubber Testing***

## Visual Inspections:

- 326 small bore Unit 1
- 362 small bore Unit 2
- 12 large bore per unit

## Unit 1 Functional Testing:

- 4 tested due to visual – satisfactory
- 12 additional small bore
- 2 large bore

## Unit 2 Functional Testing:

- 5 tested due to visual – satisfactory
- 61 small bore for outage
- 2 large bore for outage
