## Site Photographs of Fukushima Daini Nuclear Power Station

Since the occurrence of Tohoku-Chihou-Taiheiyou-0ki Earthquake we have disclosed site photographs mainly of Fukushima Daiichi Nuclear Power Station. These are photographs of Fukushima Daini Nuclear Power Station as the reference material of "The impact of Tohoku-Chihou Taiheiyo-0ki Earthquake to Nuclear Reactor Facilities at Fukushima Daini Nuclear Power Station" released on August 12.

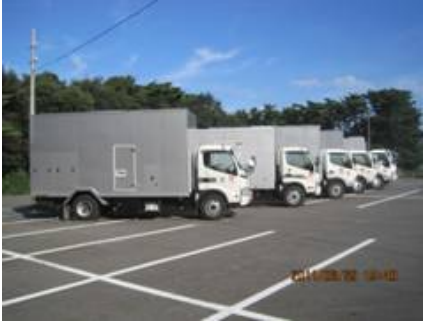
Situation after the disaster	Current situation
29 . Safety measures in case of emergency (Arrangement poewr supply vehicle)

Date            2011/8/29 Location       Near the observation deck of the plant Photo by       TEPCO Staff
29 . Safety measures in case of emergency (Arrangement of Fire engines)

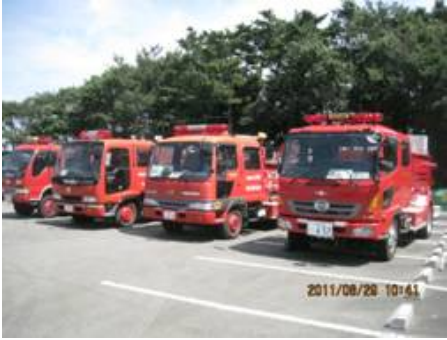
Date            2011/8/29 Location       Near the observation deck of the plant Photo by       TEPCO Staff
29 . Safety measures in case of emergency (Installement of banking)

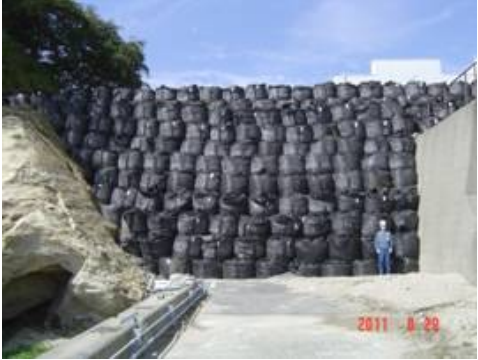
Date            2011/8/29 Location       Access road on the south of power plant Photo by       TEPCO Staff
