# Fukushima Spent Fuel Pond Failure Analysis

by W.Christoph Müller

Revision 3, 27.Oct. 2011

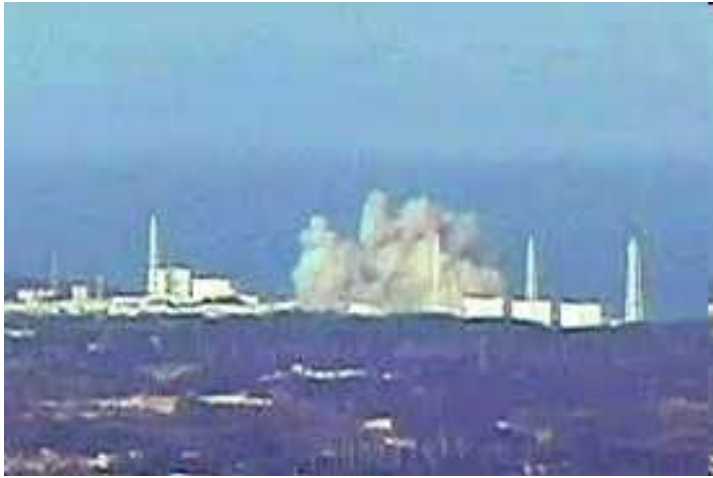
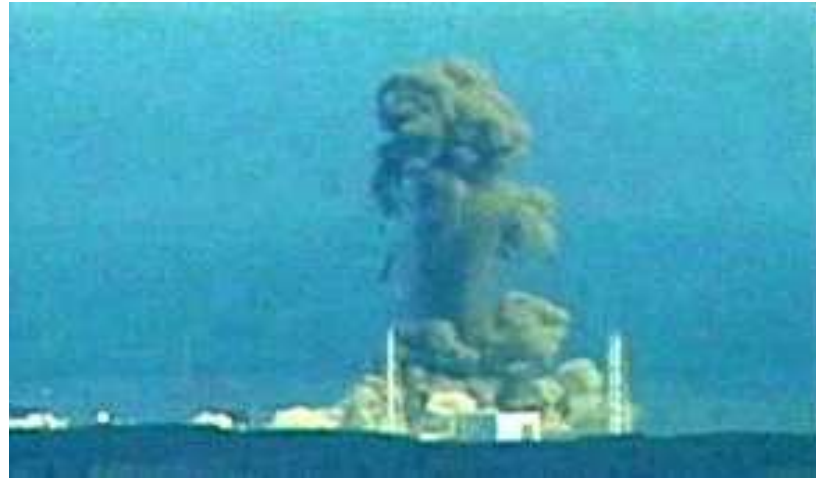
**Block 3 experienced a severe hydrogen detonation which was captured by the surveillance camera. It shows all signs a destruction by shock wave. It was converted into typical debris with the concrete and the reinforcement steel bar fully demolished**

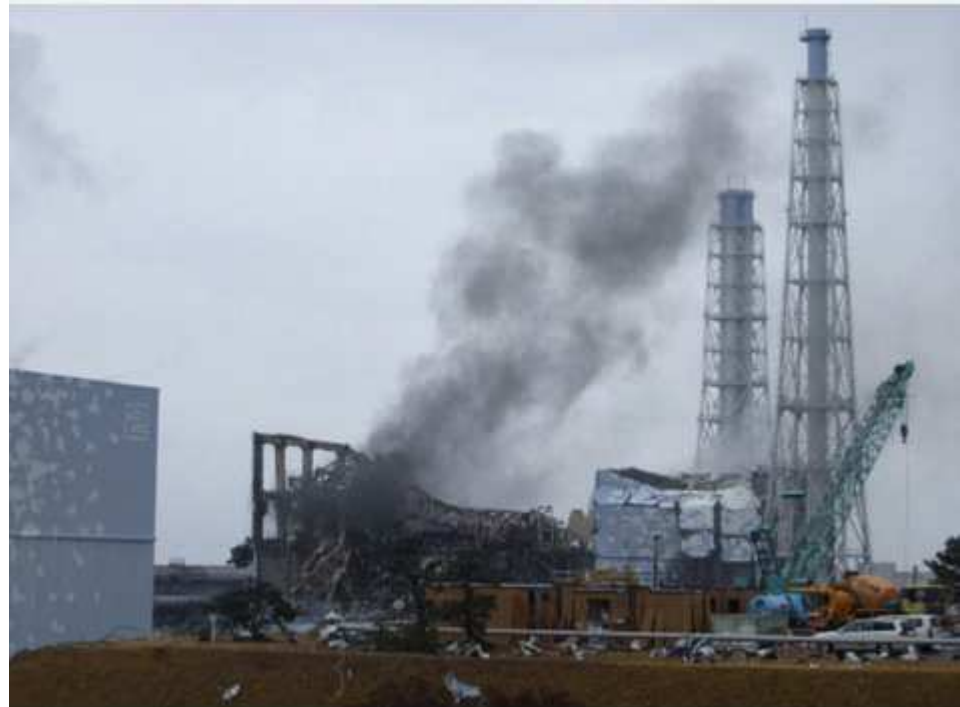
**Even the strong beam structure has collapsed and the heavy beams were relocated as can be seen in the picture. (red arrow). The plates were destroyed to debris and rubble while the beam structure of the roof fell back into the building.**

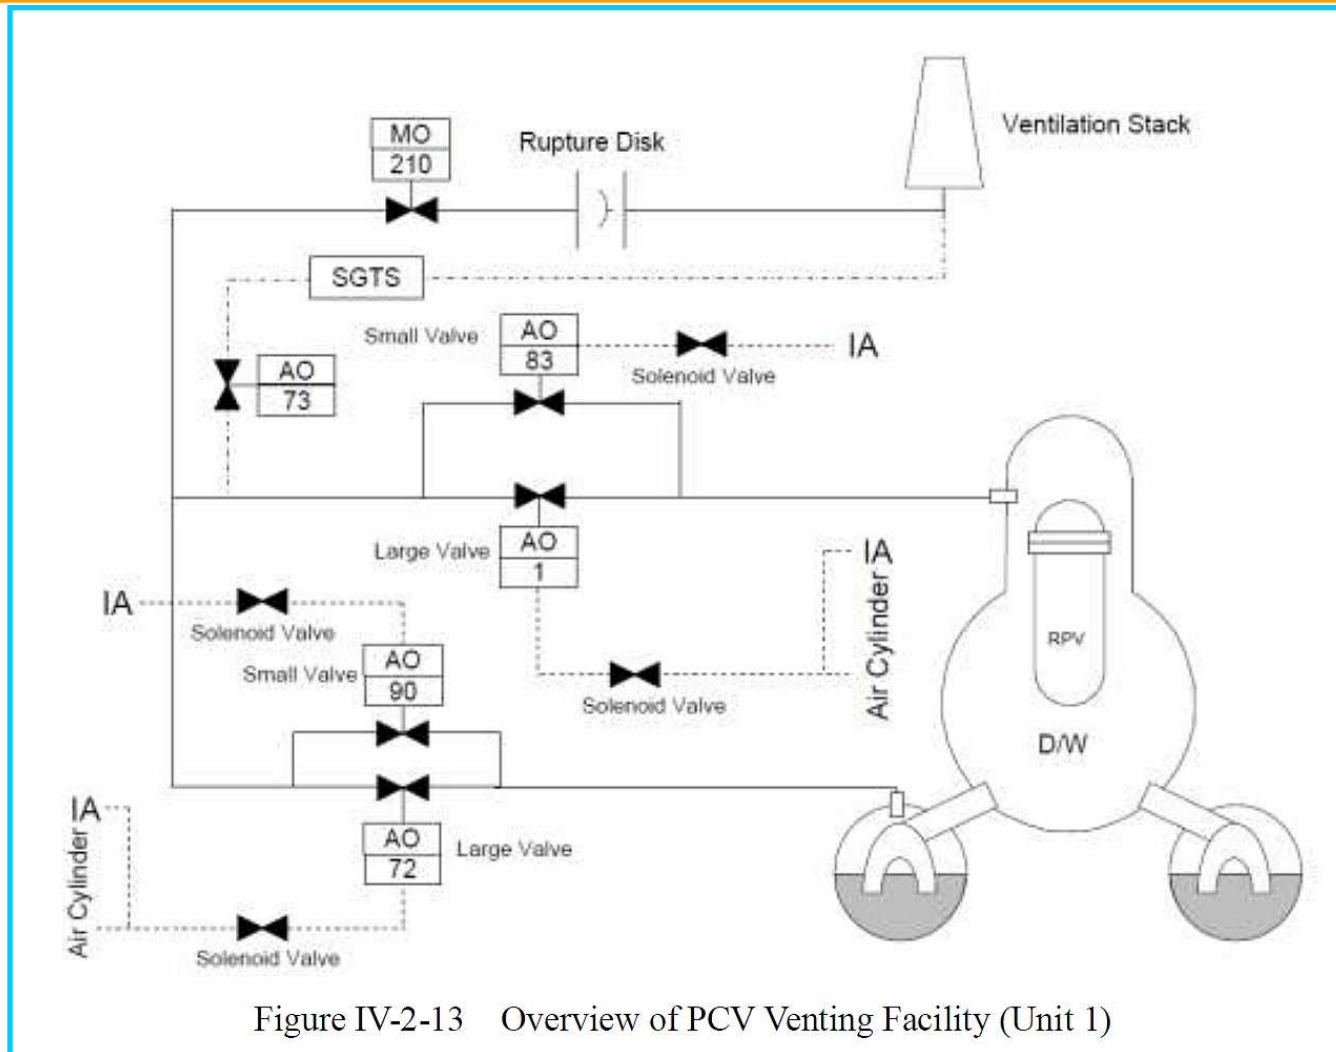
Figure IV-2-13 Overview of PCV Venting Facility (Unit 1)

The figure from the IAEA report shows the schematics which are the same for all three units. After opening the AO valves the overpressure is discharge by a direct line closed by a motor valve and a rupture disk. There is an additional flow path using part of the SGTS (stand-by gas treatment system) which is an operational system to keep the pressure inside the reactor building below atmospheric pressure.

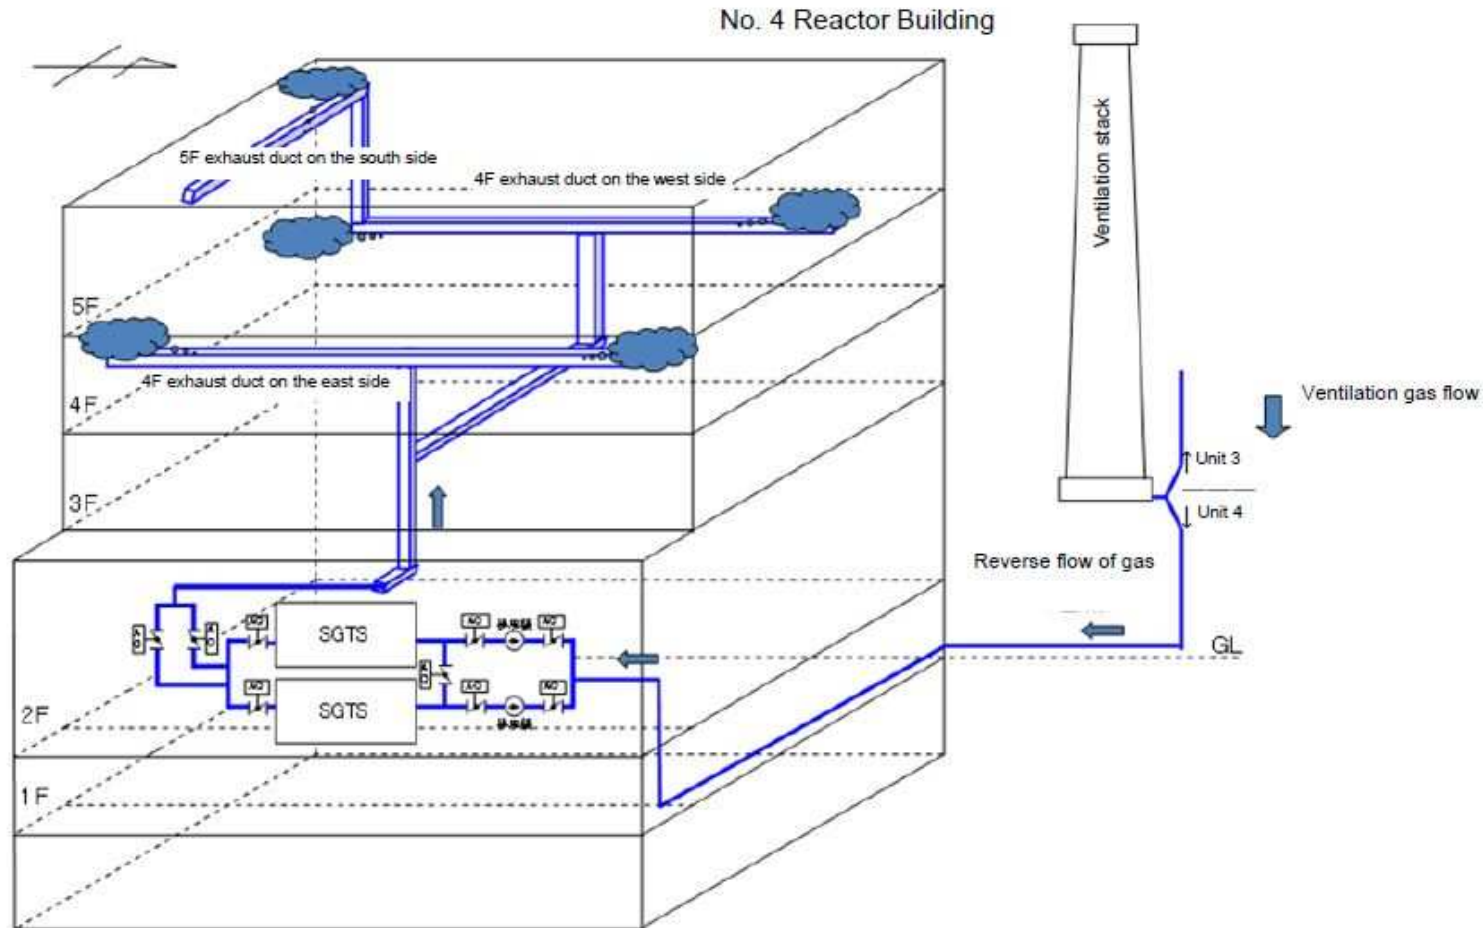
Fig. IV-5-10 Hydrogen flow route from Unit 3 to Unit 4 (estimated)

The report does not explain, why the gas did not take the short way out, but went around the corner into the next block and in spite of the flow resistance of the lines, valves, pumps and filters went all the way up the 5. floor.

One would expect that the gas flow from block 3 would go right up the stack, unless this way was blocked.

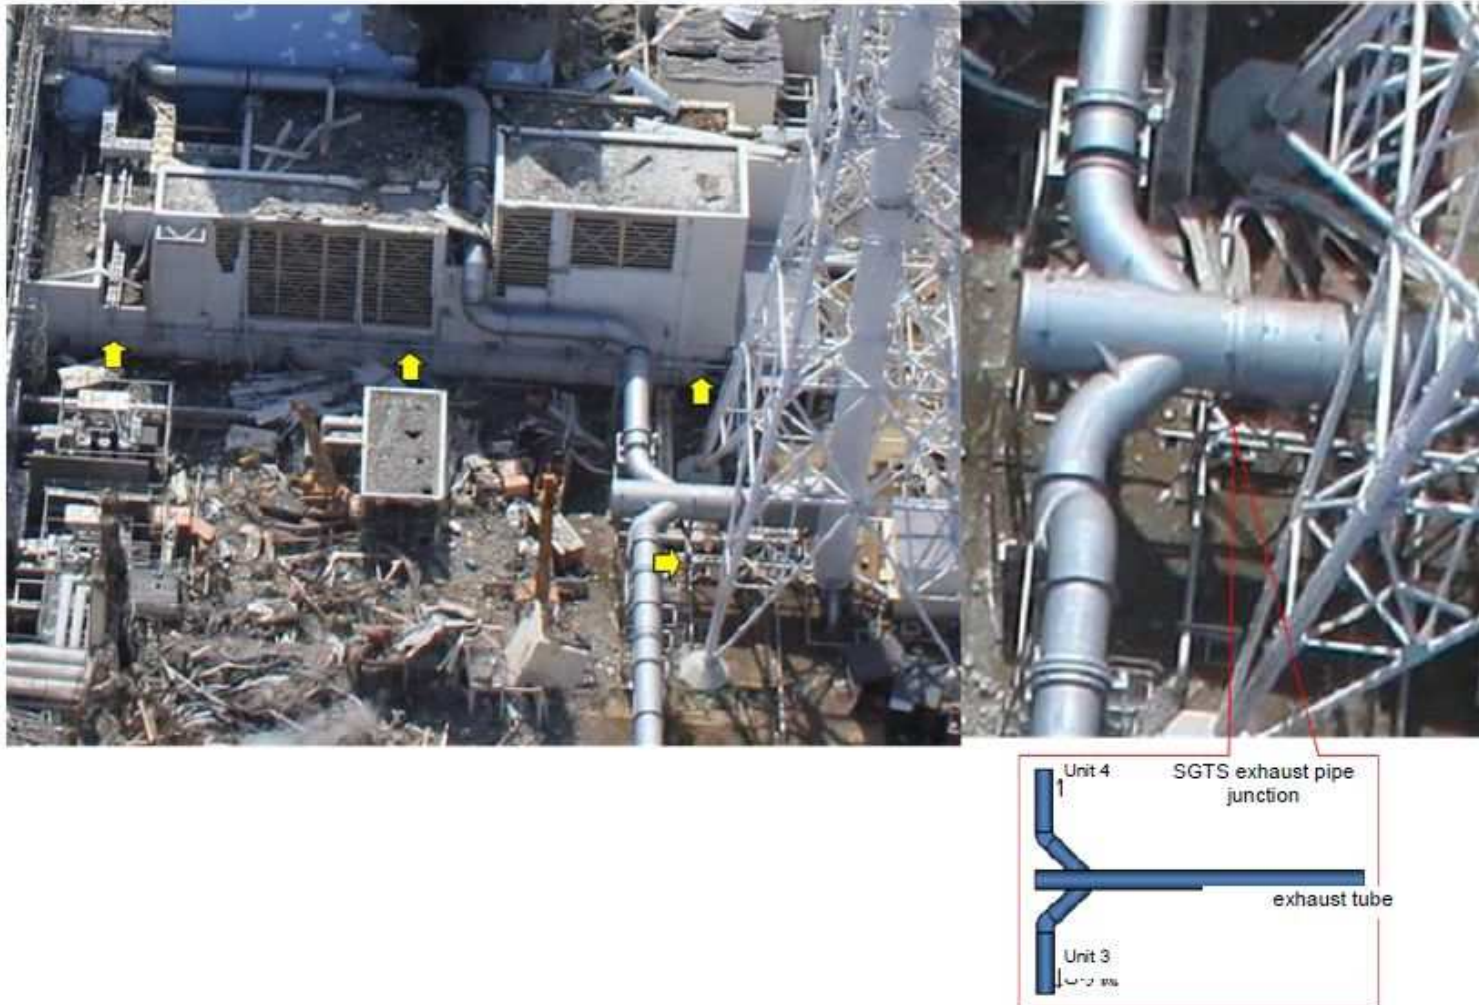
Fig. IV-5-11 Standby Gas Treatment System exhaust pipe

This figure show the exhaust pipe junction, by which the standby gas treatment system of unit 3 and unit 4 are connected.

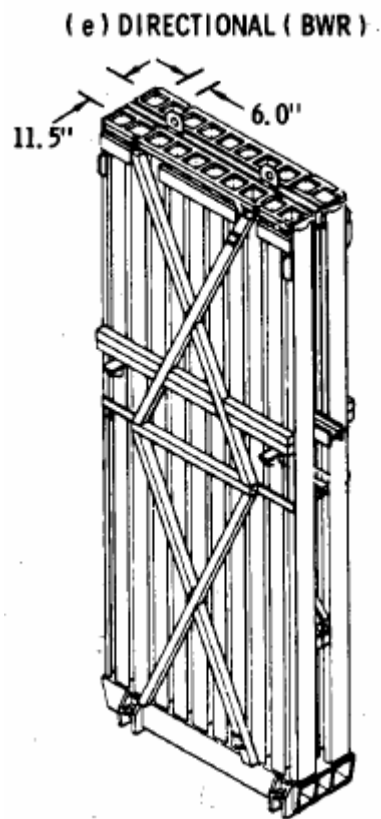
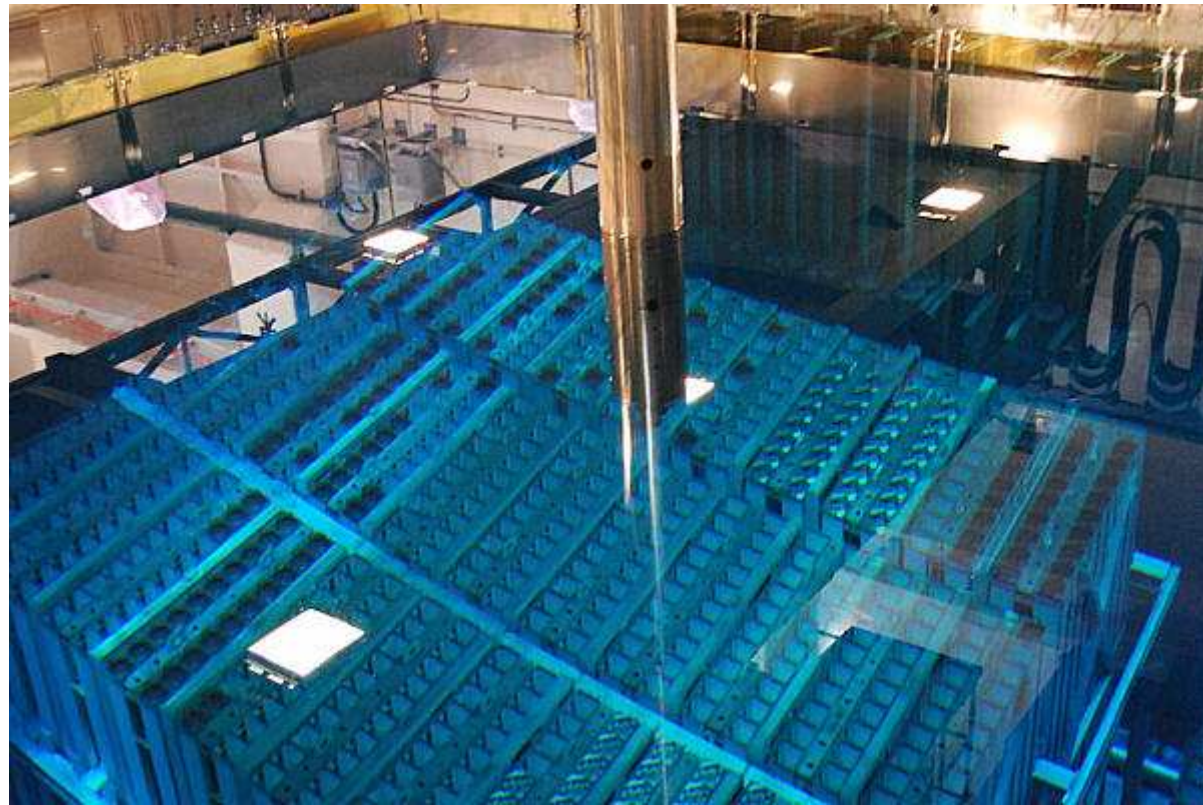
**The picture shows a Fukushima SFP. The fuel elements are stored in the typical BWR storage racks. Each element is placed in a square pipe with about 50 cm of free space below giving easy access for the cooling water.**

**In case of boiling, cooling water can enter the rack from the bottom and the top. With only little water on top counter current flow limitation will stop the top flooding.**

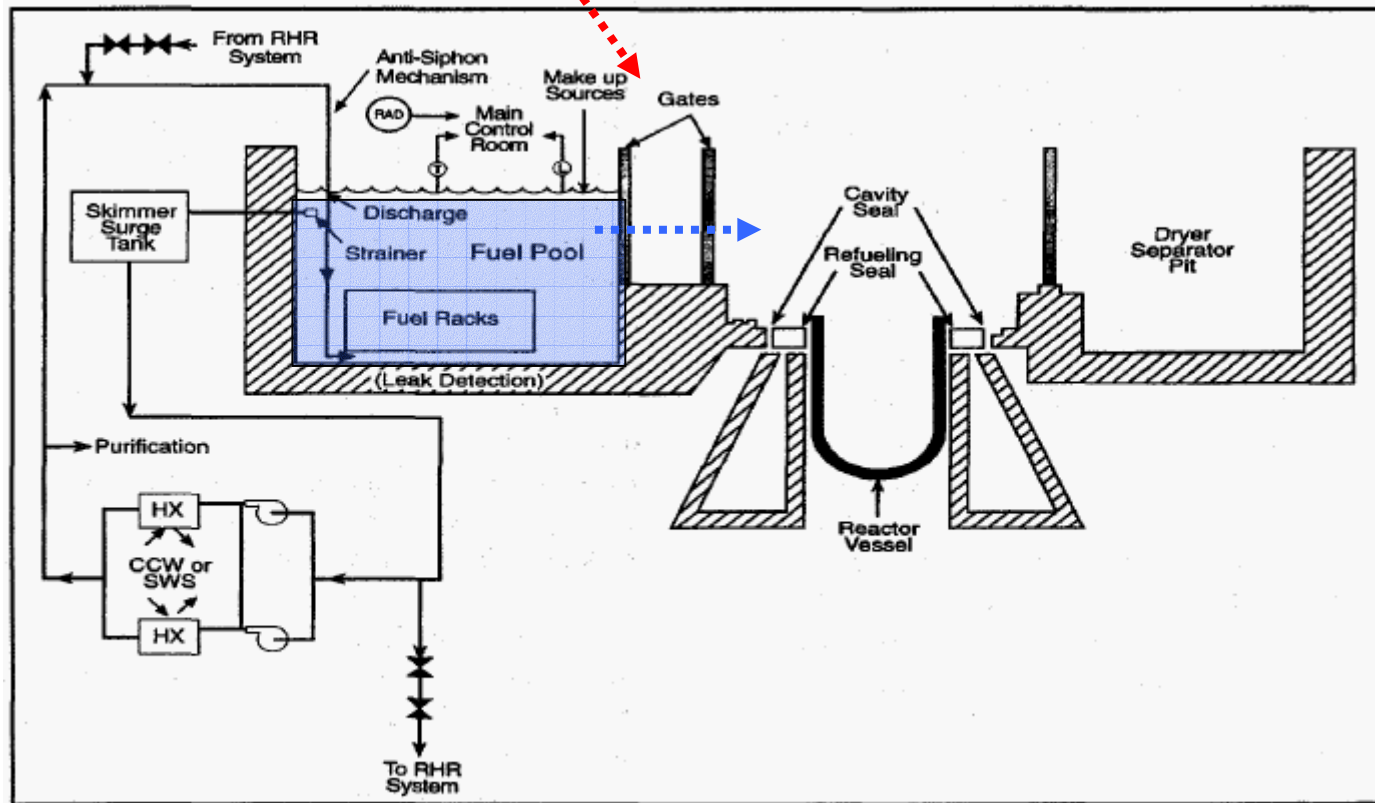
Figure 2.2 BWR Spent Fuel Cooling Systems

A possible source of the leak could be the seals around the gates on one side of the SFP. They are located between the pool and the area above the reactor vessel (reactor pit). When fuel is moved between the pool and vessel, the reactor pit is filled with water, the gates are opened, and the fuel can be moved to or from the reactor core while remaining under water.

The closed gates are made watertight by an inflatable seal, similar to a bicycle innertube. Electric compressors are used to keep these tubes inflated to replace leakage of air.

In case of station blackout they will lose the air sooner or later and water will leak from the SFP to the reactor pit and back.

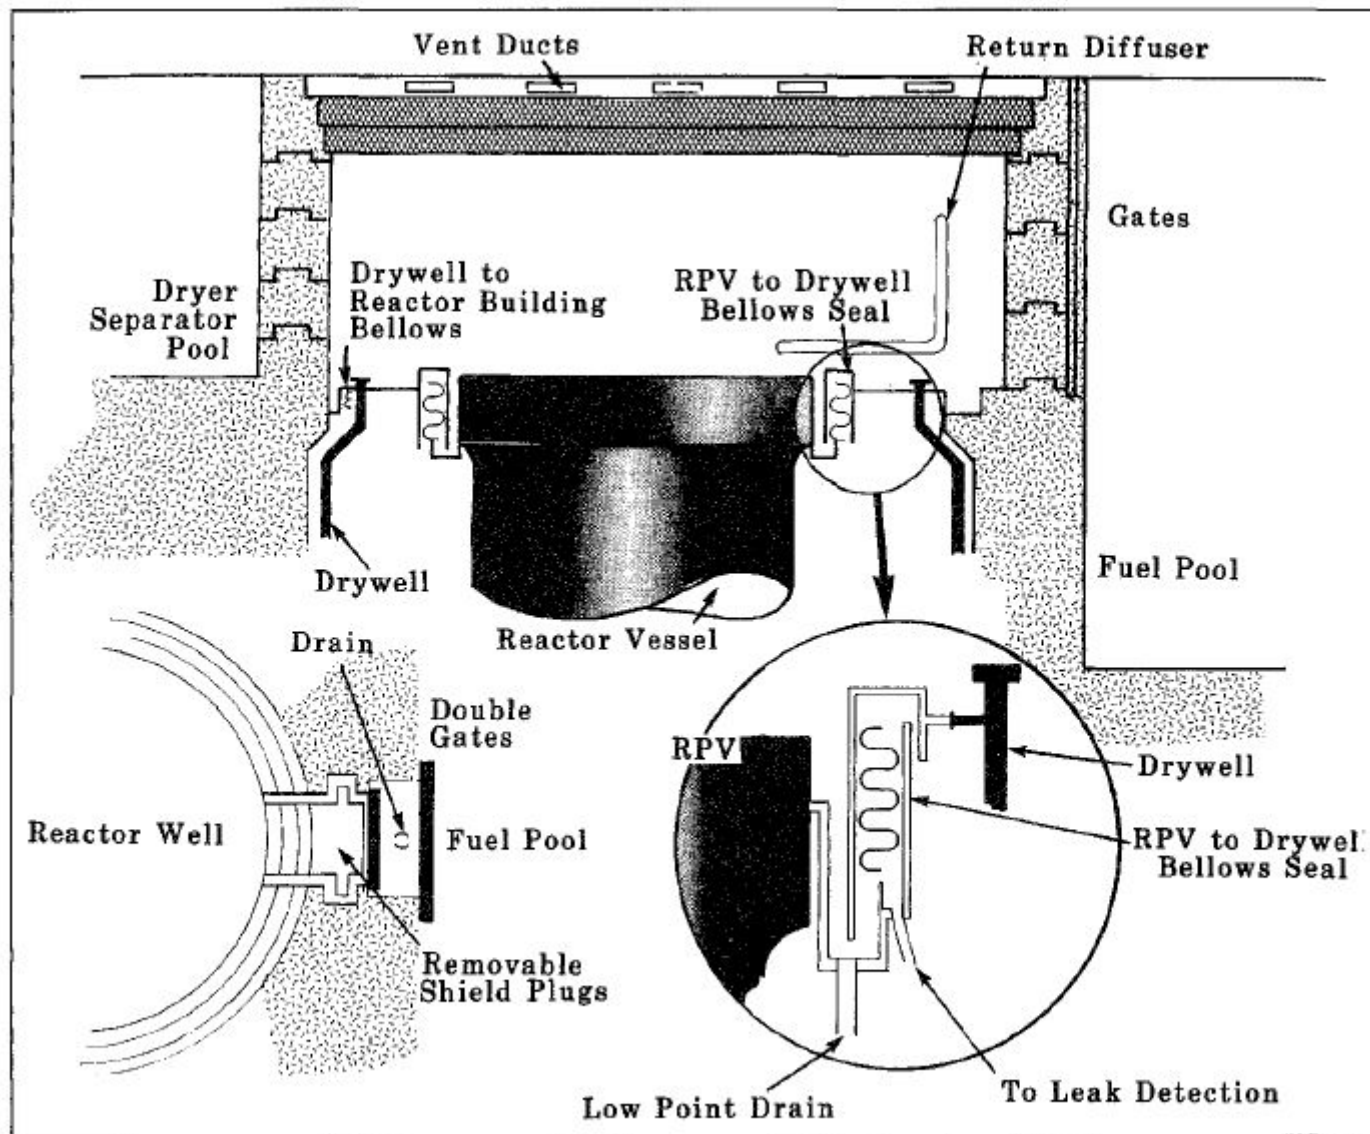
**Figure 8-1** Reactor Well Seals

As can be seen from the next figure, the designer have taken this safety issue into account and designed the adjacent pits in such a way that the water does not leak below the top of the fuel elements. So the cooling water is not lost, it is only distributed in a different way. If the SFP level is going down the cooling water will flow back into the SFP and be available for the cooling process.

In order to loose cooling water we have to hypothesize a second leak in the reactor pit. This is only feasible by a leak from the reactor pit to the drywell. This path is closed by bellows which look failsafe.

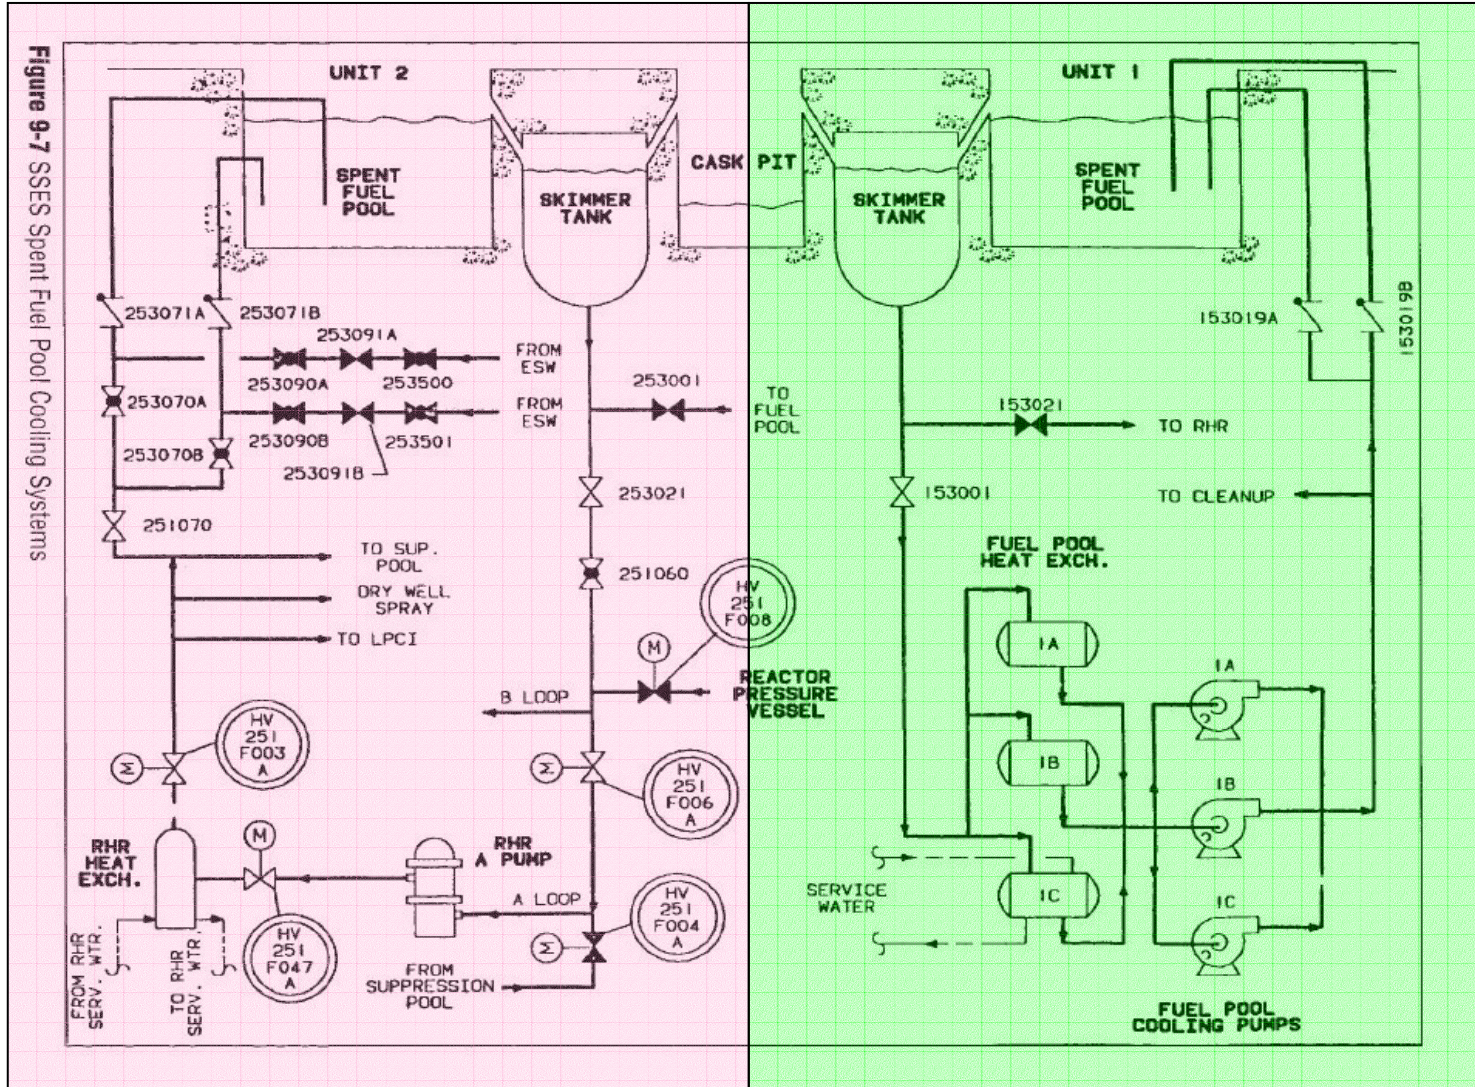
Design scheme of SFP cooling in Block 1 and 2 of Susquehanna GE Marl I plant,  
 from David Lochbaum "Nuclear Waste Disposal Crisis" PennWell Books, 1996  
 (Normal operation = green, emergency operation = red)

From the figure it can be concluded that in case of emergency operation and loss of battery power the pumps will stop and the motor valves remain open. In this case siphoning may suck the water from the SFP on the top of the building to some tanks or systems below.
