UNITED STATES  
NUCLEAR REGULATORY COMMISSION  
REGION IV  
612 EAST LAMAR BLVD, SUITE 400  
ARLINGTON, TEXAS 76011-4125

EA 11-024

SUBJECT: COOPER NUCLEAR STATION - NRC TRIENNIAL FIRE PROTECTION  
INSPECTION REPORT 05000298/2010006; PRELIMINARY WHITE FINDING

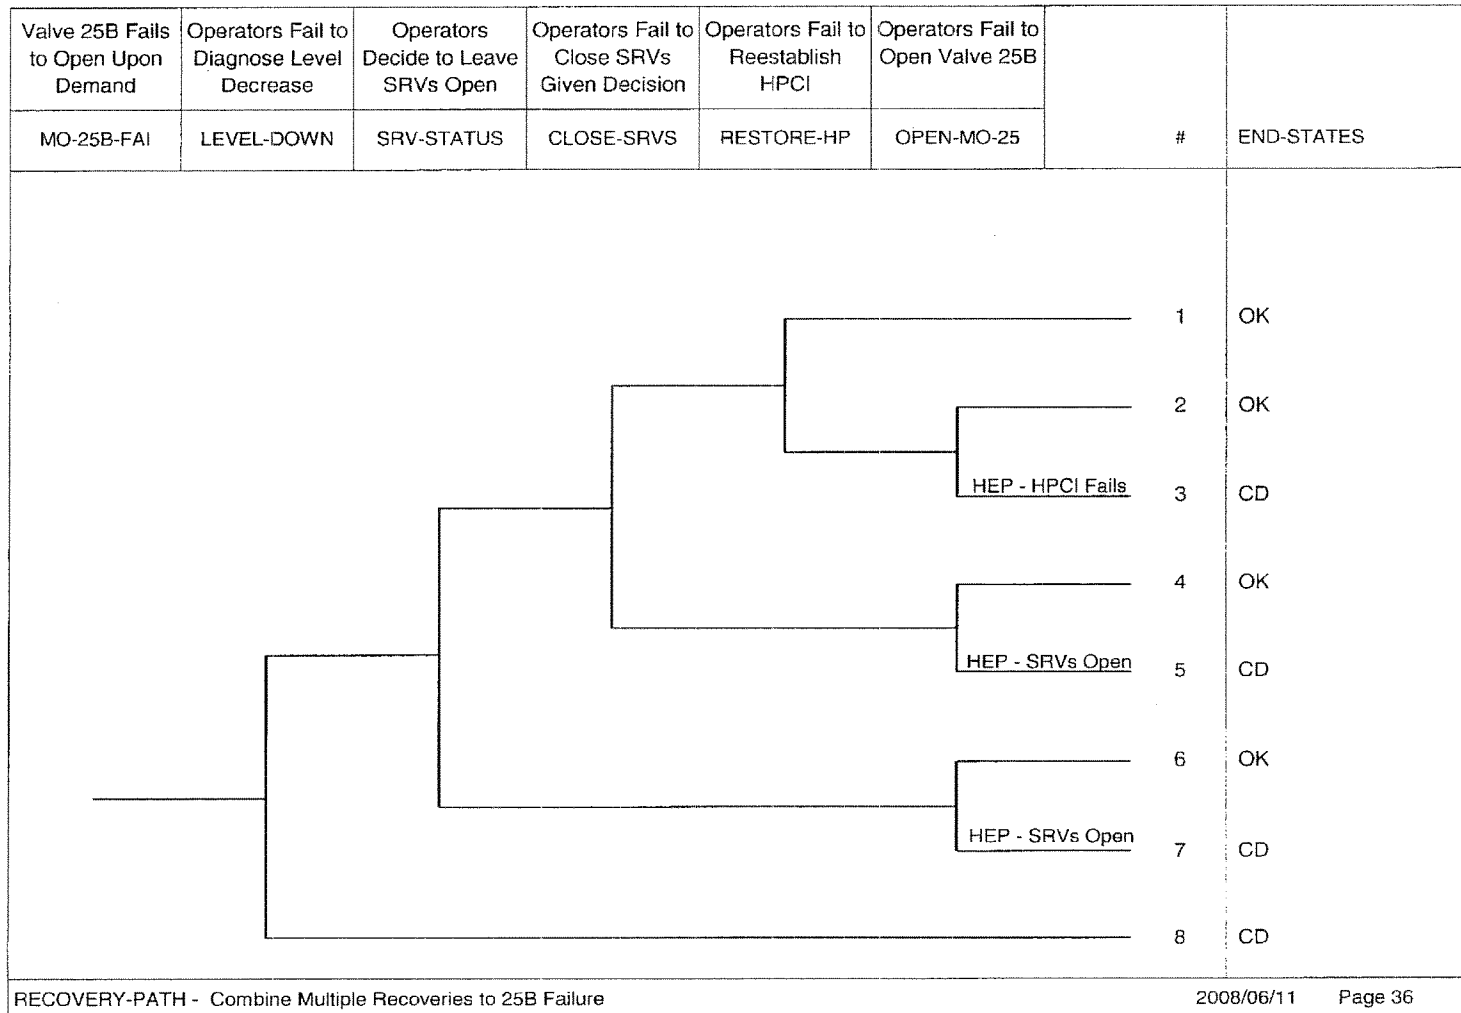
5. The analyst used an event tree, RECOVERY-PATH, shown in Figure 2 in the Attachment, to evaluate the likelihood of operator recovery via either restoration of HPCI or manually opening Valve RHR-MO-25B. The resulting non-recovery probability was  $7.9 \times 10^{-2}$ . **[Note: This value was adjusted to 1.01E-3 in the current analysis based on improvements made to Procedure 5.4FIRE-S/D.]**

Using the event tree in Figure 2 and the split fractions in Table 4, the analyst calculated a combined non-recovery probability of 1.01E-3.
